11/26 Link Incident: Audit Overview and Agency Response

Citizen Oversight Panel

3/2/22

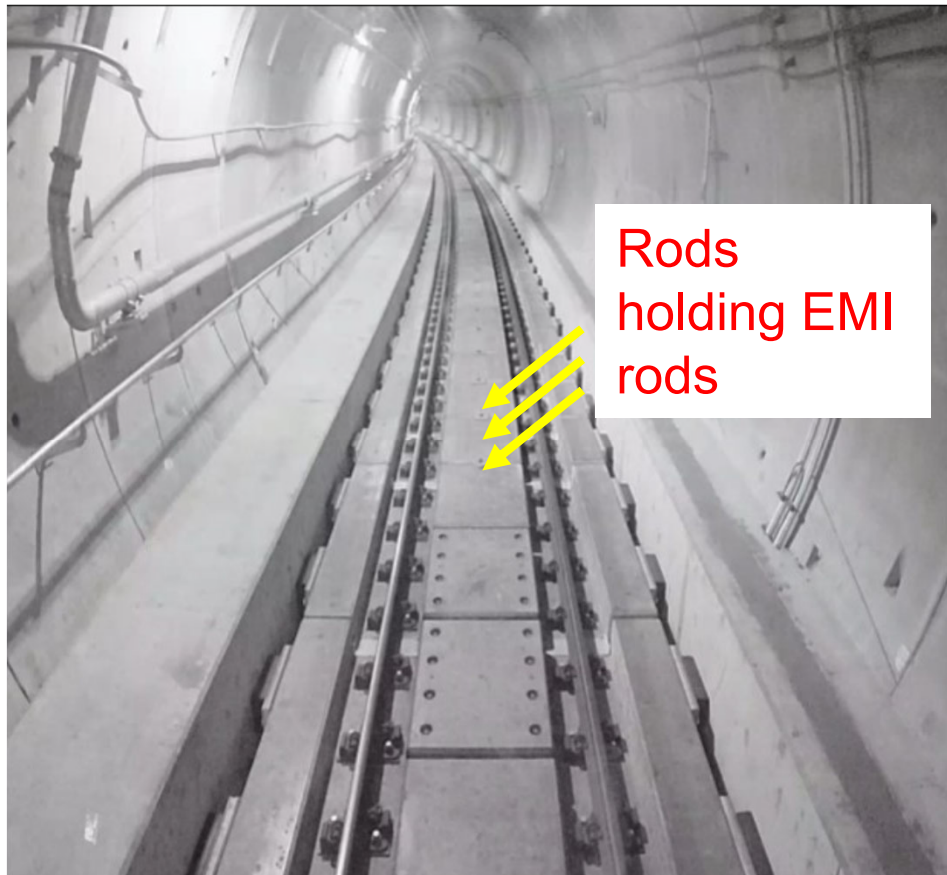
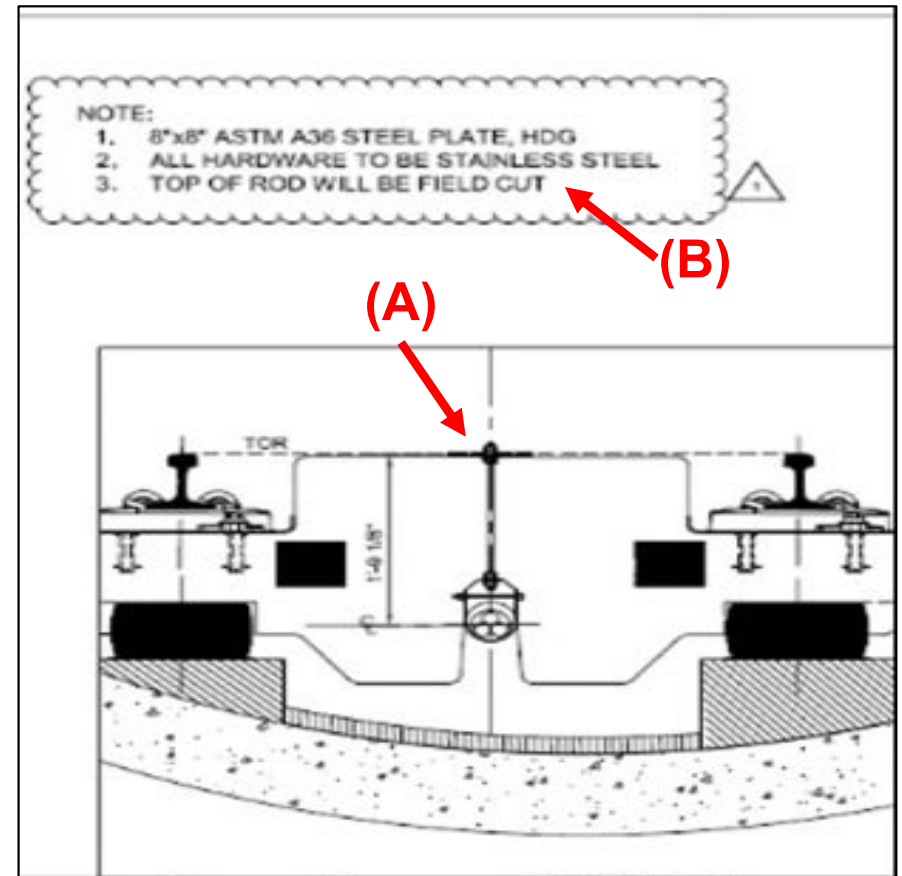
Electromagnetic interference (EMI) rods

Previously damaged EMI rod (left) and damaged vehicle (right)

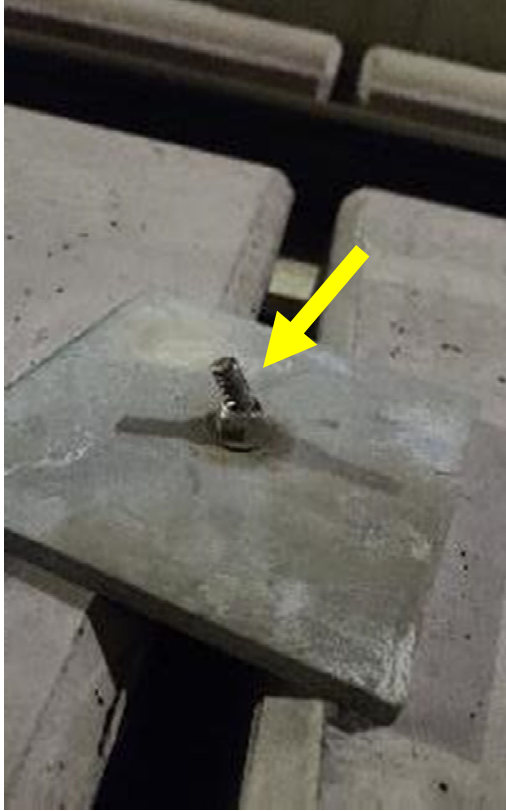
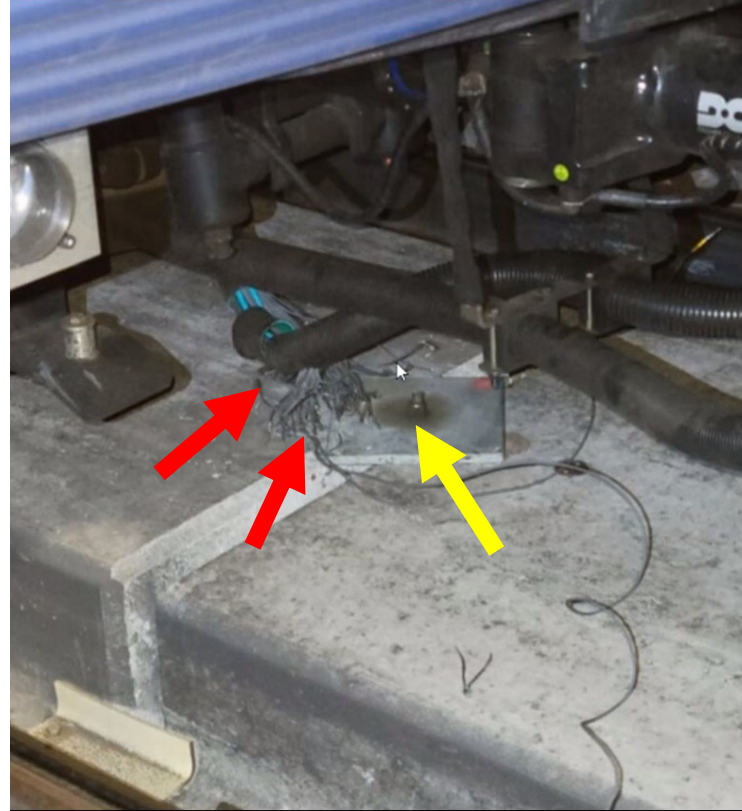
Damage caused by EMI rod

Conduit damage to light rail vehicle

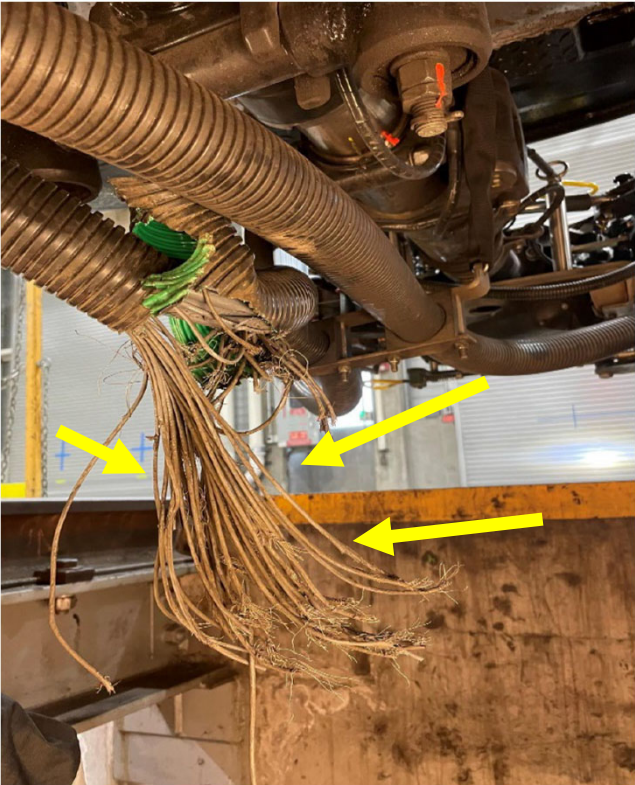
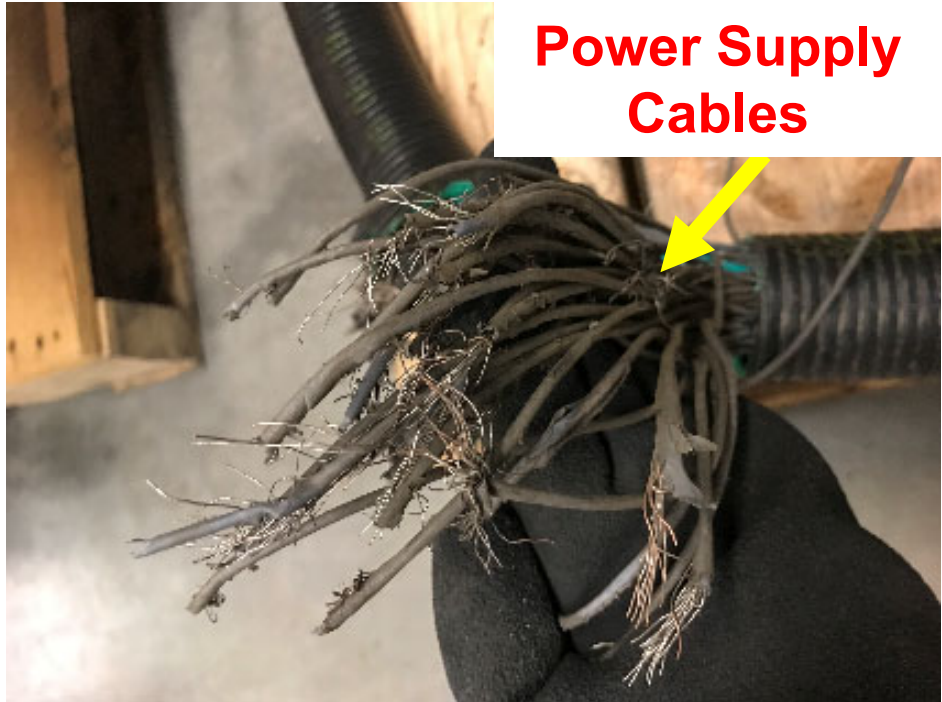
Post-incident vehicle clearance checks

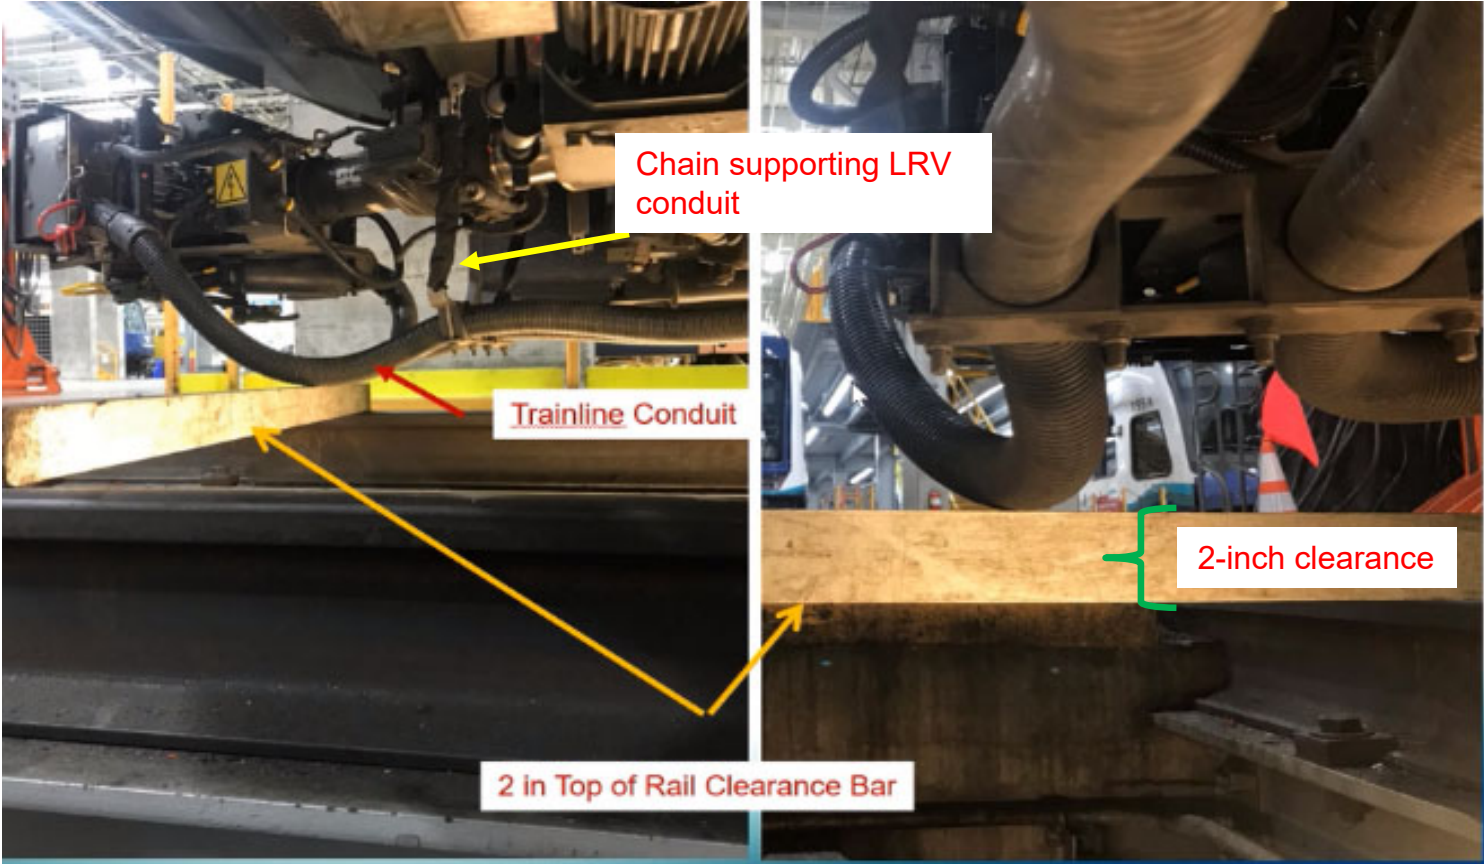
Configuration differences

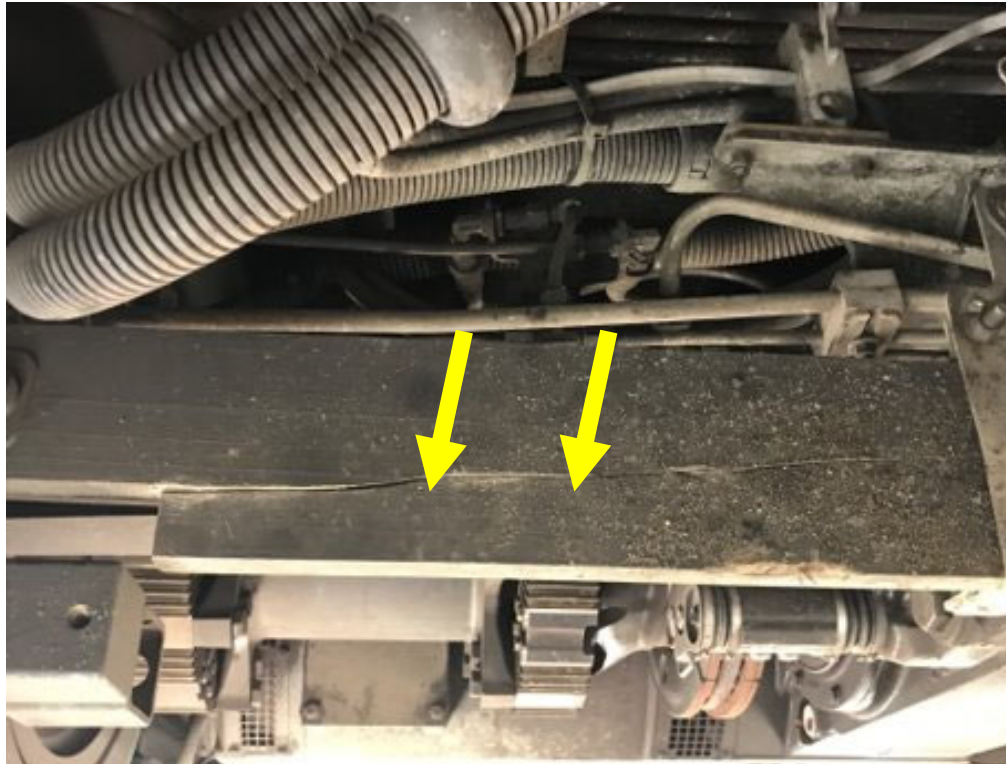
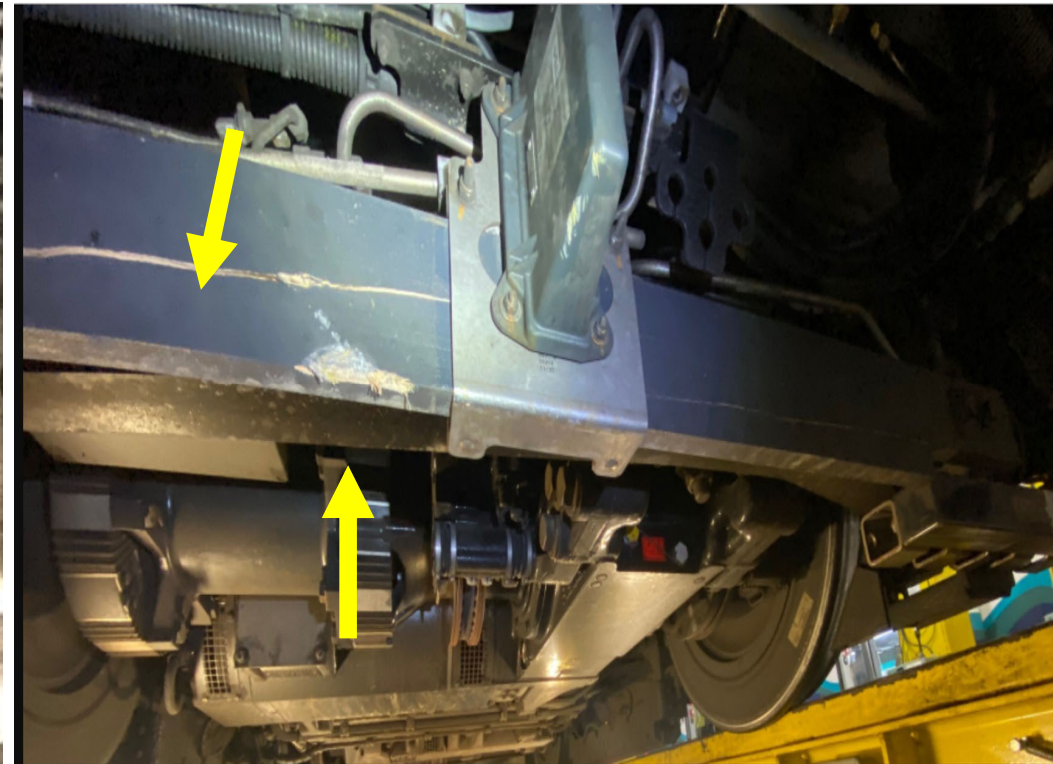
Damage occurring prior to incident

- Audit team reviewed 2,800 work orders, finding 16 relating to EMI rods or related damage.
 - 5 work orders for damage to Series 1 vehicles.
 - 3 work orders for damage to Series 2 vehicles.
 - 8 work orders for rods.
- King County Metro was looking into the issue and notified Sound Transit Engineering.
- King County Metro Safety, Sound Transit Operations, and Sound Transit Safety were not notified, as established by procedures.

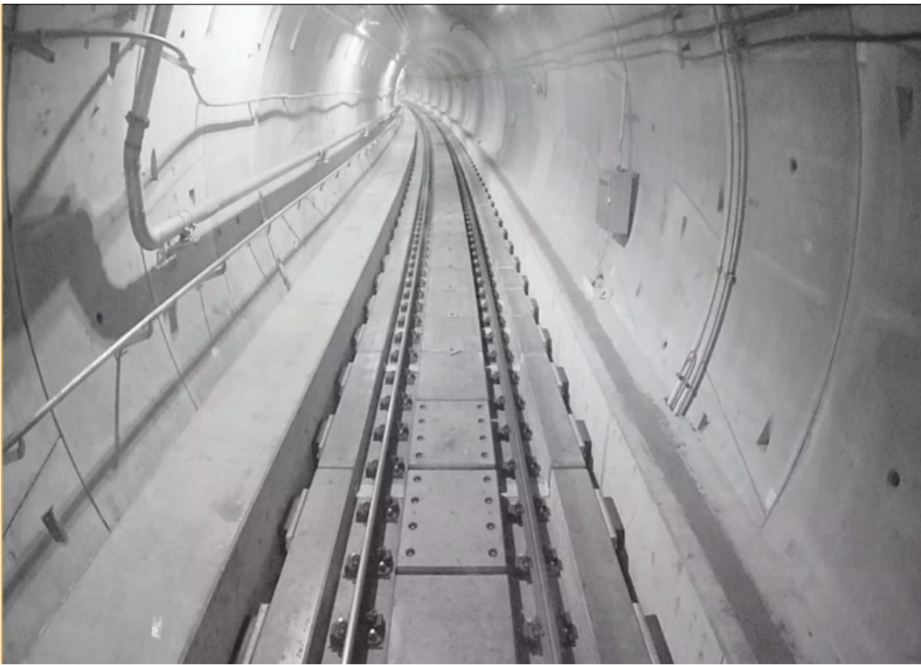
8:20pm (+1 minute) – 1,000 feet north of UW Station, the train loses power and comes to an abrupt stop

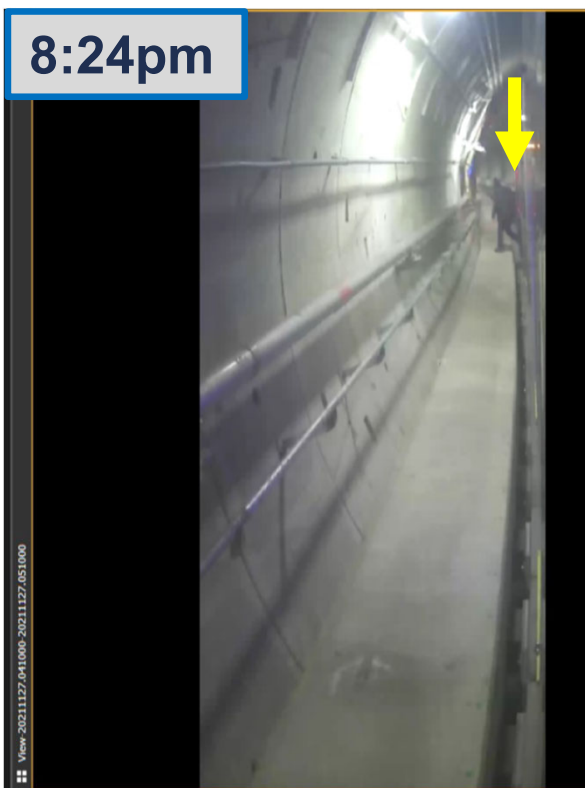
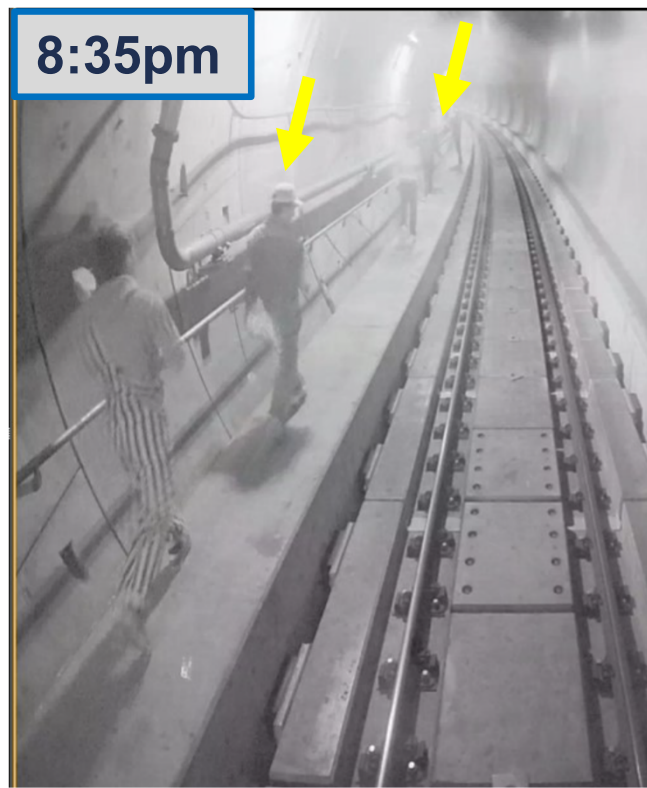
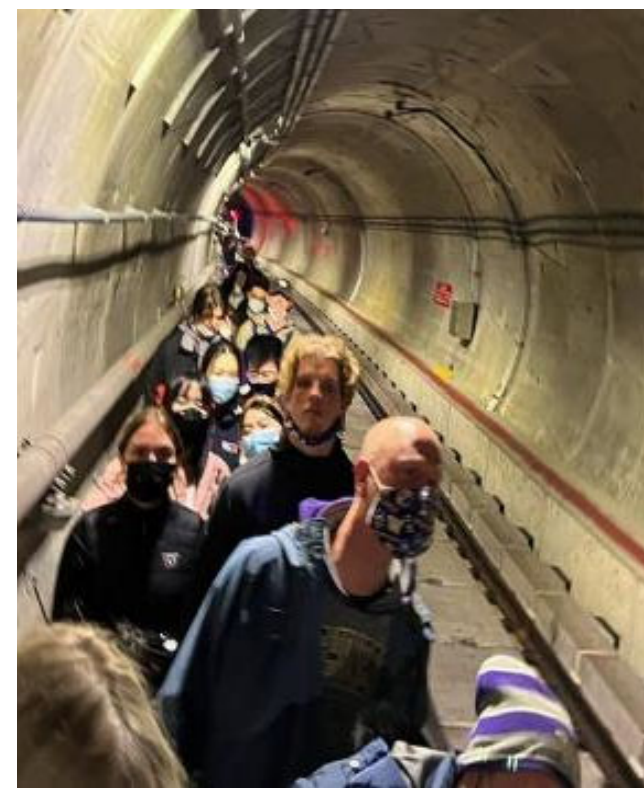
8:24 (+4 mins): passengers begin self-evacuating the train
