APPENDIX D

**Winters House Construction Minimization
and Avoidance Technical Memorandum
and Landscape Report**

Winters House Construction Minimization and Avoidance Technical Memorandum

Sound Transit, East Link Project

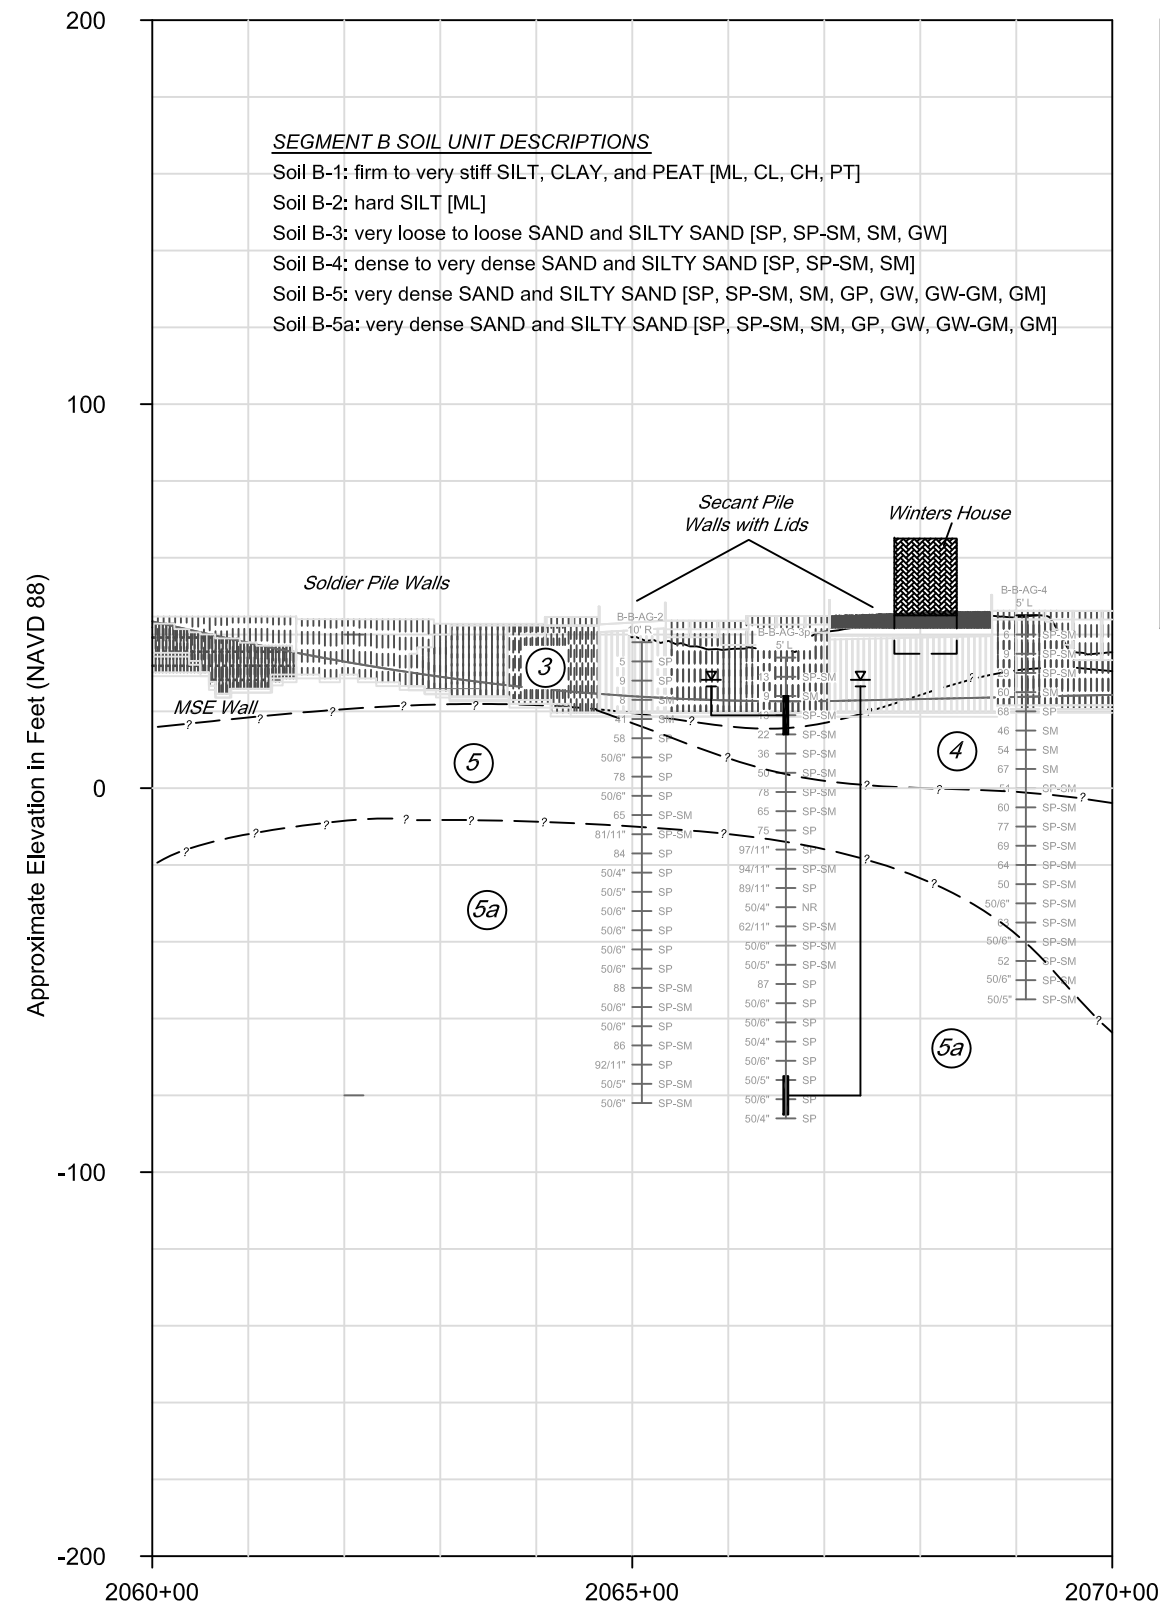
FIGURE 2

- Figure 2 provides a structural cross section of the transit corridor illustrating the elements of this structure and its approximate setting in relation to the Winters House. In this figure, the approximate location of the Winters house foundation walls and footings are shown. The secant pile walls near the house are shown where they will extend below the basement of the house. This figure also illustrates the approximate subsurface strata and groundwater location as measured in nearby soil borings.

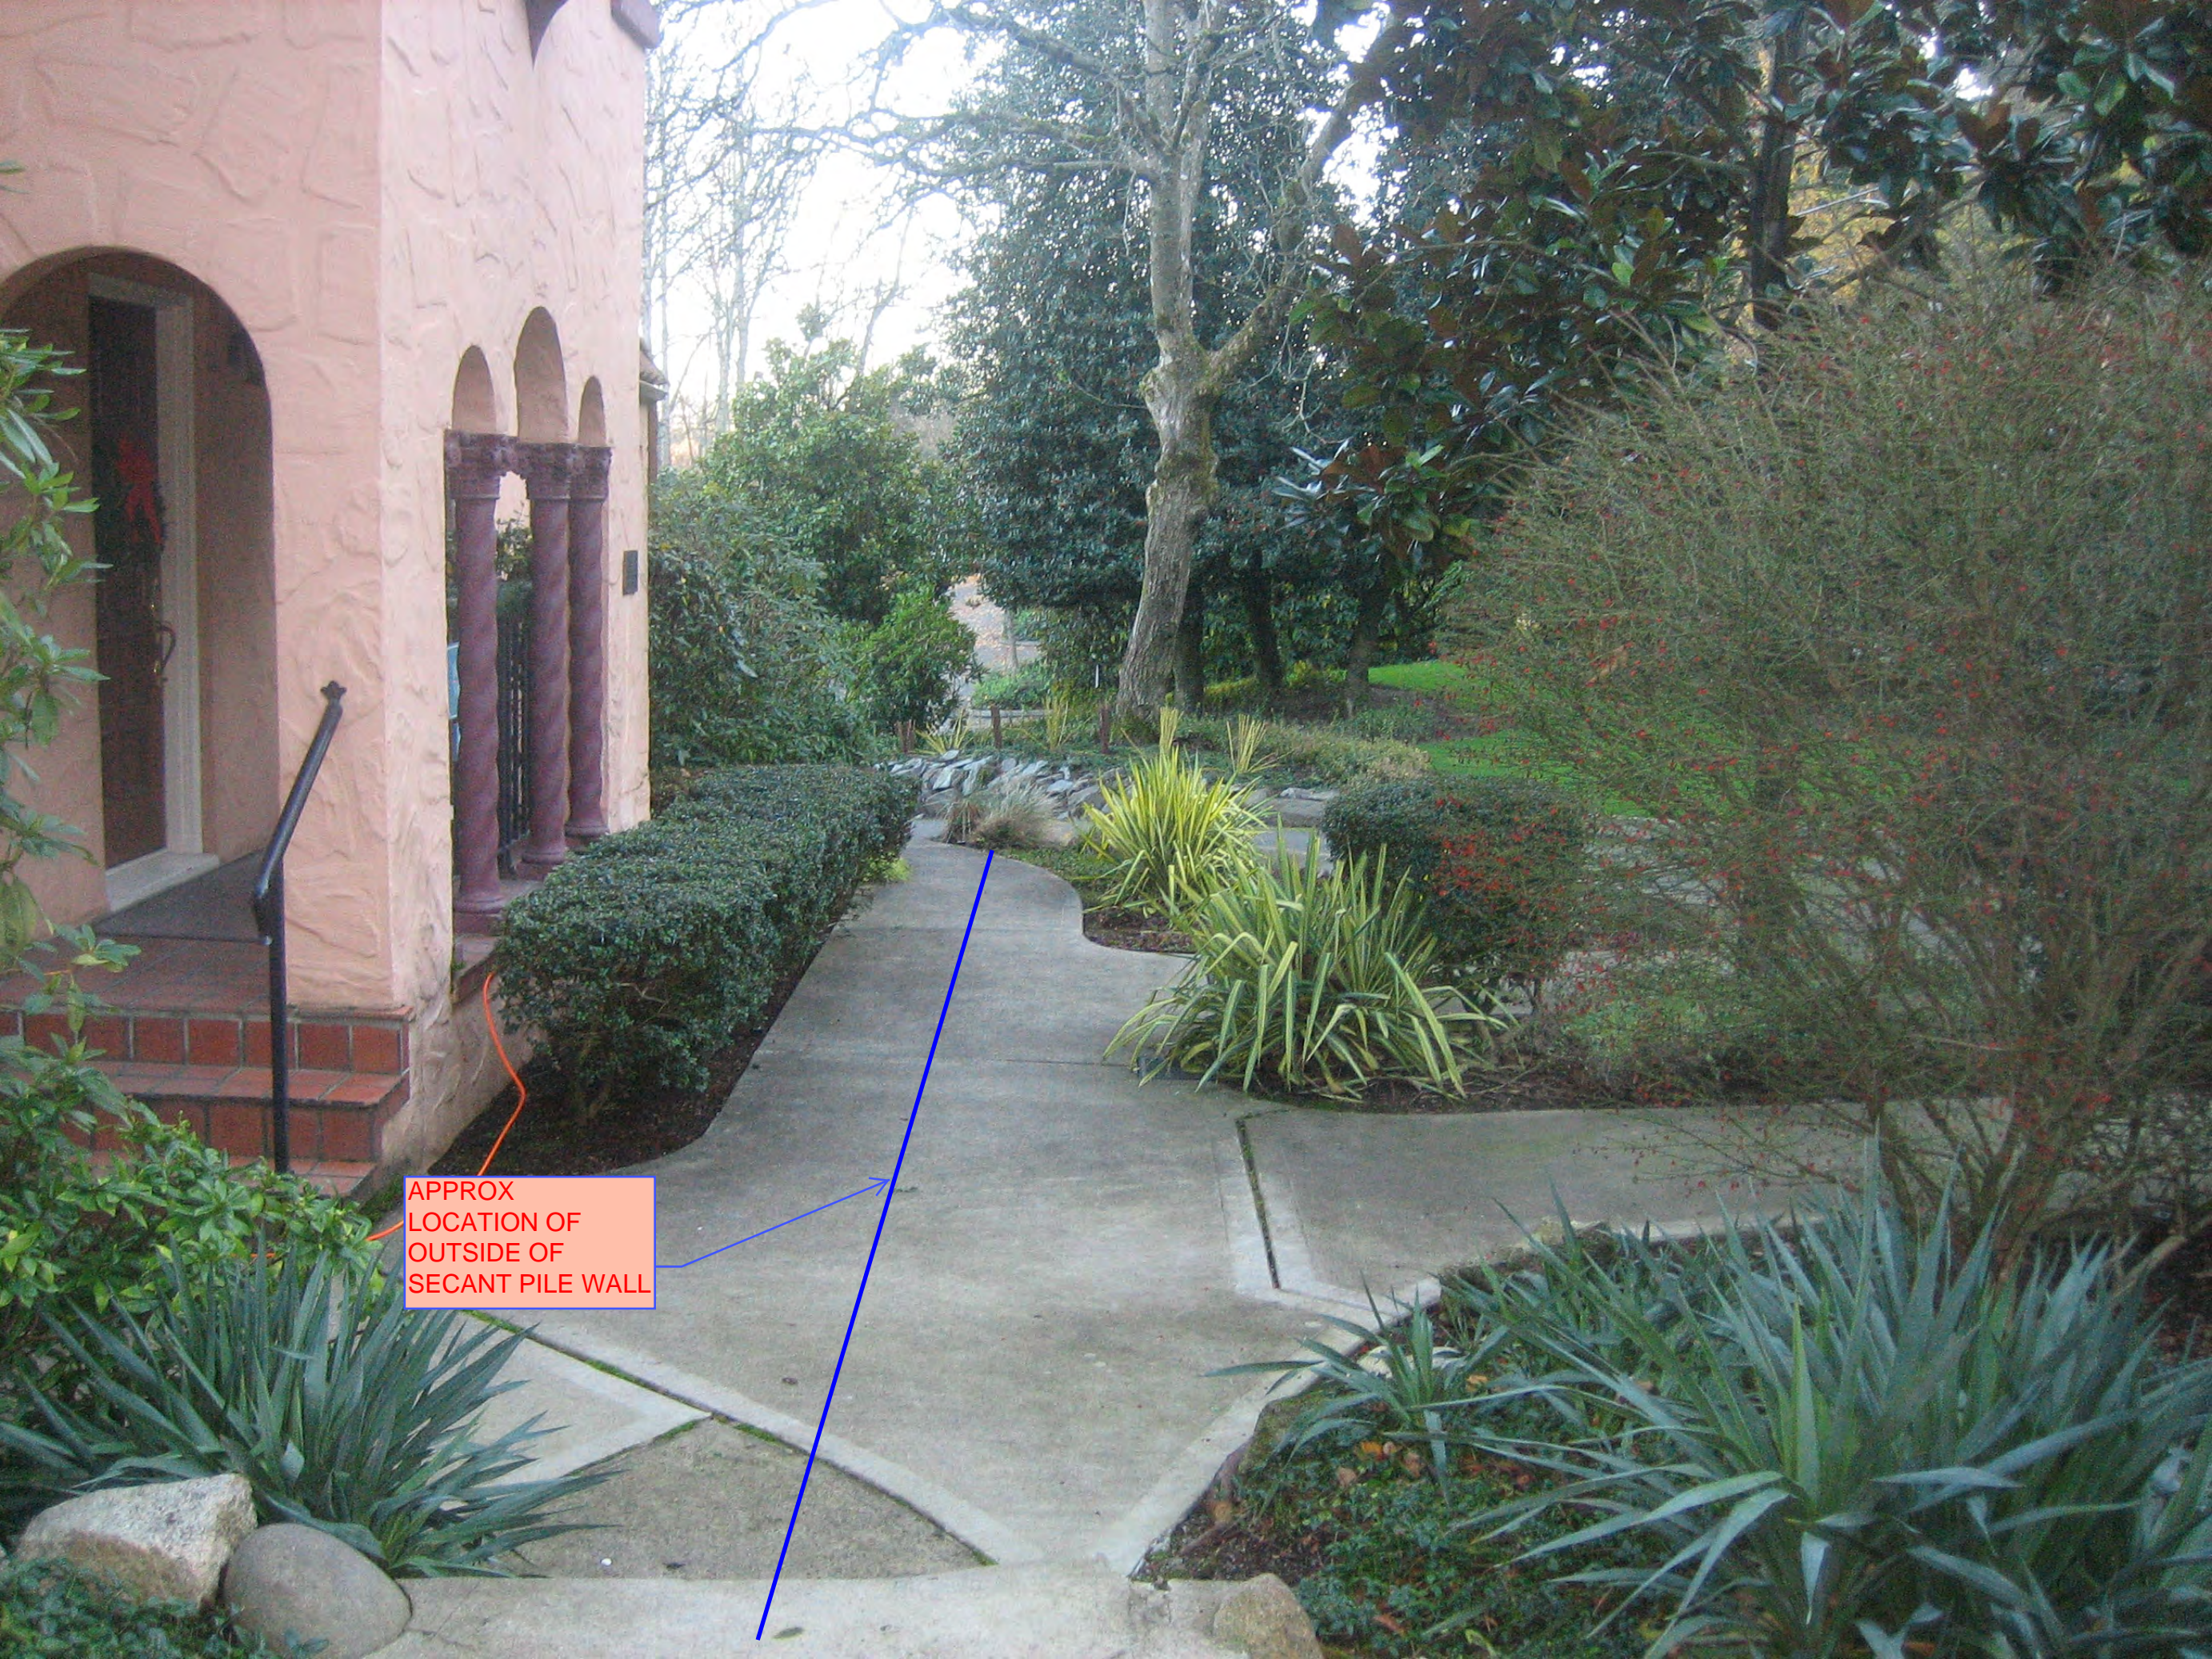
8. **Lateral Deflection of Piles.** The most likely cause of damage that could occur to the Winters House would likely result from lateral deflection of the walls of the transit corridor during construction. Lateral (horizontal) movement of the corridor secant wall next to the house could result in an approximately equal amount of vertical settlement of the slab-supported porch along the west side of the Winters House.

APPROX
LOCATION OF
OUTSIDE OF
SECANT PILE WALL

Basement

Front Porch

~4'-6"

9. **Support of porch along the west side of Winters House.** Based on the configuration shown in Figure 2, and further investigation and verification of shape, configuration, and depth of supporting slab, it may be helpful to provide small piles (referred to as pin piles) or other shallow temporary supporting system or walls to provide increased support and assurance that the soil next to this foundation is not disturbed. Final evaluations of the foundation conditions will be verified during the final design process. Permanent supports will be designed to fully support the soils and footings of the porch.

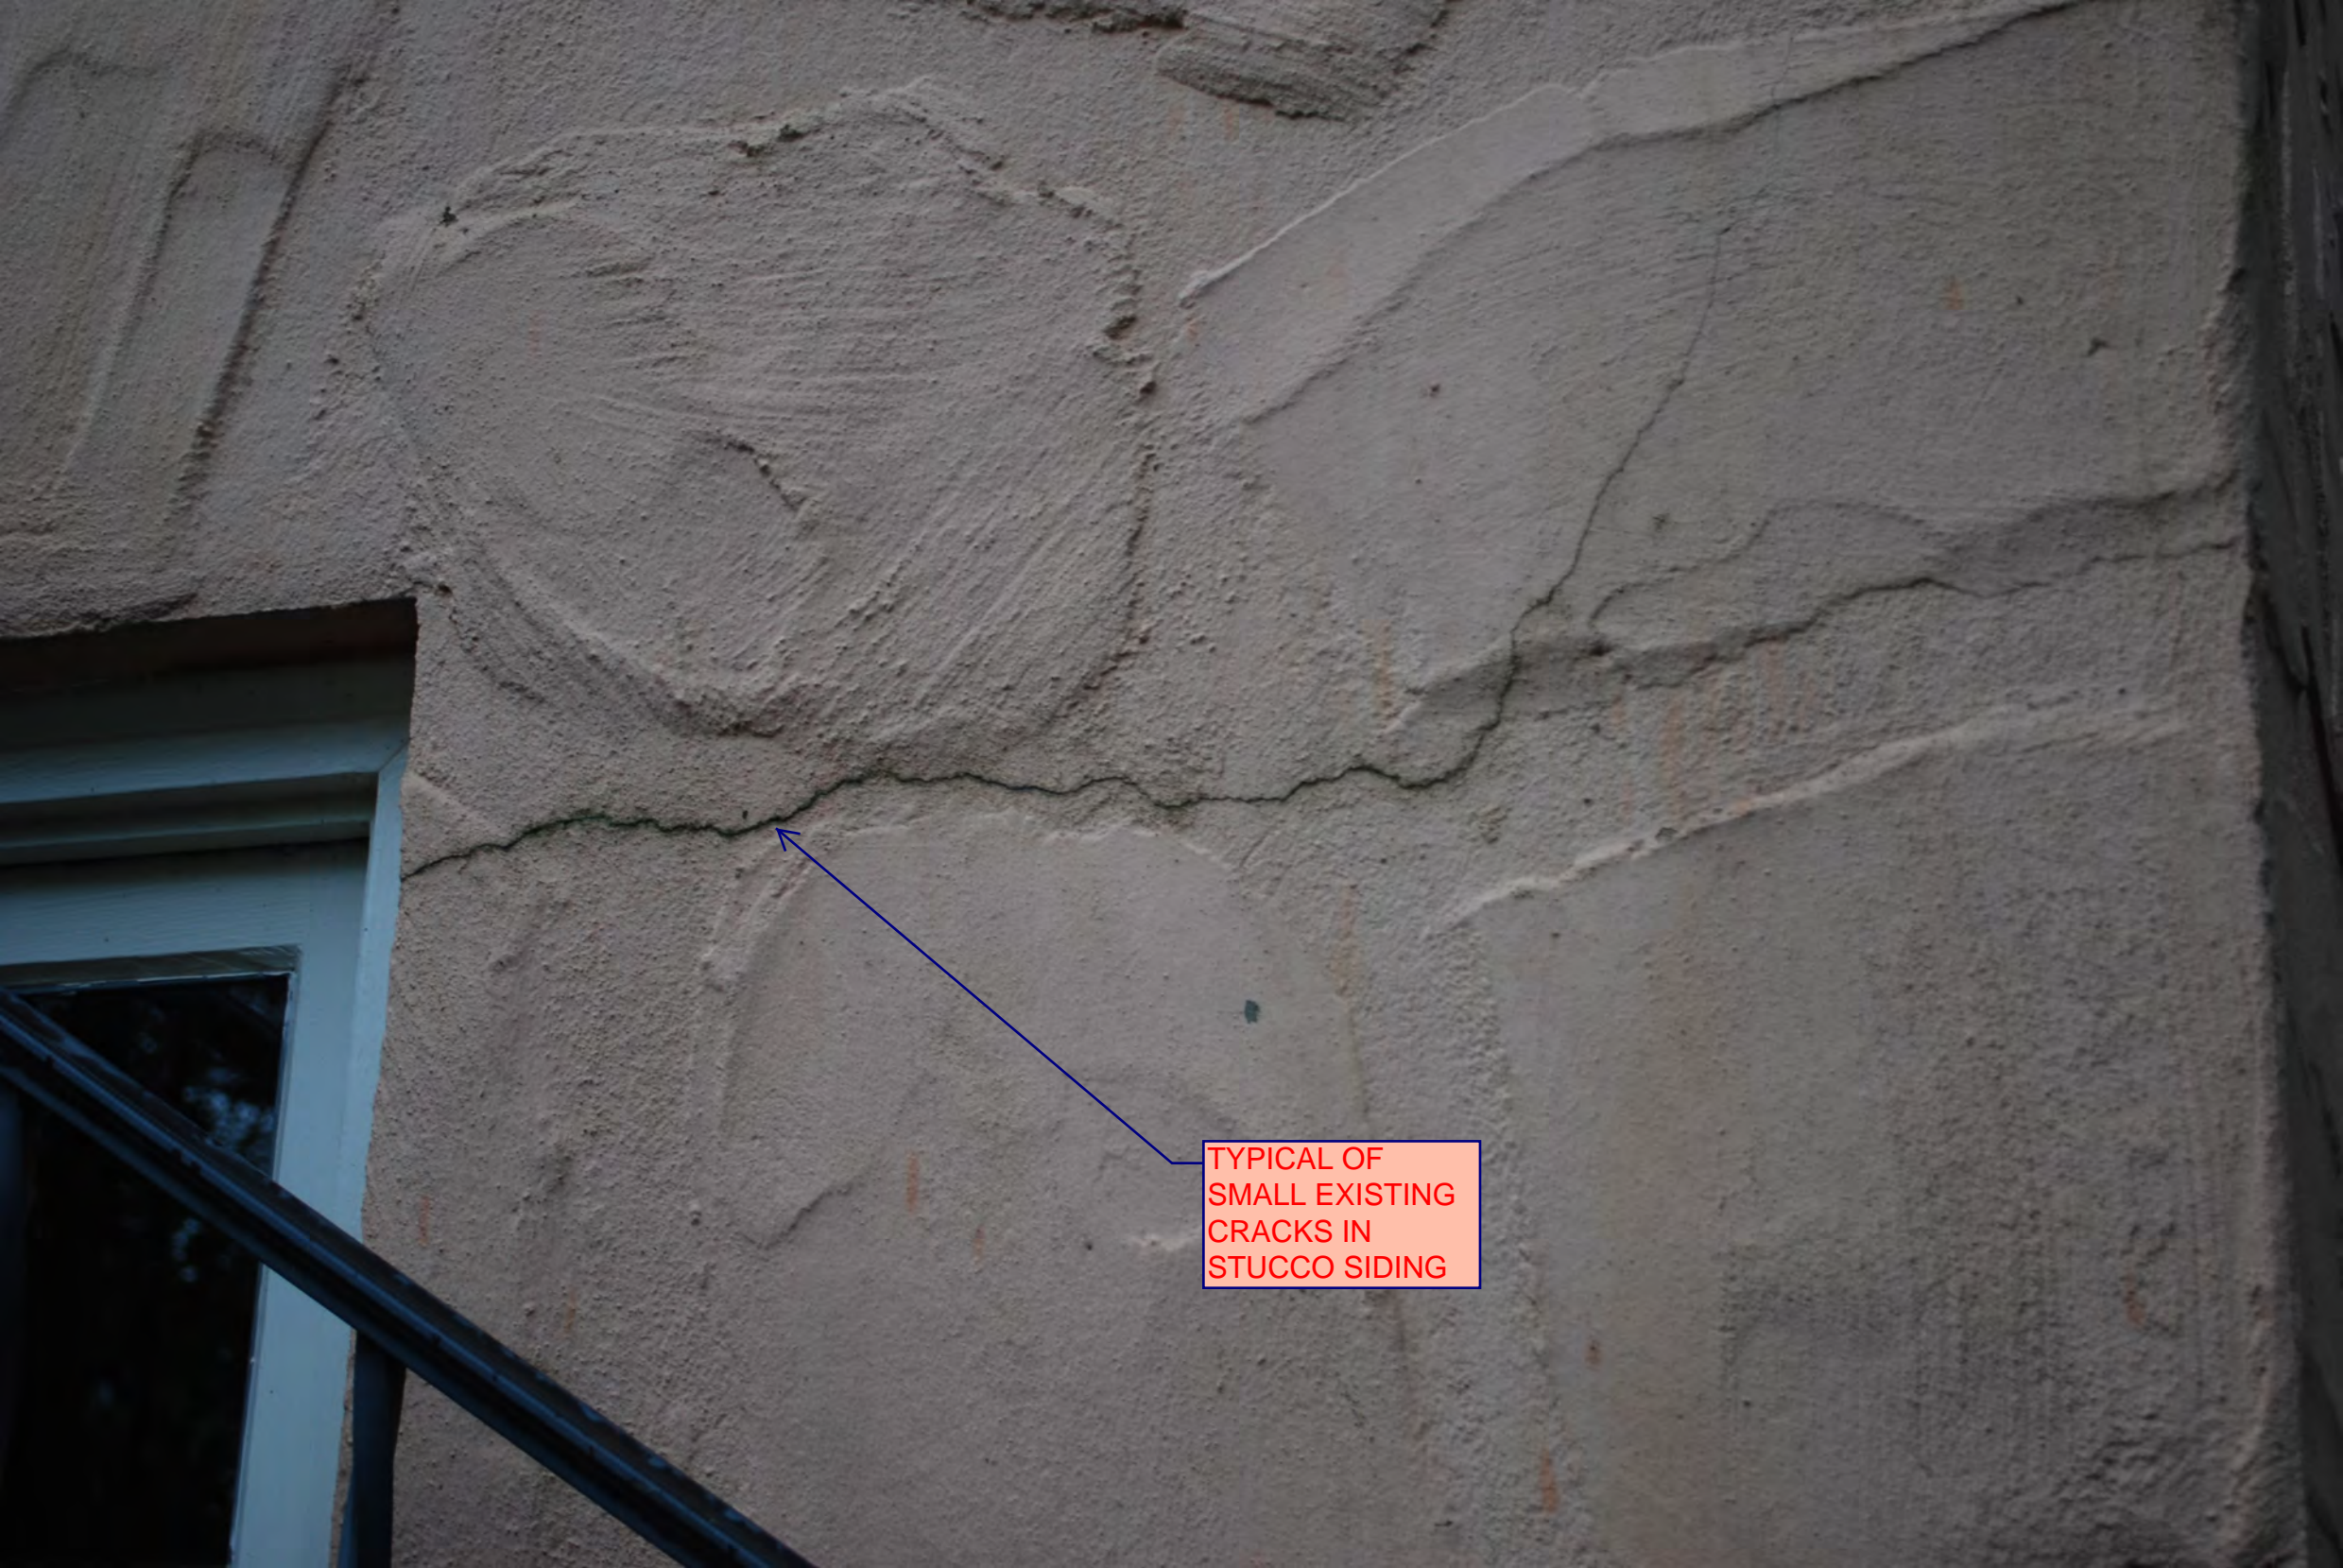
TYPICAL OF
SMALL EXISTING
CRACKS IN
STUCCO SIDING

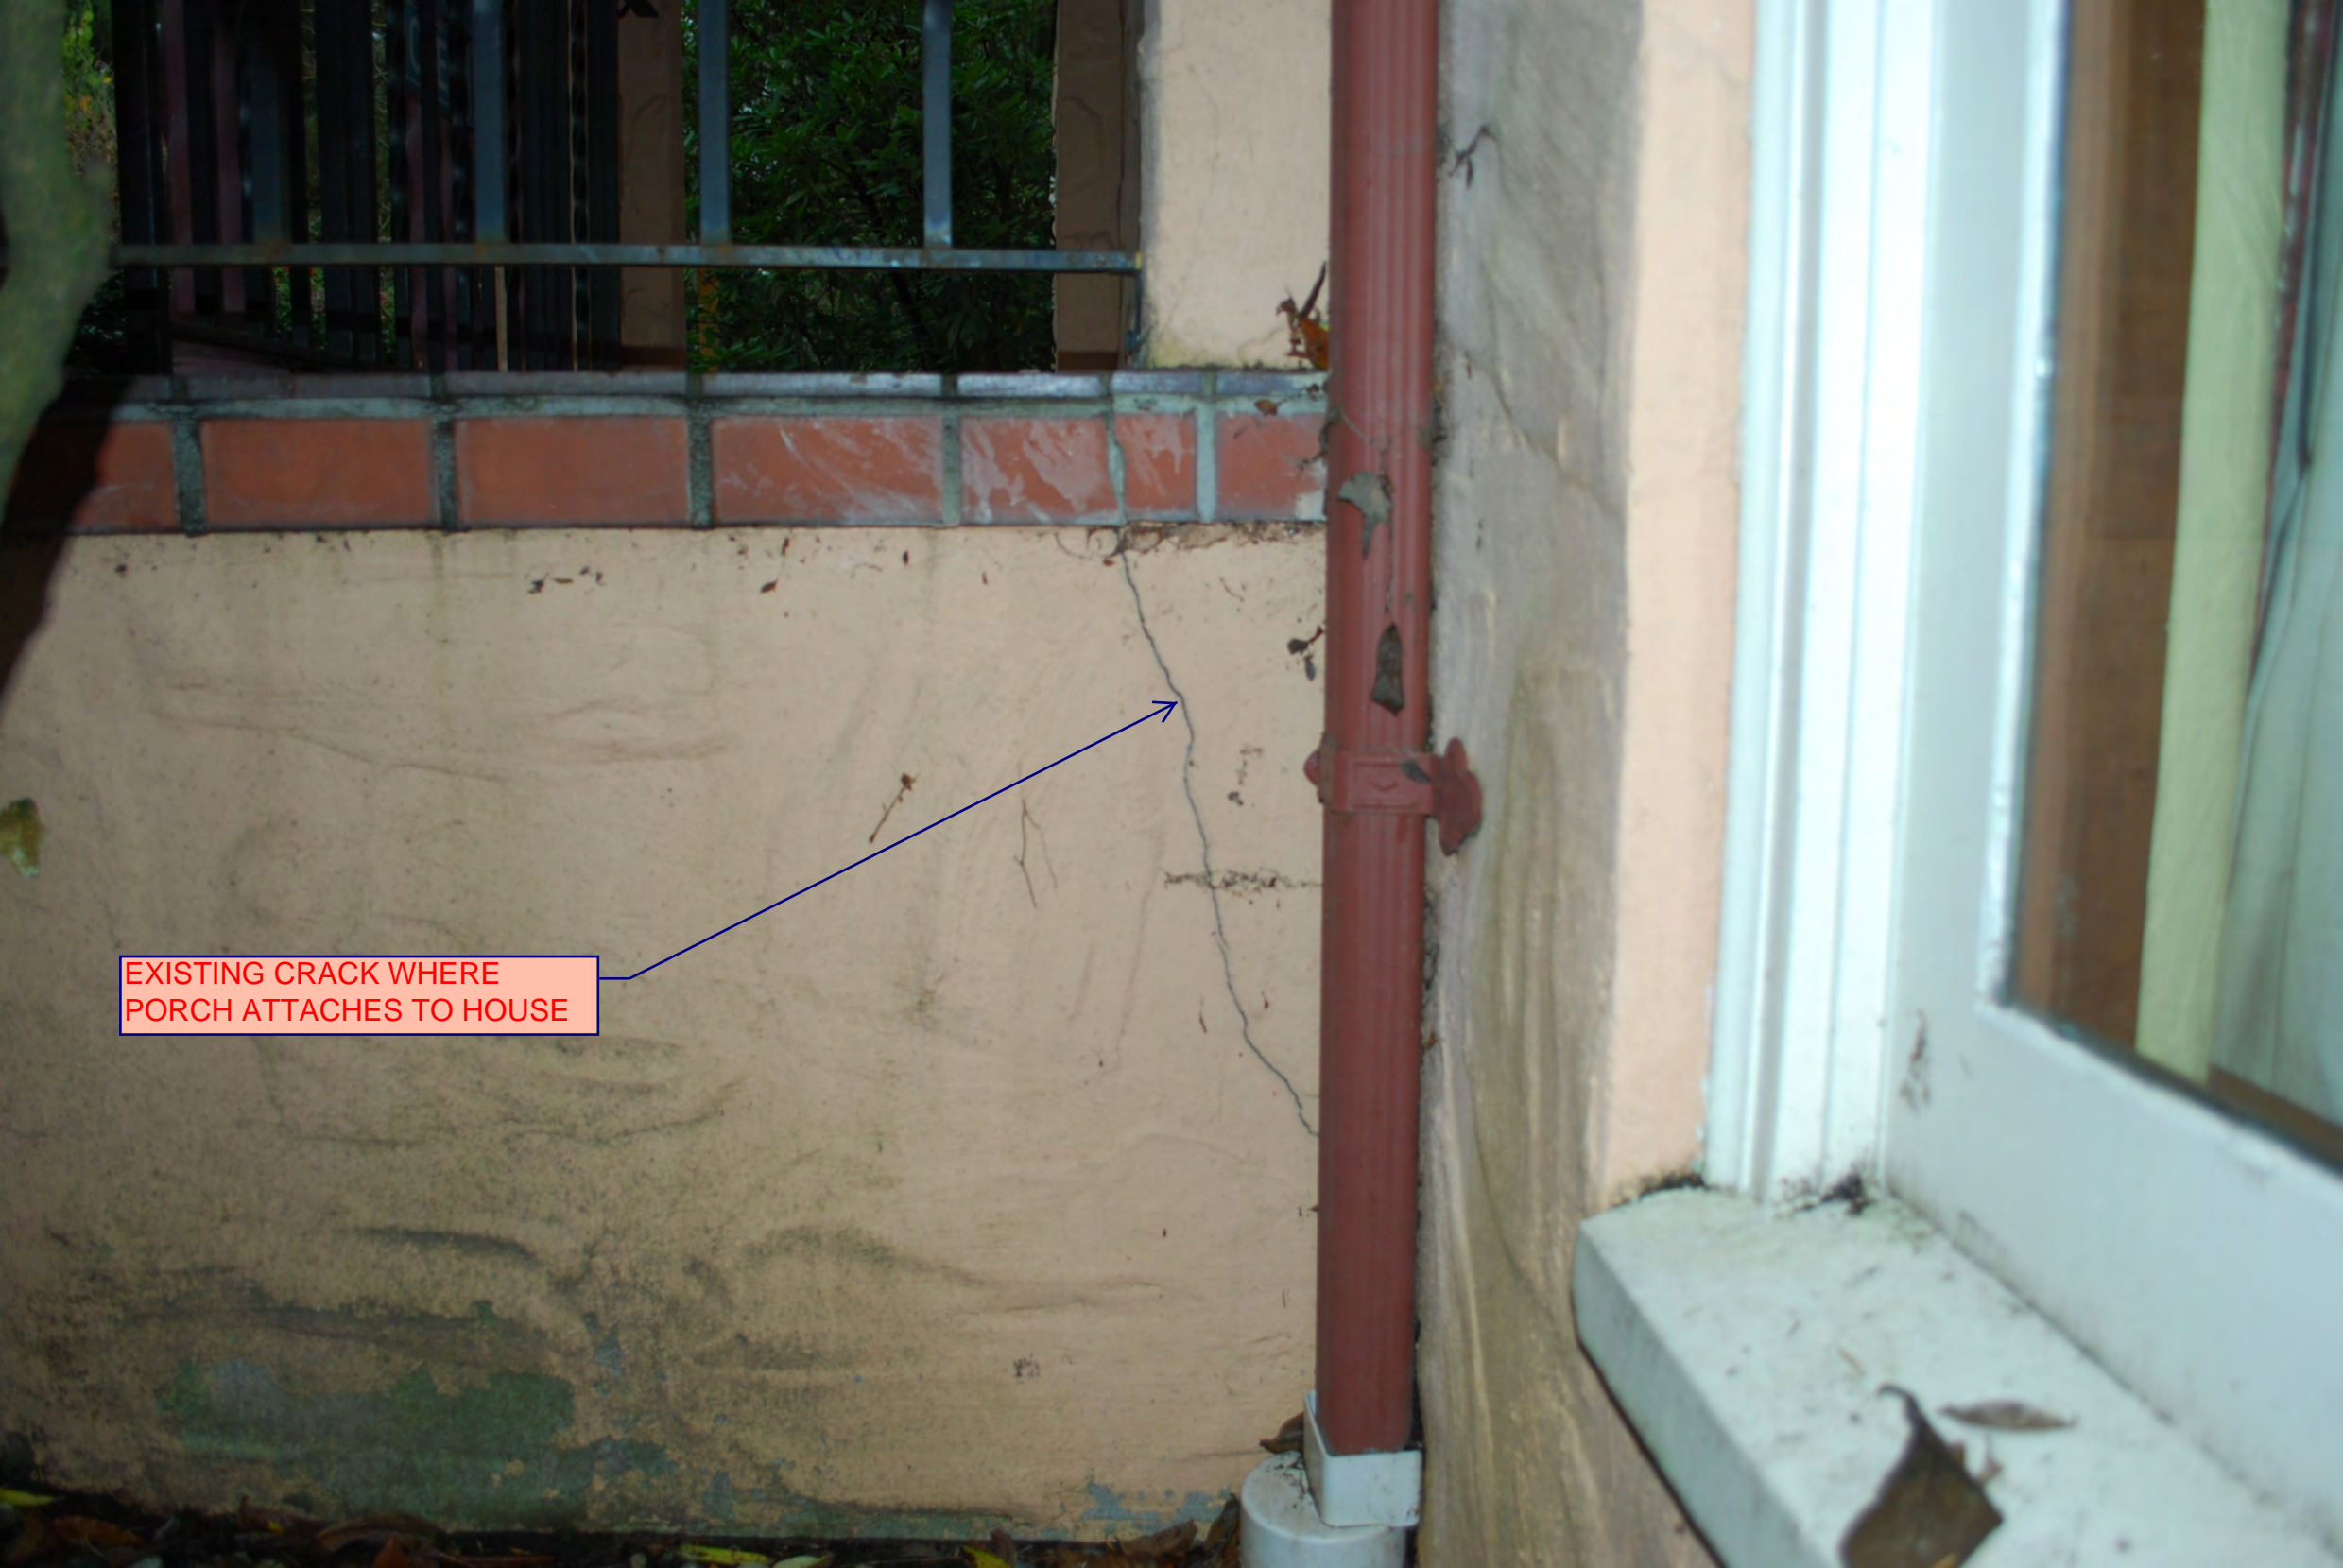
EXISTING CRACK WHERE
PORCH ATTACHES TO HOUSE
