**DRAFT Internal Audit Report:**

**Link Light Rail Service Event  
from November 26, 2021**

Report #: 2021-19

**Sound Transit Audit Division**

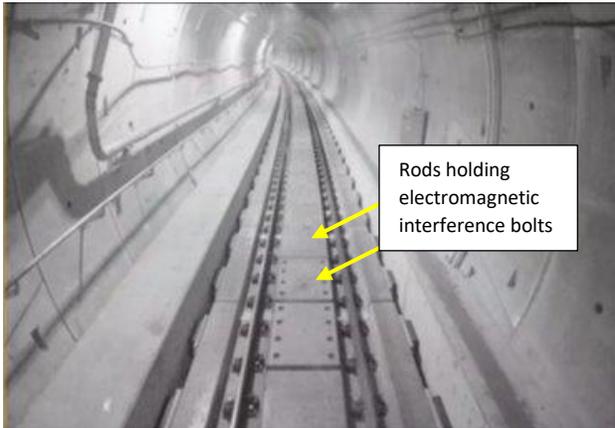
At 8:20, about 1,000 feet into the northbound tunnel, the train appeared to have struck an object in the trackway, stalled and came to an abrupt stop. It lost all power, including HVAC and presumably all communication capabilities with passengers (see figures 5 and 6). There were no injuries.

**Figure 5.** Photograph from Train 6 (Car 246) just before impact with rods holding EMI bolts on the floating trackway.

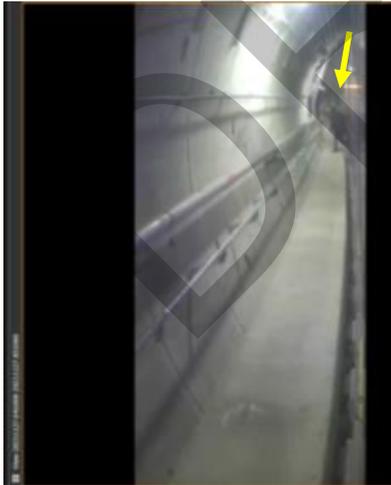
After several minutes without any communication from the operator, as early as four minutes after the train stopped and went dark, passengers started self-evacuating from the train using emergency door release handles.

**Figure 7.** Photograph of passenger self-evacuating Train 6 at 8:24.

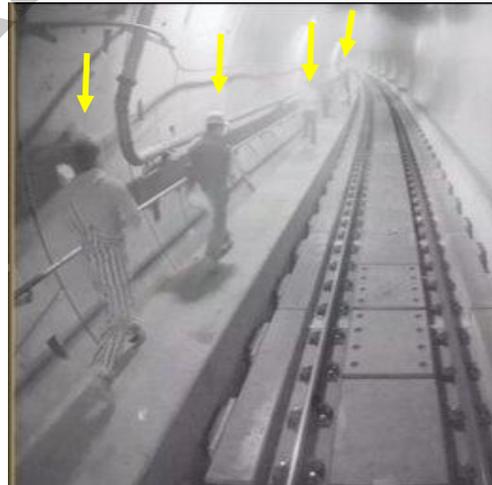
**Figure 8.** Photograph of passengers self-evacuating Train 6 at 8:35.

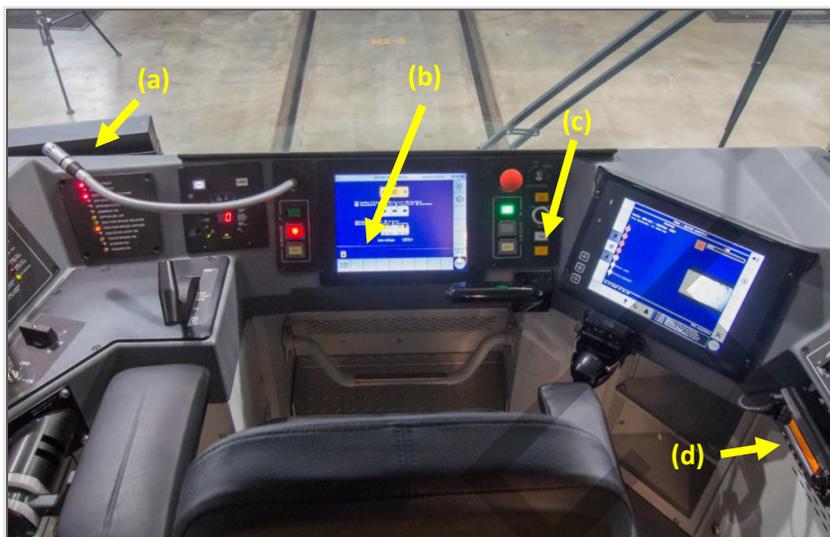
Based on transmission transcripts, no formal communication from the operator to the passengers occurred for 12 minutes, even though there is a public address button available, as noted on the operator's display screen in the Siemens vehicle. This display (figure 9) shows the location of items relevant to communicating with passengers.

**Figure 9.** Photograph of inside the operating cab of Series 2 LRV with arrows pointing at (a) Microphone, (b) Live PA button location on TOD screen, (c) PTT button for intercom, and (d) LRV onboard radio. Source: LRV Operator Training Manual

Camera footage inside the cab confirmed that the operator did not attempt to use the internal PA system until approximately 8:32.

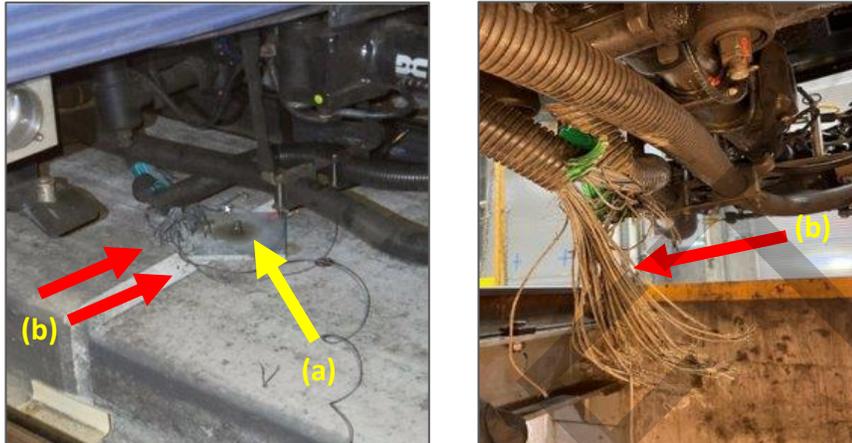
Train 6 was towed back to the Operations and Maintenance Facility that evening. Car 264 sustained \$12,453.95 of damage to the trainline conduit.

**Figure 11.** Photographs of damage from underneath Train 6 (Car 246) with arrows pointing at (a) the EMI rod and bolt that were struck by the conduit, and (b) the damage done to the power supply conduit cables.

Shortly after the incident, Sound Transit Link Operations instructed King County Metro to quarantine Car 264, pending the full investigation.

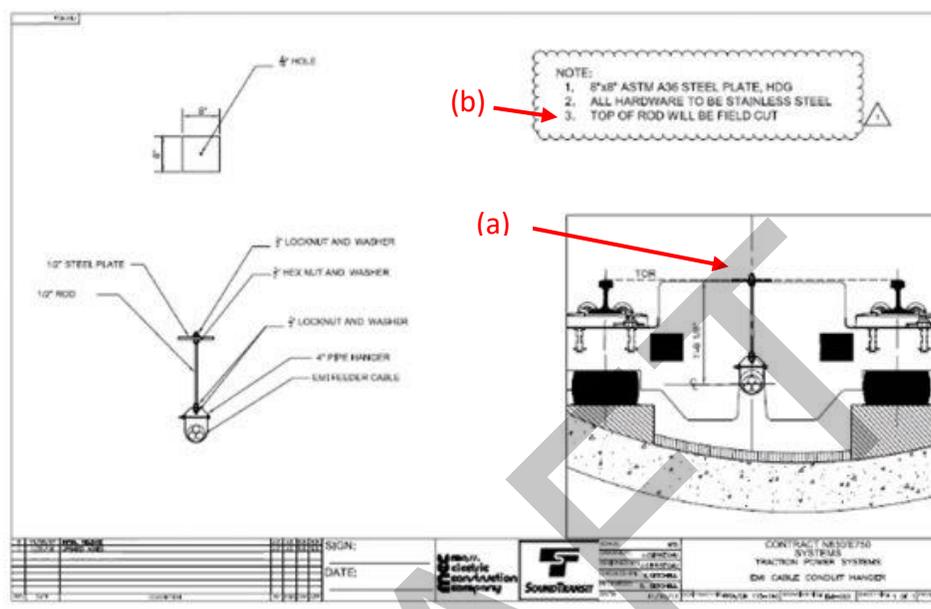
- a.2. Additionally, construction procedures require field inspections to verify that contractors constructed track as designed. Shop drawings noted that EMI rod design would 1) protrude above the top of rail in design, and 2) that the EMI "Top of Rod was to be field cut"; however, it was unclear on the shop drawing where to cut the rod and how much clearance to ensure.

The design, however, had two indicated concerns that were not found until after the November 26, 2021 event, shown below in this shop drawing: (a) that the rod and bolt holding the EMI feeder cable protruded the top of rail (TOR), and (b) that the top of the rod was to be field cut. How much to be cut was not specified on this shop drawing.

**Figure 14.** Shop Drawing of the EMI Feeder cable, along with the floating slab; showing (a) the EMI bolt and rod protruding TOR, and (b) that the rod needed to be field cut modified in red by Audit Division)

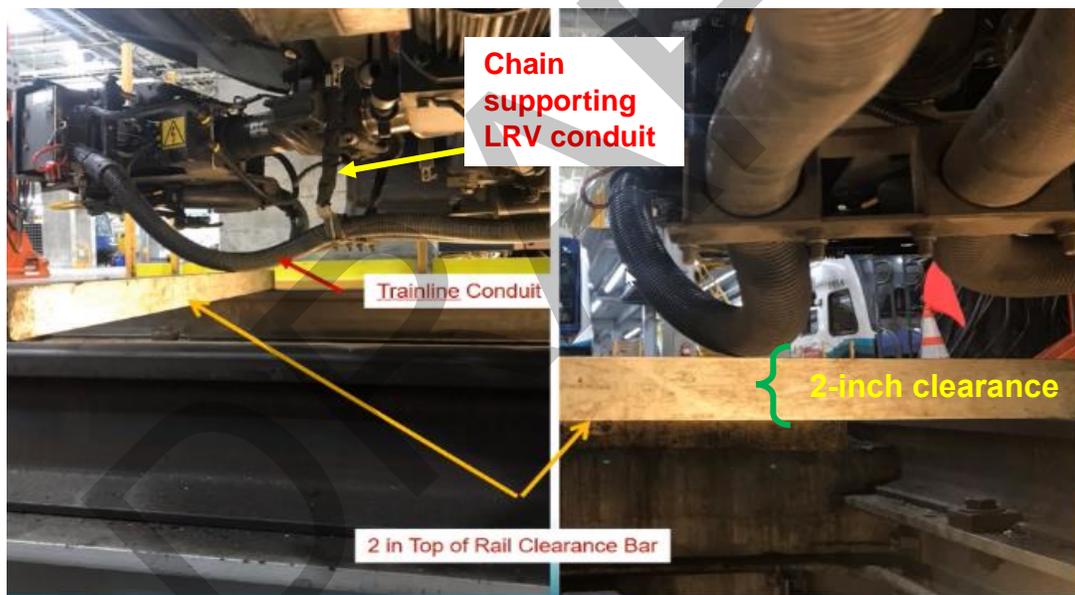
- a.5. Sound Transit requires ground clearance testing to check ground clearances before introducing new vehicles into the transit system. Ground clearance testing for the Series 2 vehicles was completed. However, testing was improperly done because it was not done at a proper “crush load” weight, nor tested at a historically high-ridership location.

**Finding a.5.** Vehicle clearance testing was improperly done because it was not done at a proper crush load weight, nor tested at a historically high ridership location.

Continuing to use the incorrect weight load, train tests then checked to ensure it had a minimum 2-inch coupler clearance above top of rail when empty, as required. Again, at the time of testing, the minimum spacing test passed the coupler clearance test, but as we learned later, the 2-inch specification was not the correct measurement for a Series 2 train but rather, it matched the specification for Sound Transit's other light rail vehicle, the Series 1.

**Figure 17.** Photograph of Series 2 trainline conduit hanging near 2-inch clearance bar, as specified for a Series 1 vehicle and not a Series 2, modified in red by Audit Division.

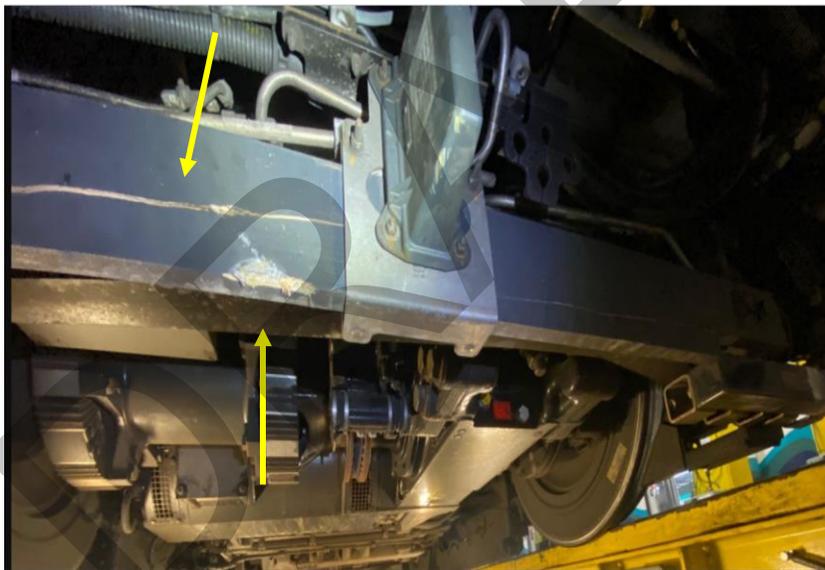
Prior to November 26, 2021, King County Metro vehicle maintenance staff were discovering Link vehicles being damaged on their oak boards, also known as Safety Boards, which help prevent people or objects from rolling under the train. As shown below, there is a large crack and gouge taken out of the board, denoting the train had struck an object at a considerable speed

**Figure 19.** Photograph of a damaged Series 2 vehicle, and arrow pointing to Oak "Safety" Board

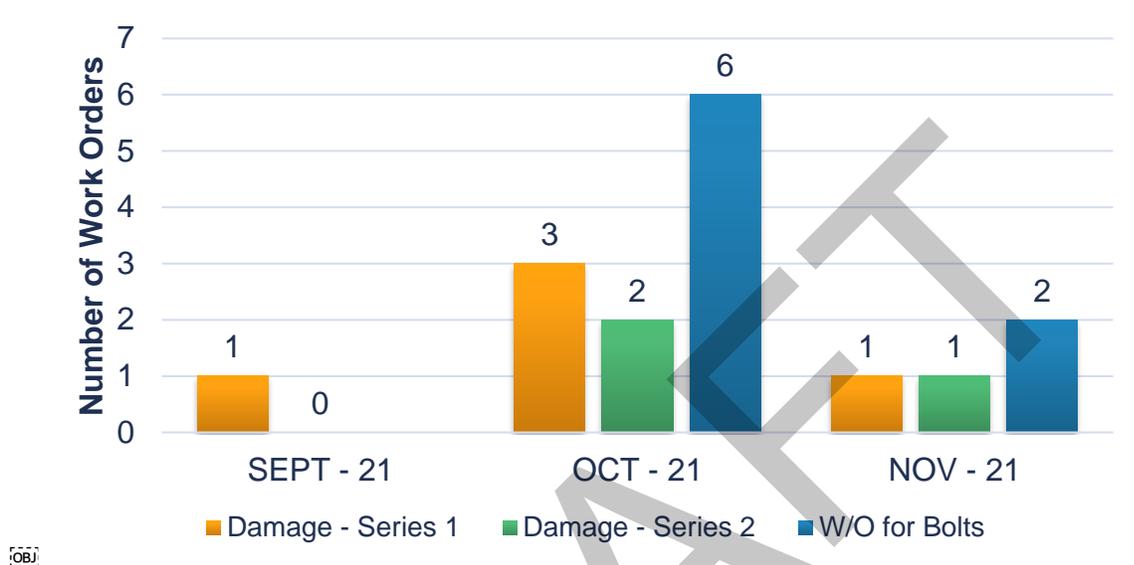
- a.8. Beginning a month prior to the Nov. 26 event, maintenance work orders recorded several other incidents where 1-Line trains were striking an object under the vehicle, later determined to be the EMI rod that damaged the train on the night of Nov. 26.

Ultimately, we found 16 work orders which related our keyword search, as shown below in Figure 19.

**Figure 19.** Vertical bar graph trends of reported work order damage for Series 1 and Series 2 trains, and work orders for "bolts".

As shown in the data here, Series 1 vehicles were the first being damaged. The graph above illustrates that the earliest work order for damage dates back to September. That work order, dated September 16, 2021, stated damage was done to the "Safety Bar" on a Series 1 train. The work order shows it was prioritized as a general repair and then closed four days later.
