Background

Engineering Study

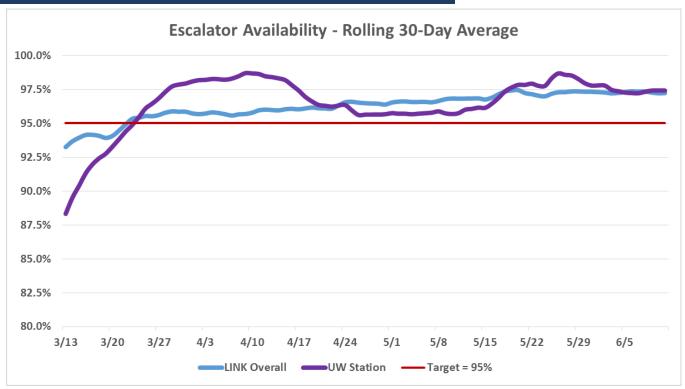
Recent Performance

- Rolling 30 day average availability has improved
- Escalator
 performance
 since late March
 is above target
 availability
