11/26 Link Incident: Audit Overview and Agency Response

Rider Experience and Operations Committee

2/9/22

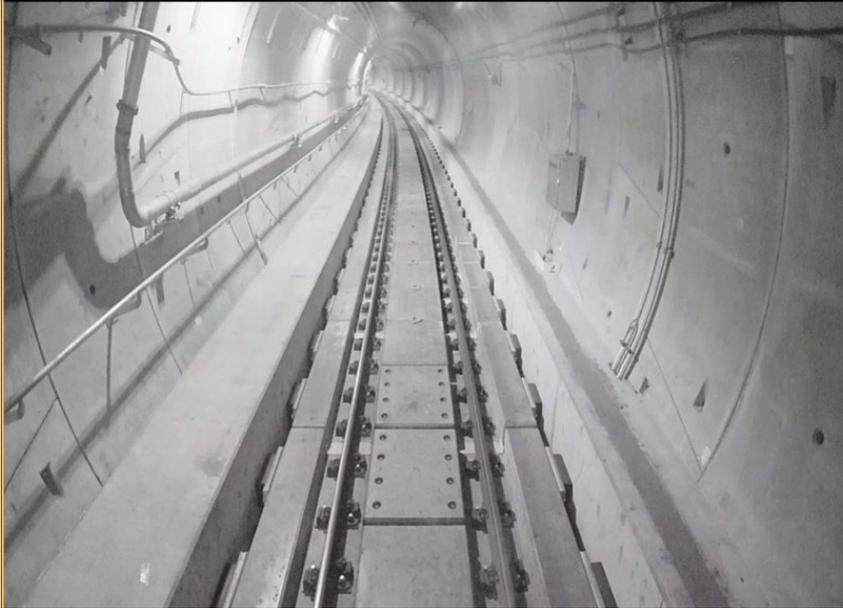
8:20pm (+1 minute) – 1,000 feet north of UW Station, the train loses power and comes to an abrupt stop

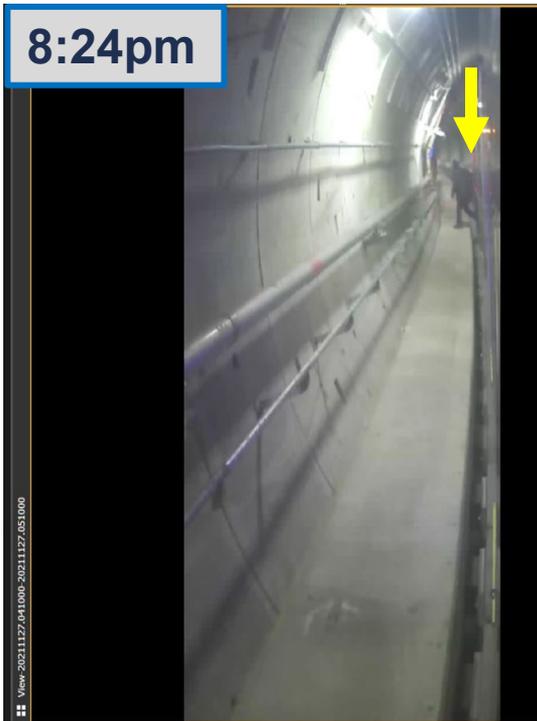
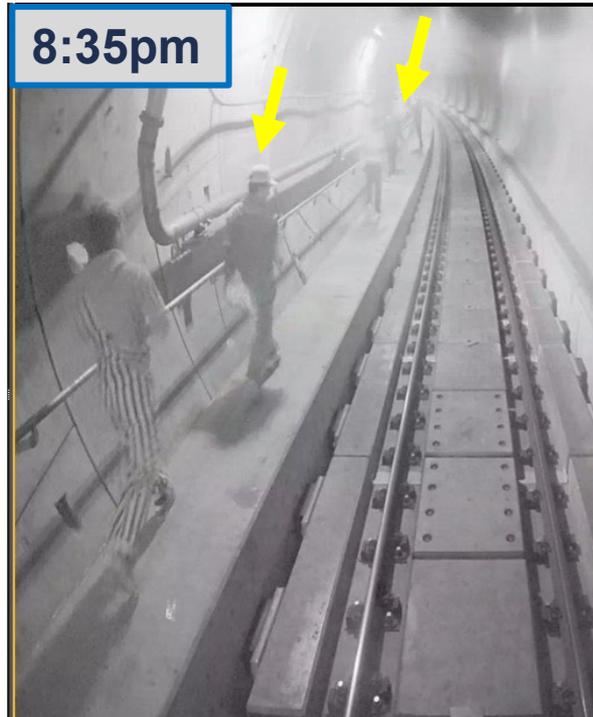
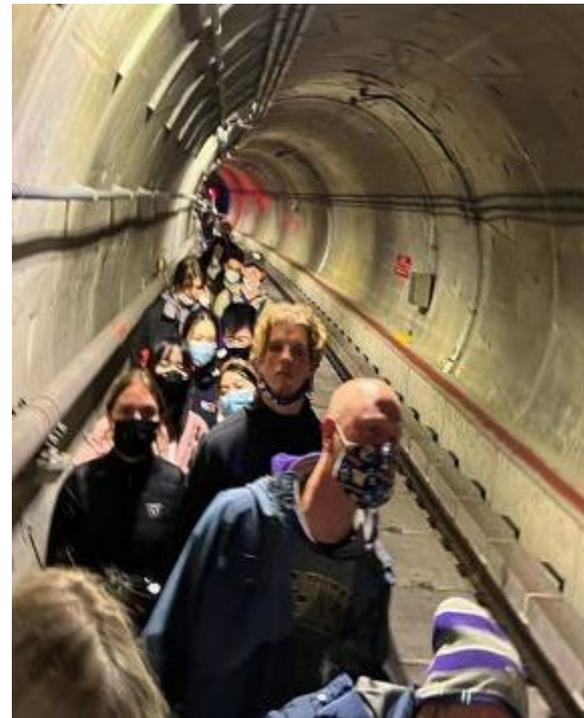
8:24 (+4 mins): passengers begin self-evacuating the train

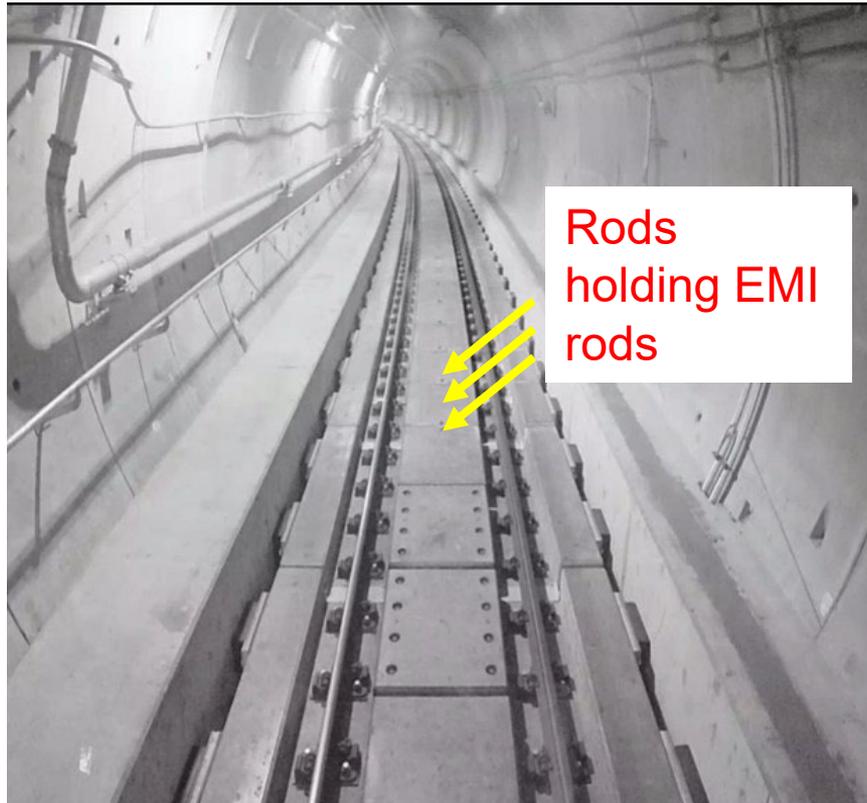
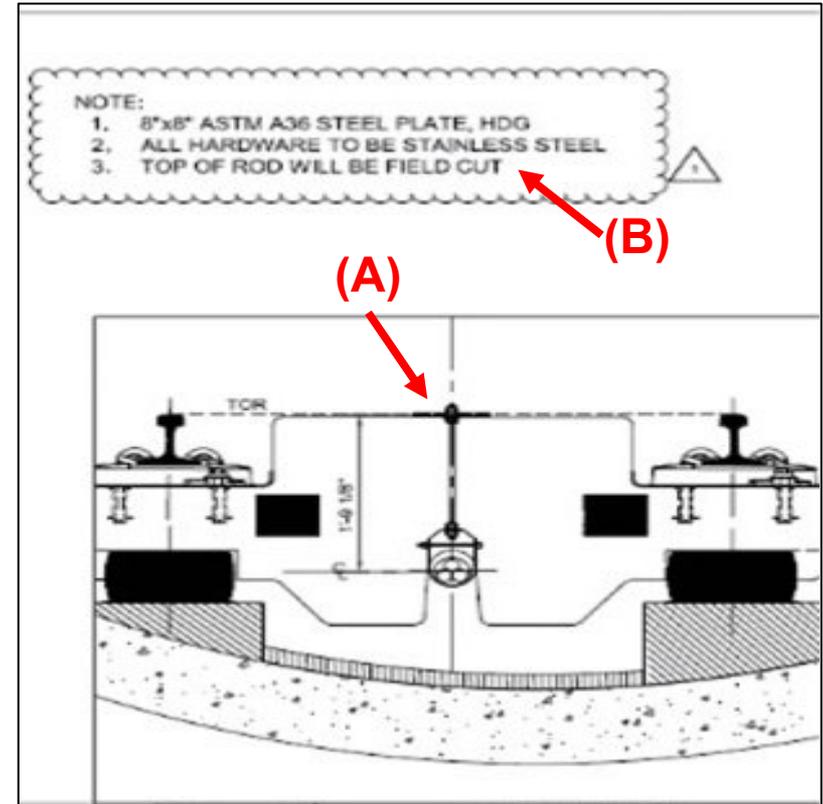
Electromagnetic interference (EMI) rods

1. Series 2 train vehicle struck a protruding EMI rod between the rails which severed cables beneath the vehicle.
2. Pre-revenue testing processes had not fully considered clearance differences between Series 1 and Series 2 vehicles under all possible operating conditions.
3. Previous rod strikes and non-disabling vehicle damage were being reported by maintenance staff but were not properly escalated.

- Field cut all protruding rods per approved design.
- Raised the trainline cables on Series 2 vehicles.
- Adjusted vehicle clearance requirements in our design verification testing.
- Applied these requirements to East Link testing.
- Refined special event procedures to ensure adequate staffing and passenger communications

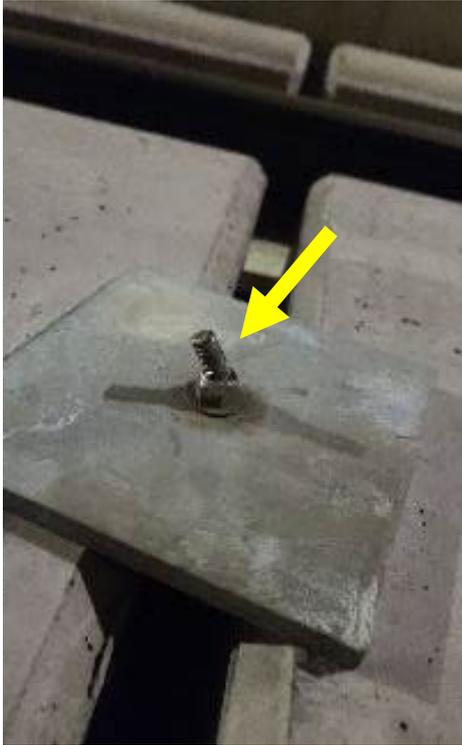
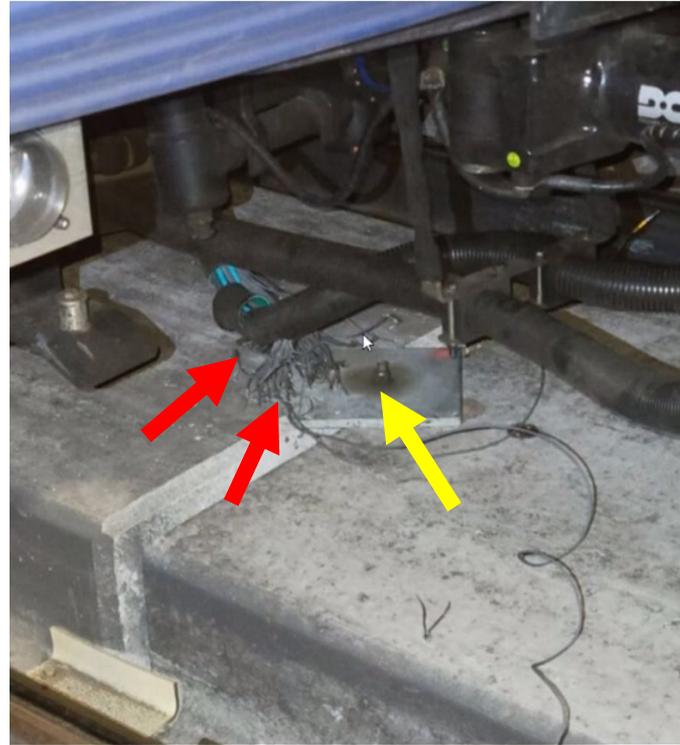
Previously damaged EMI rod (left) and damaged vehicle (right)

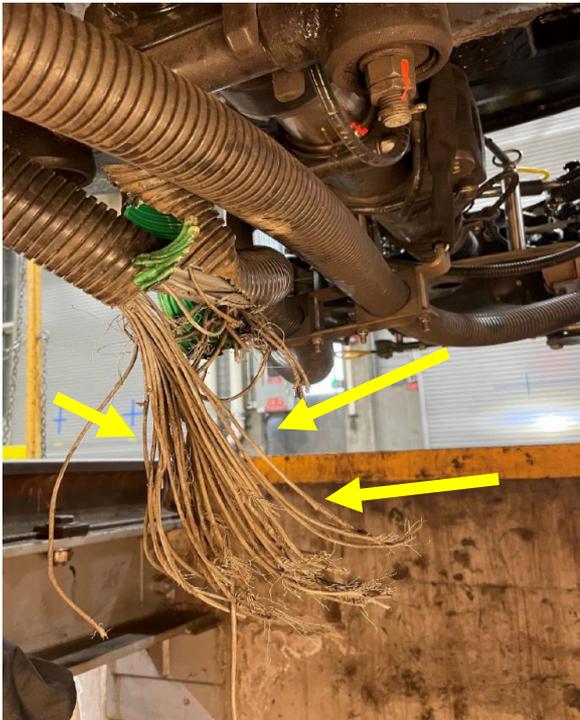
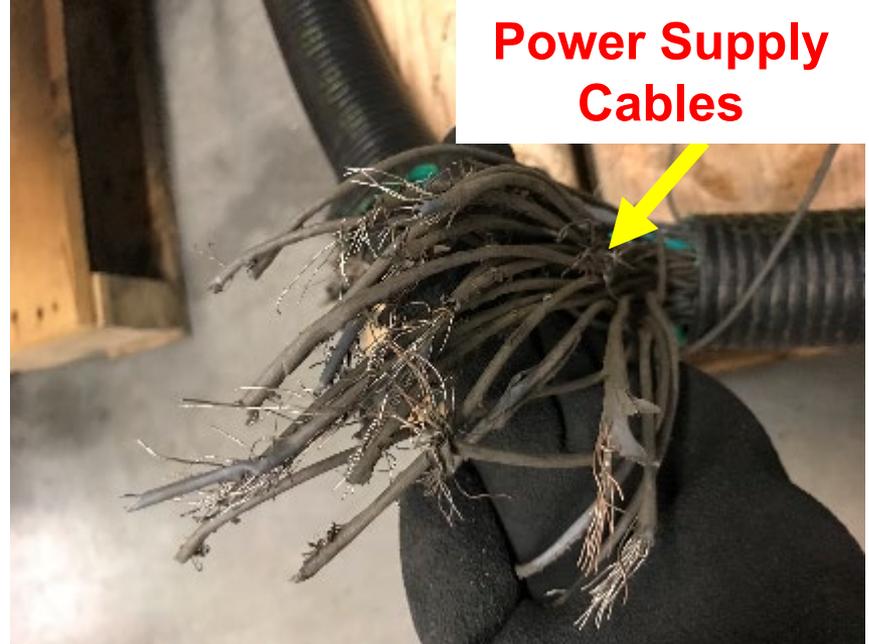
Damage caused by EMI rod

Conduit damage to light rail vehicle

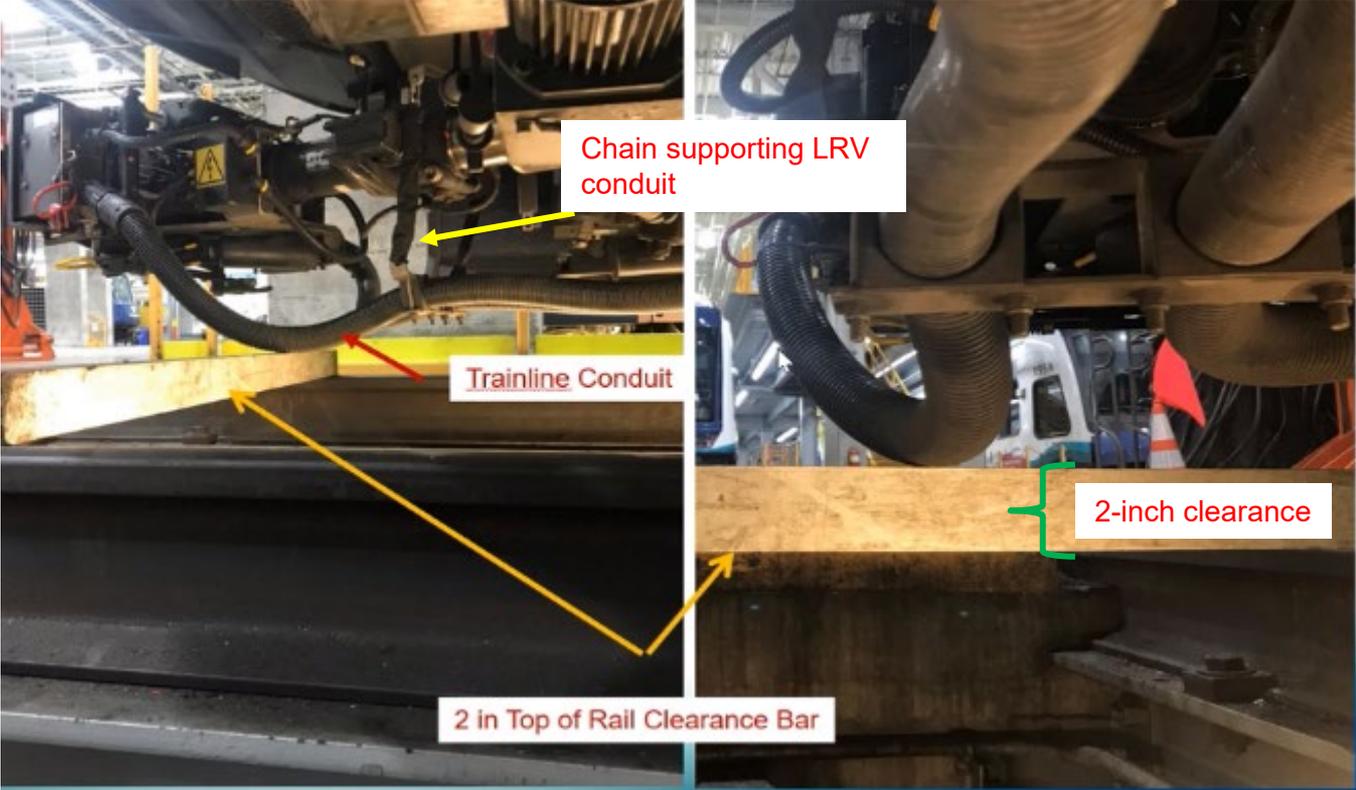
Post-incident vehicle clearance checks

Configuration differences

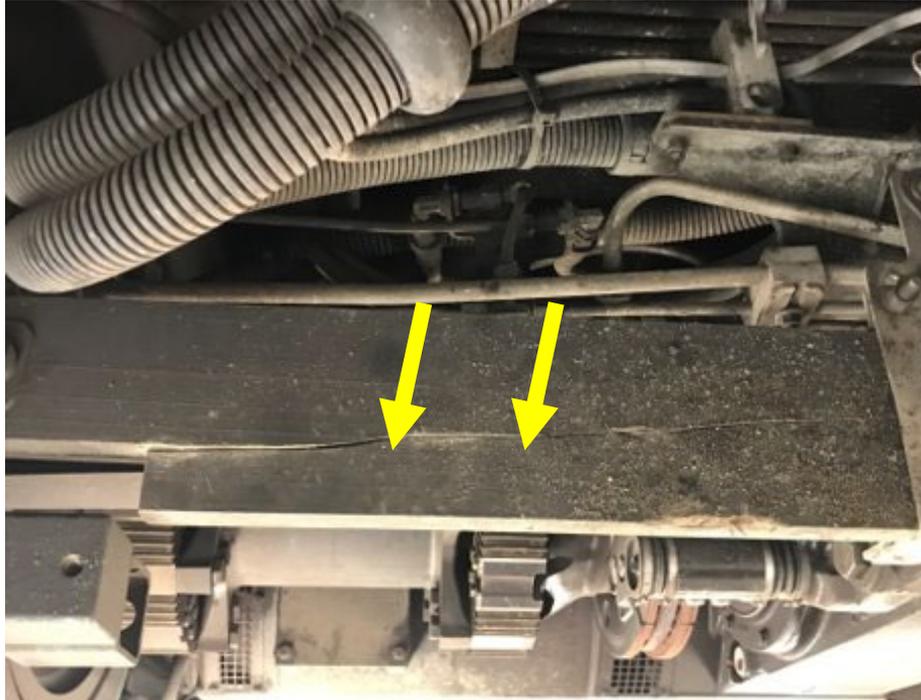
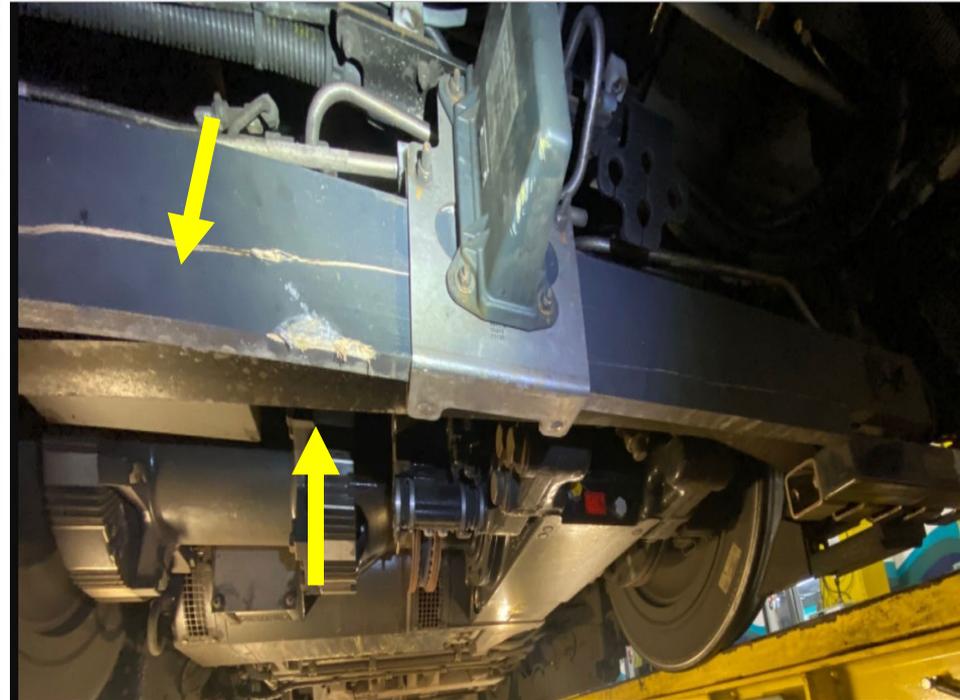
Damage occurring prior to incident

- Audit team reviewed 2,800 work orders, finding 16 relating to EMI rods or related damage.
 - 5 work orders for damage to Series 1 vehicles.
 - 3 work orders for damage to Series 2 vehicles.
 - 8 work orders for rods.
- King County Metro was looking into the issue and notified Sound Transit Engineering.
- King County Metro Safety, Sound Transit Operations, and Sound Transit Safety were not notified, as established by procedures.
