Internal Audit Report:

**Link Light Rail Service Event
from November 26, 2021**

Report #: 2021-19

Sound Transit Audit Division

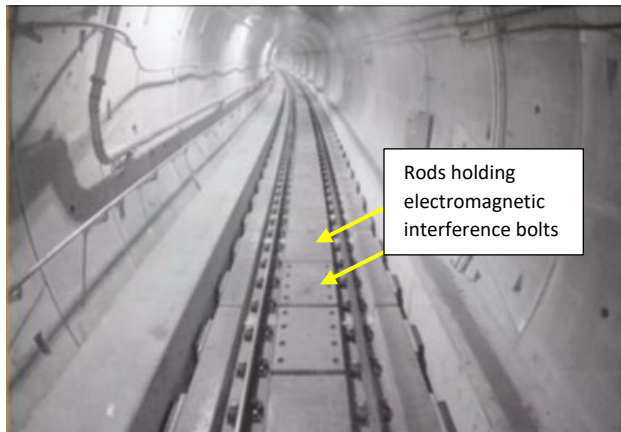
At 8:20, about 1,000 feet into the northbound tunnel, the train appeared to have struck an object in the trackway, stalled and came to an abrupt stop. It appeared to have lost all power, including HVAC and presumably all communication capabilities with passengers (see figures 5 and 6). There were no injuries.

Figure 5. Photograph from Train 6 (Car 246) just before impact with rods holding EMI bolts on the floating trackway.

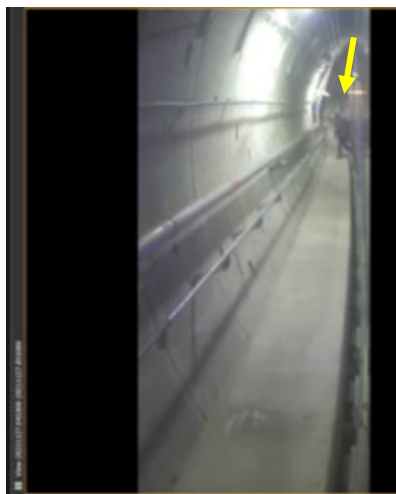
After several minutes without any communication from the operator, as early as four minutes after the train stopped and went dark, passengers started self-evacuating from the train using emergency door release handles.

Figure 7. Photograph of passenger self-evacuating Train 6 at 8:24.

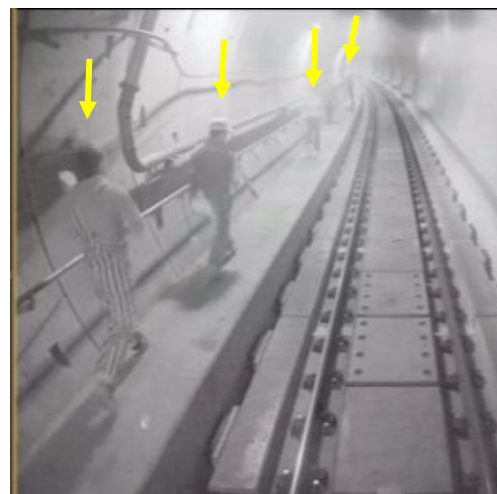
Figure 8. Photograph of passengers self-evacuating Train 6 at 8:35.

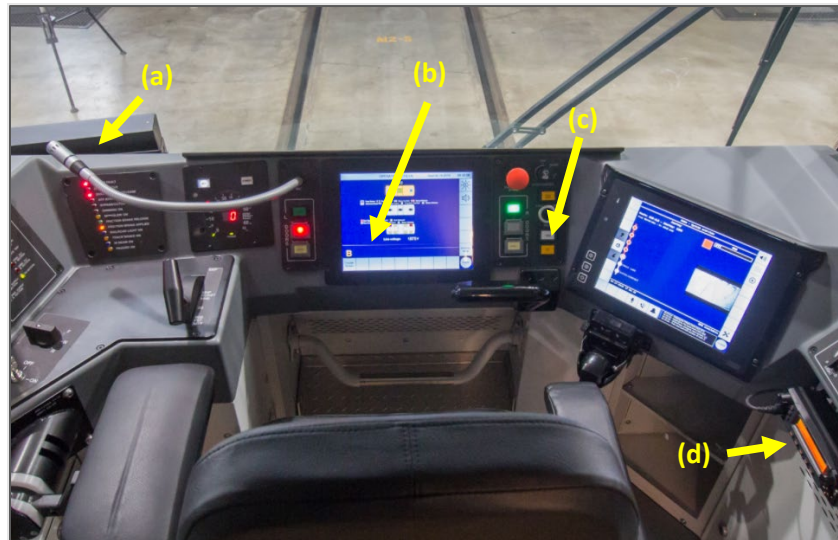
Based on transmission transcripts, no formal communication from the operator to the passengers occurred for 12 minutes because the operator stated the screen went dark, implying that the power was out and the PA was not operable. This display (figure 9) shows the location of items relevant to communicating with passengers.

Figure 9. Photograph of inside the operating cab of Series 2 LRV with arrows pointing at (a) Microphone, (b) Live PA button location on TOD screen, (c) PTT button for intercom, and (d) LRV onboard radio. Source: LRV Operator Training Manual

Camera footage inside the cab confirmed that the operator did not attempt to use the internal PA system until approximately 8:32.

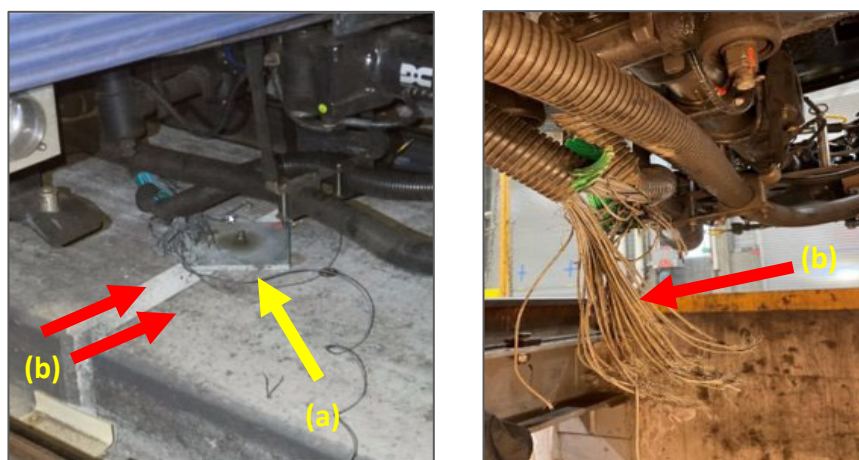
Train 6 was towed back to the Operations and Maintenance Facility that evening. Car 264 sustained \$12,453.95 of damage to the trainline conduit.

Figure 11. Photographs of damage from underneath Train 6 (Car 246) with arrows pointing at (a) the EMI rod and bolt that were struck by the conduit, and (b) the damage done to the power supply conduit cables.

On January 6, 2022, Car 264's repairs were completed, and it returned to service.

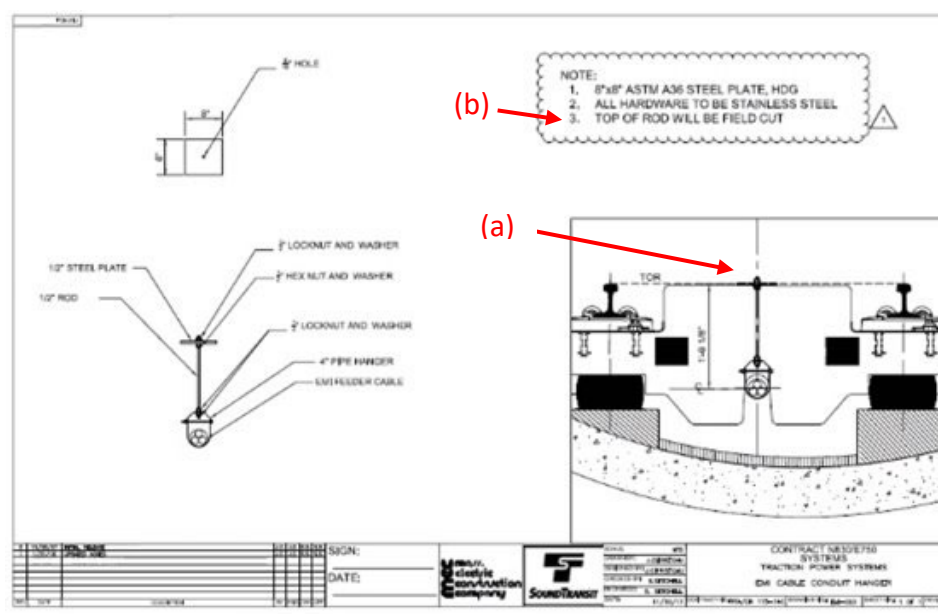
The design, however, had two indicated concerns that were not found until after the November 26, 2021 event, shown below in this shop drawing: (a) that the rod and bolt holding the EMI feeder cable protruded above the top of rail (TOR), and (b) that the top of the rod was to be field cut. How much to be cut was not specified on this shop drawing.

Figure 14. Shop Drawing of the EMI Feeder cable, along with the floating slab; showing (a) the EMI bolt and rod protruding TOR, and (b) that the rod needed to be field cut modified in red by Audit Division)

Through our interviews, we learned that the construction contractor, Mass Electric, had noted "cut off excess rod" as part of their 2017 construction work plan. However, Sound Transit's Construction Management Consultant, Mott McDonald, did not ensure the construction contractor completed the work and cut the rods, leaving the aforementioned rods exposed above the top of rail.

Finding a.2. It was noted on shop drawings of the Northgate Link Extensions' (NGLE) electromagnetic interference (EMI) conduit hanger that the rods which hold the EMI hangers on the floating slab had 1) protruded above the TOR in design and after installation, and 2) that the EMI "Top of Rod was to be field cut"; however, it was unclear on the shop drawing where to make the cut.

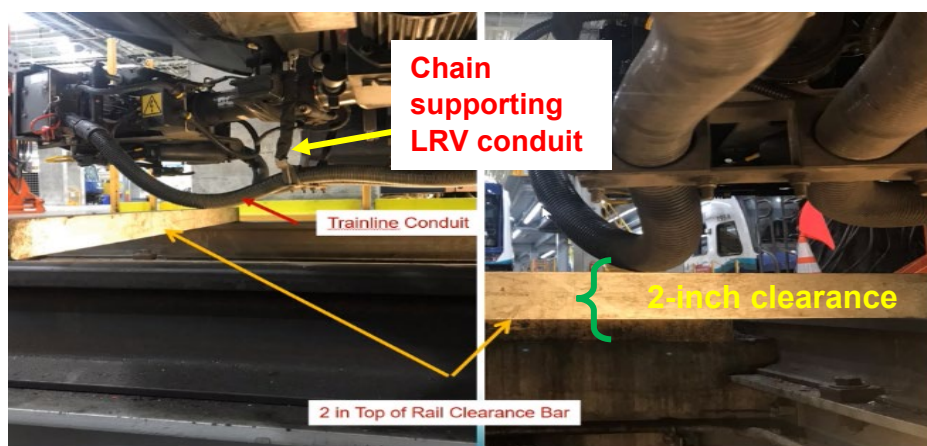
Finding a.5. Vehicle clearance testing was incomplete because it was not done at a proper crush load weight, nor tested at a historically high ridership location.

Continuing to use the incorrect weight load, train tests then checked to ensure it had a minimum 2-inch coupler clearance above top of rail when empty, as required. Again, at the time of fleet qualification testing, the minimum spacing test passed the coupled vehicle clearance test, but as we learned later, the 2-inch specification was not the correct measurement for a Series 2 train but rather, it matched the dimension appropriate for suspension design Sound Transit's other light rail vehicle, the Series 1.

Figure 17. Photograph of Series 2 trainline conduit hanging near 2-inch clearance bar, as specified for a Series 1 vehicle and not a Series 2, modified in red by Audit Division.

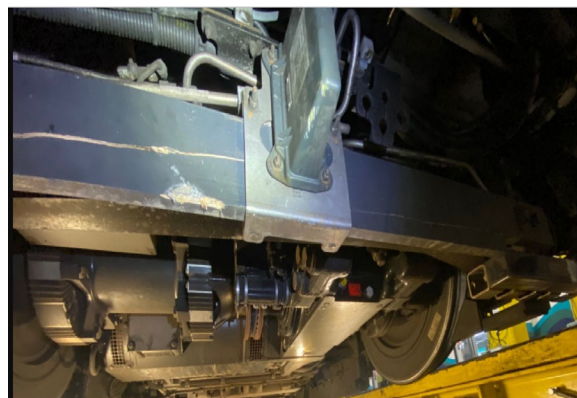
Prior to November 26, 2021, King County Metro vehicle maintenance staff were discovering Link vehicles being damaged on their oak boards, also known as Safety Boards, which help prevent people or objects from rolling under the train. As shown below, there is a large crack and gouge taken out of the board, denoting the train had struck an object at a considerable speed

Figure 19. Photograph of a damaged Series 2 vehicle, and arrow pointing to Oak "Safety" Board

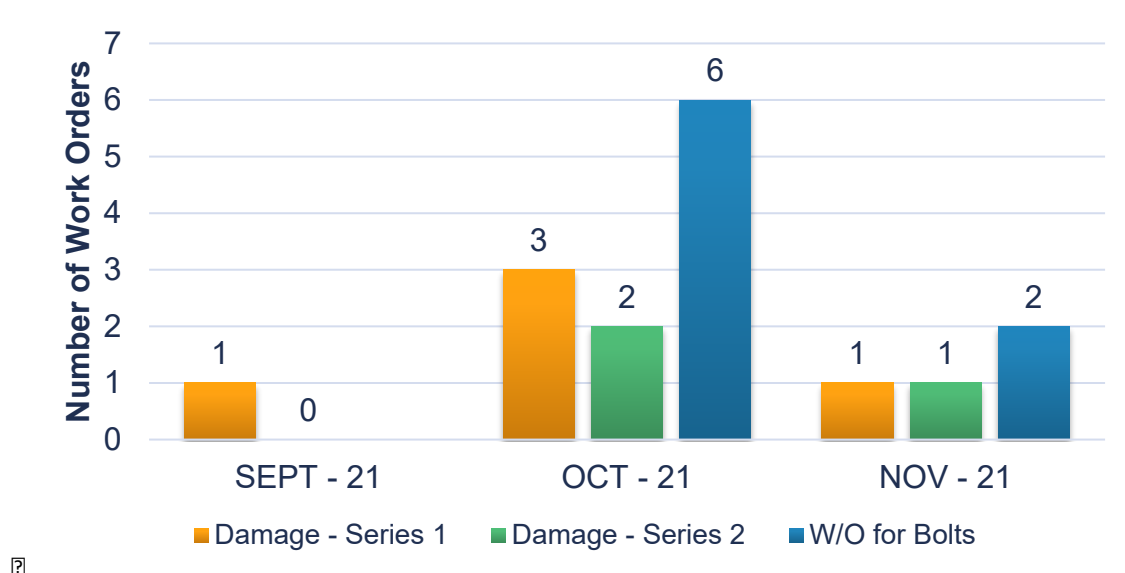
Ultimately, we found 16 work orders which related our keyword search, as shown below in Figure 19.

Figure 19. Vertical bar graph trends of reported work order damage for Series 1 and Series 2 trains, and work orders for "bolts".

As shown in the data here, Series 1 vehicles were the first being damaged. The graph above illustrates that the earliest work order for damage dates back to September. That work order, dated September 16, 2021, stated damage was done to the "Safety Bar" on a Series 1 train. The work order shows it was prioritized as a general repair and then closed four days later.
