Appendix D

Wetland and Stream Photographs

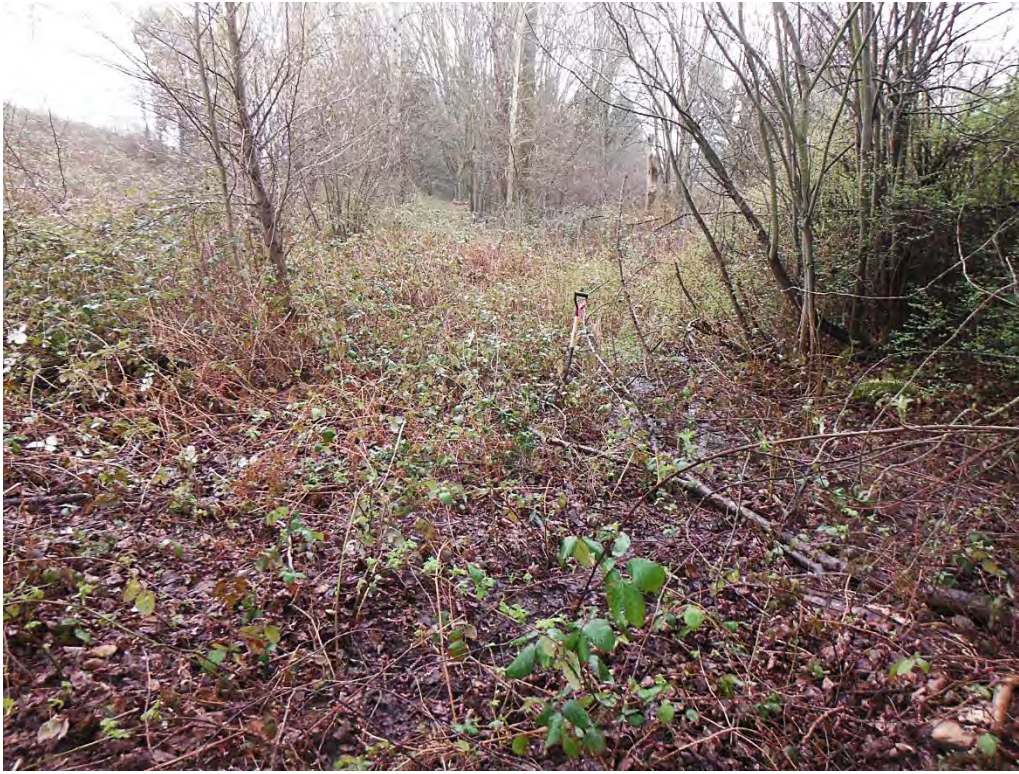
Wetland 5-1: north end of wetland in I-5 right-of-way (ROW), looking south. Himalayan blackberry is overgrowing wetland; scattered willows and American brooklime is also present.

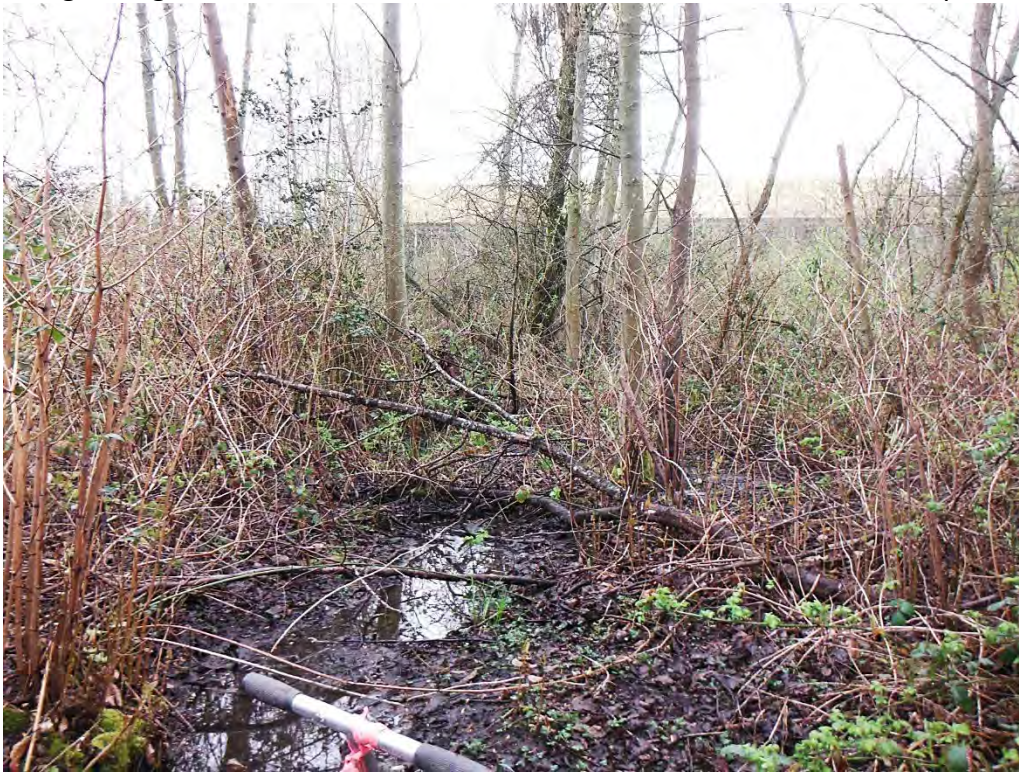
Wetland 6-2: northeast end of the wetland near the outlet of Massey Creek, looking east. Vegetation consists of young black cottonwood trees, blackberry, and salmonberry.

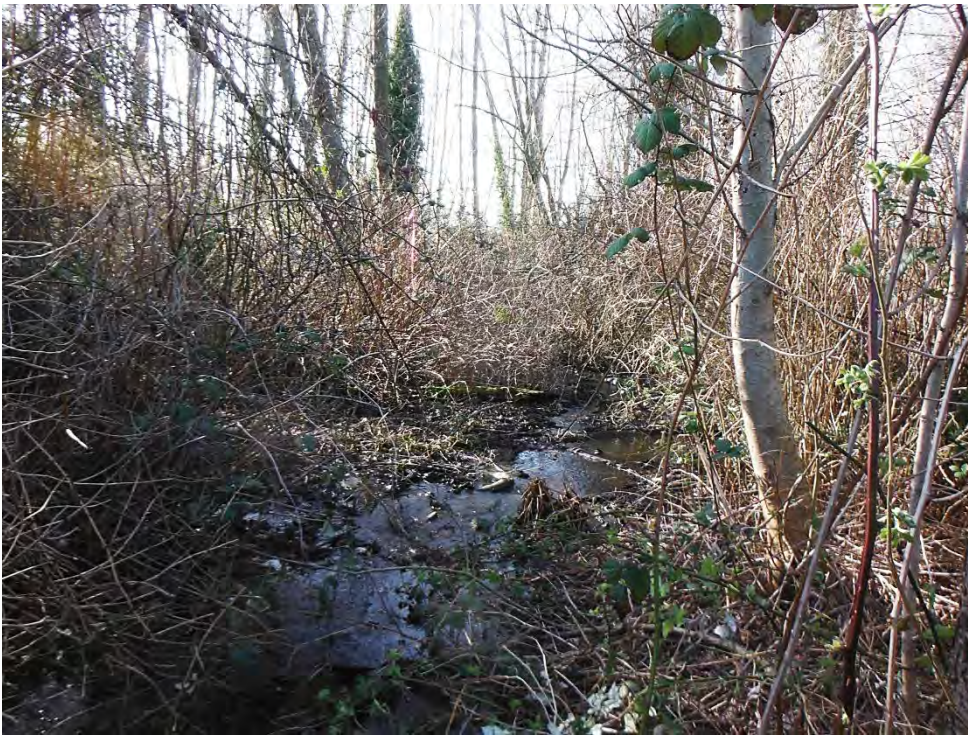
Wetland 6-2: east end of the wetland near the outlet of Massey Creek, looking west. Vegetation consists of young black cottonwood trees, blackberry, and salmonberry.

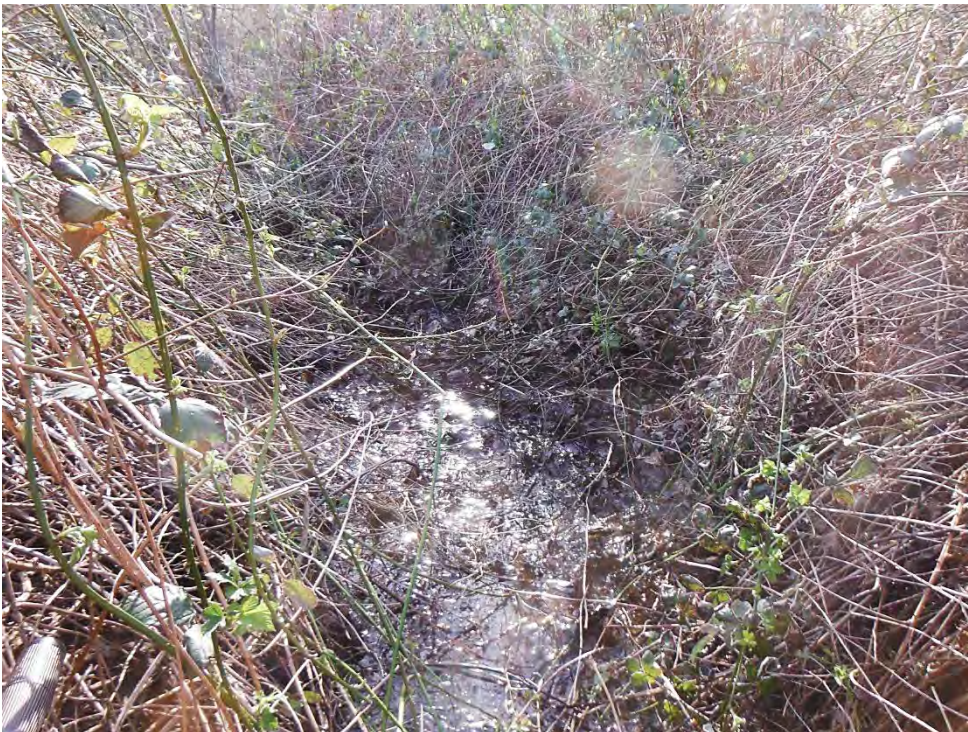
Wetland 6-3: looking south. Small depression that was sparsely vegetated during March 2014 site visit. Himalayan blackberry fringes the perimeter.

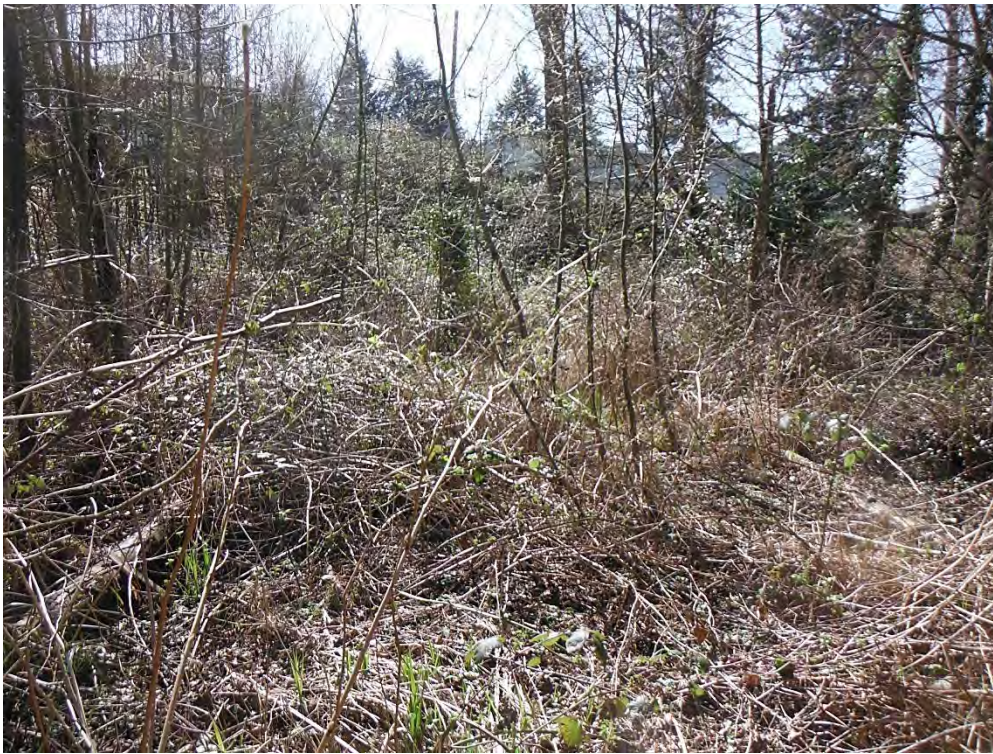
Wetland 6-4: eastern portion of wetland looking south. Forested vegetation community comprised of young red alder, Himalayan blackberry, and reed canarygrass.

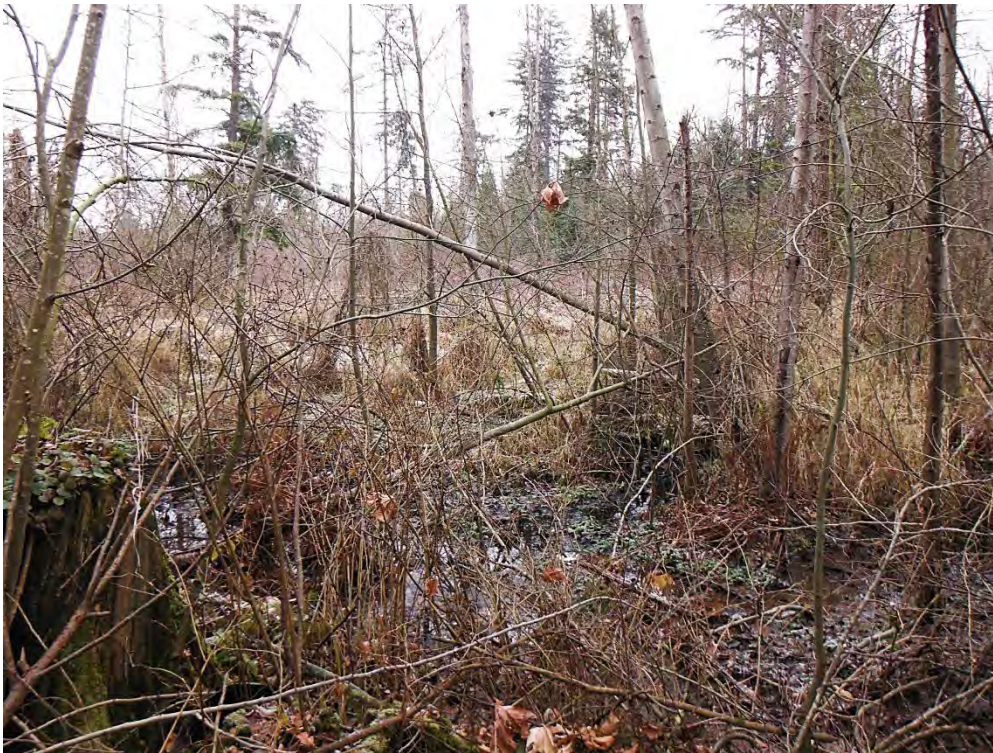
Wetland 12-1: representative conditions in south portion of McSorley Creek wetland outside of FWLE alternatives. Mature forest consisting of black cottonwood, Sitka spruce, and red alder is predominant. See McSorley Creek stream photos for wetland conditions at McSorley Creek on east side of SR 99.

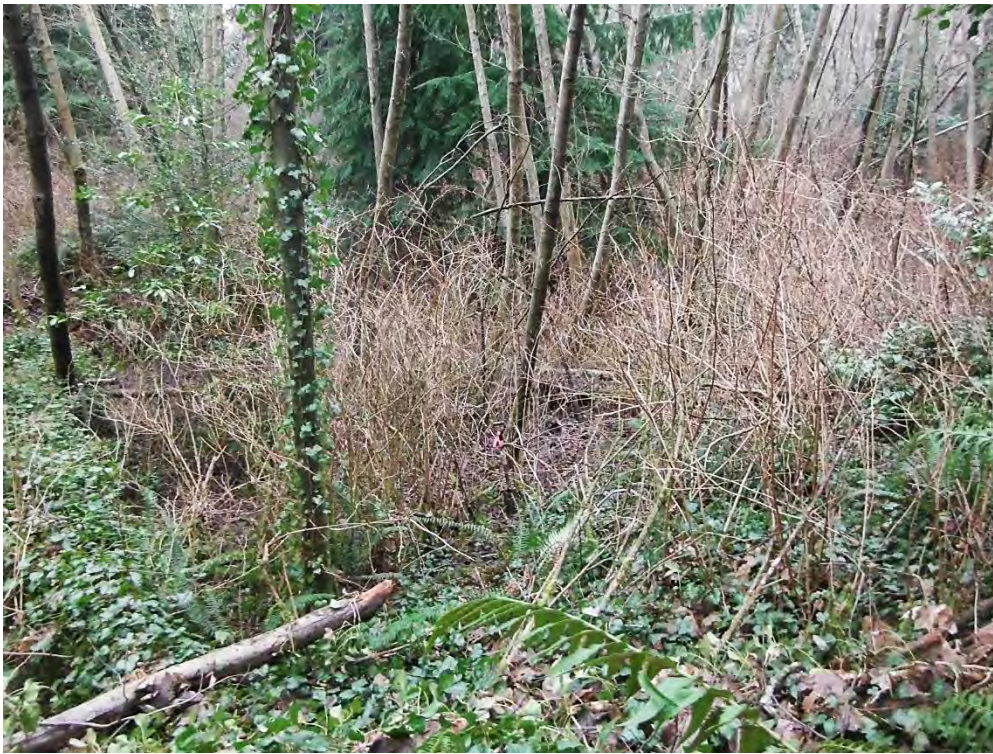
Wetland 12-1 (McSorley Creek Wetland): southeast corner of wetland in I-5 ROW. Vegetation in ROW is primarily red alder and salmonberry. Sitka spruce/western hemlock forest is in interior of wetland, west of the I-5 ROW.

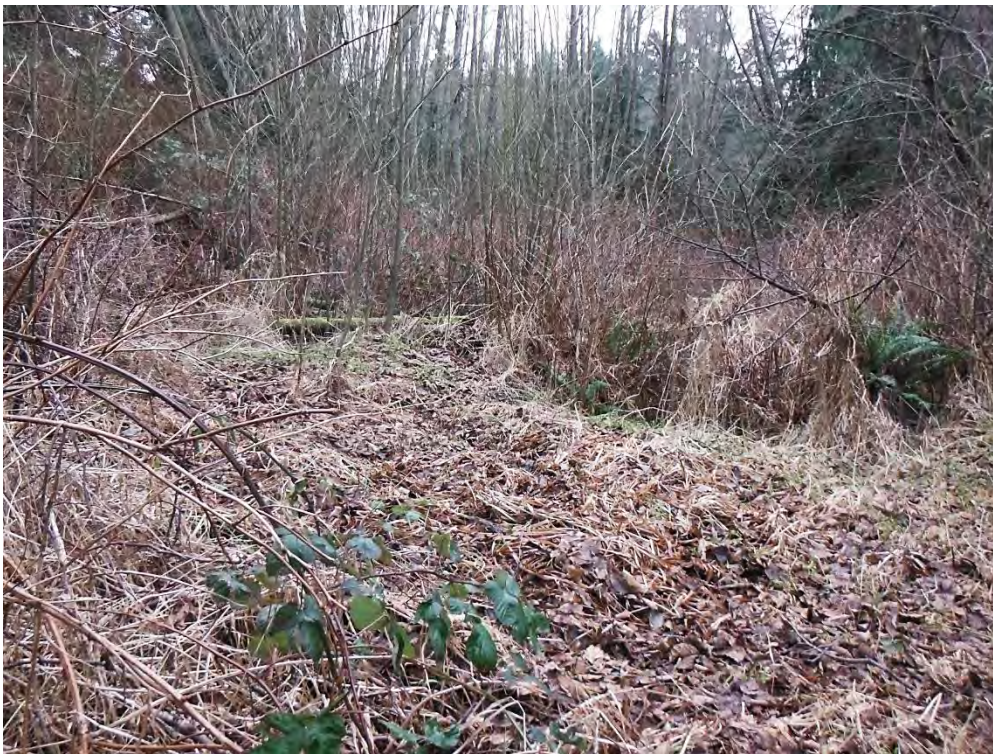
Wetland 12-1 (McSorley Creek Wetland): north portion wetland in I-5 ROW, looking south. Vegetation in this portion of the wetland is predominantly small-fruited bulrush, reed canarygrass, and young alder saplings.

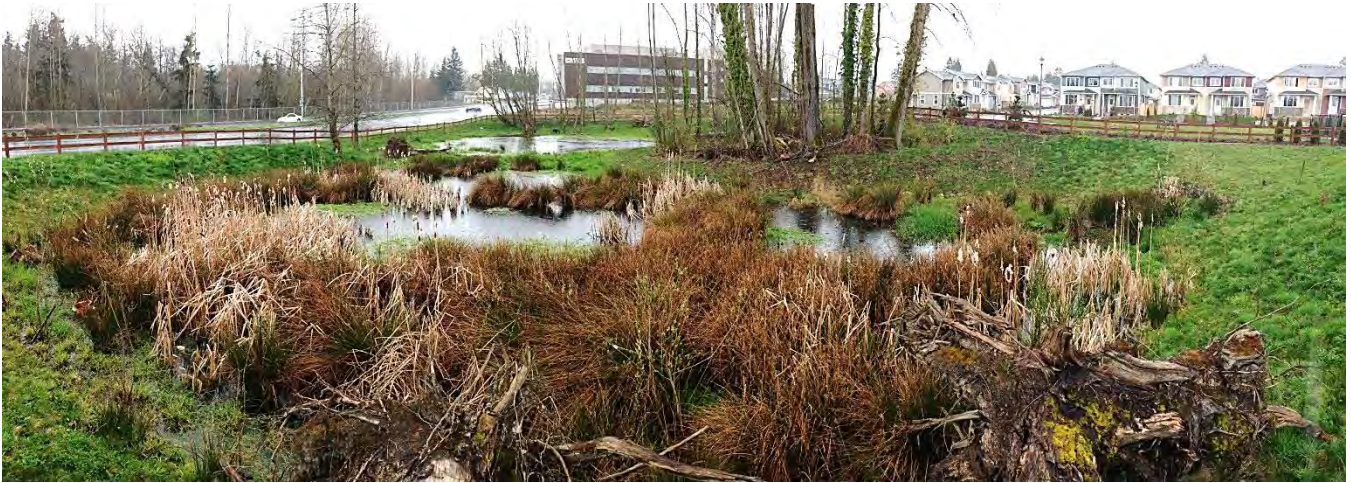
Wetland 12-2: overview of wetland looking south from north boundary. Emergent community consists of soft rush, *Glyceria*, and cat-tail. Red alder and cottonwood trees surround the perimeter. Surface water drains from the wetland via vertical drain in photo background.

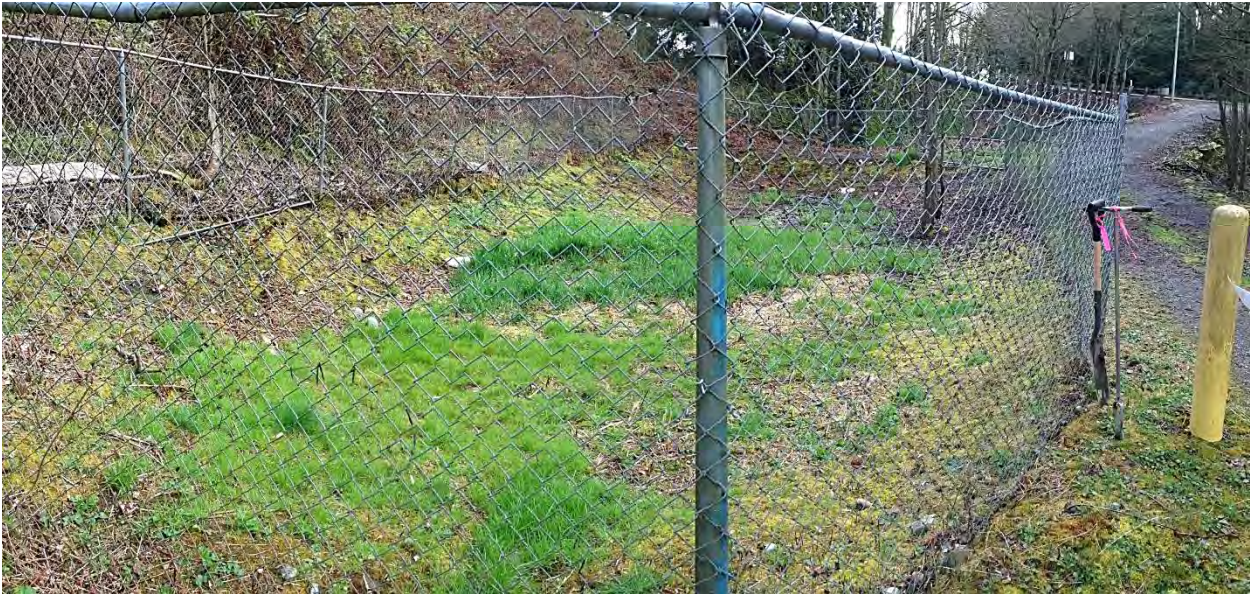
Wetland 16-1: looking south. Excavated feature dominated by reed canarygrass. Inlet in background discharges to Redondo Creek.

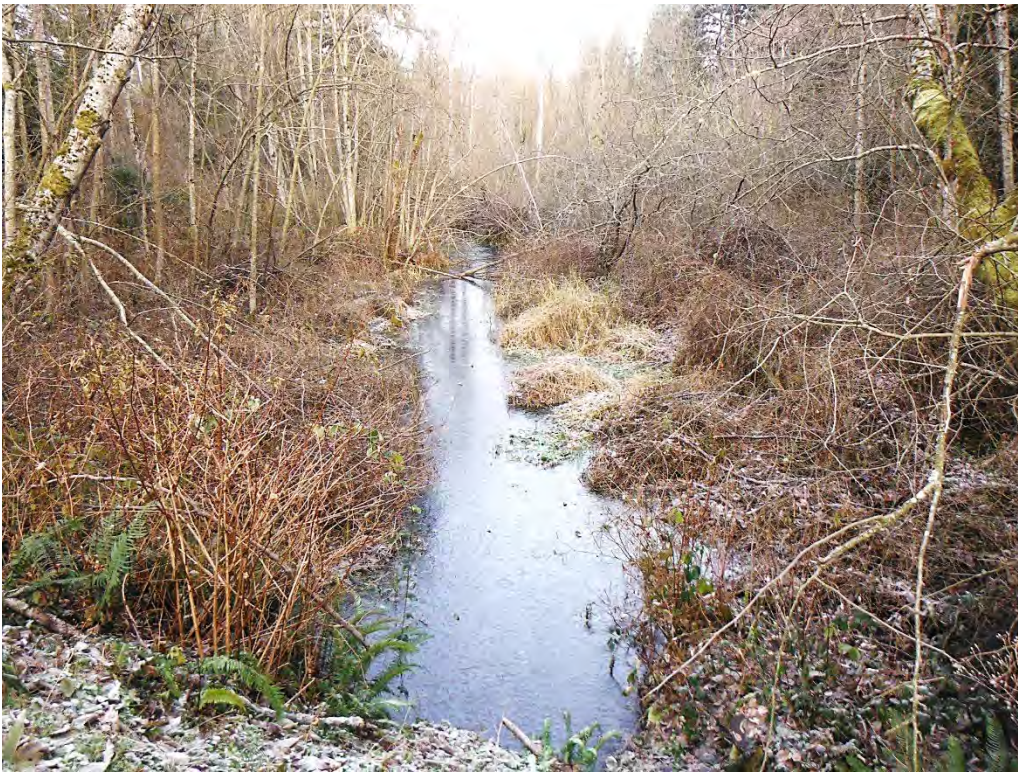
Wetland 17-2: looking south from S 304th Street. Forested community is dominated by red alder. Redondo Creek flows through wetland.

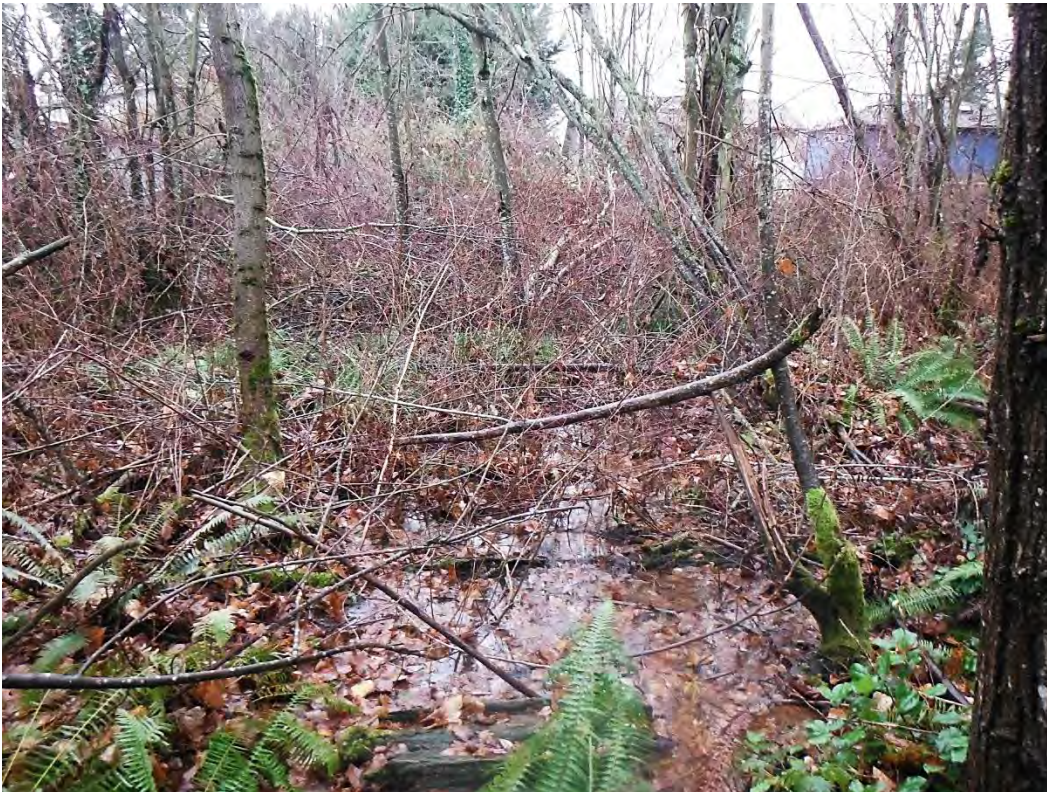
Wetland 17-2: northeast from S 270th Street. Forested community is dominated by red alder.

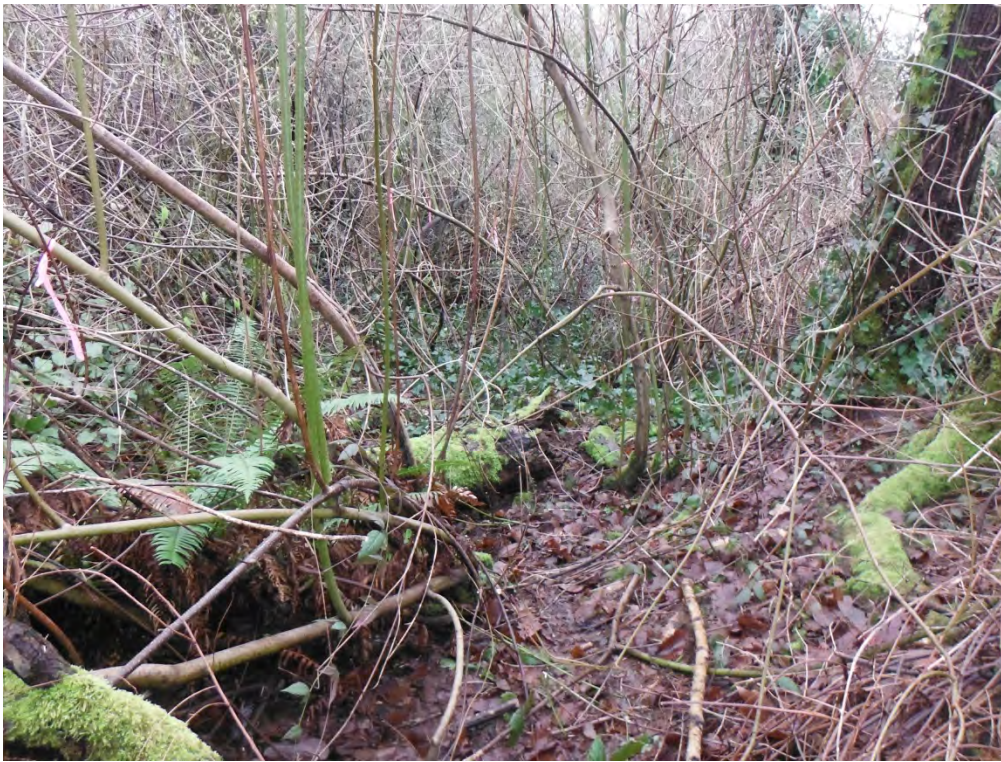
Wetland 20-3: looking northeast. Scrub-shrub wetland dominated by redosier dogwood.

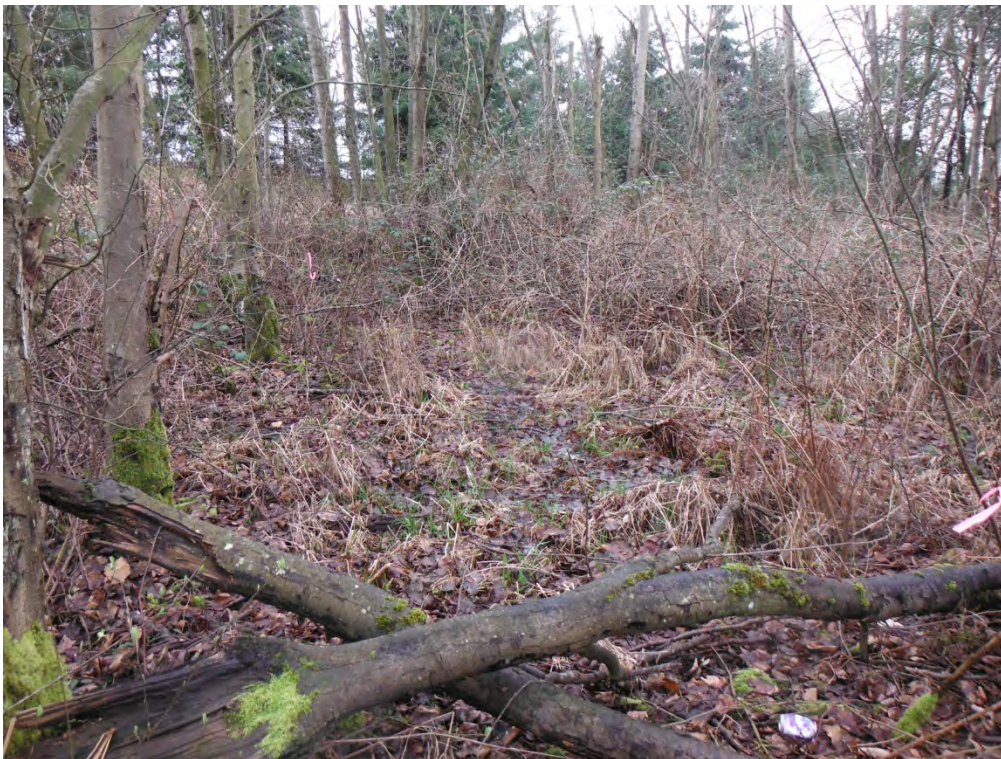
Wetland 24-2: eastern portion of wetland. Scrub-shrub wetland dominated by salmonberry, reed canarygrass, and slough sedge.

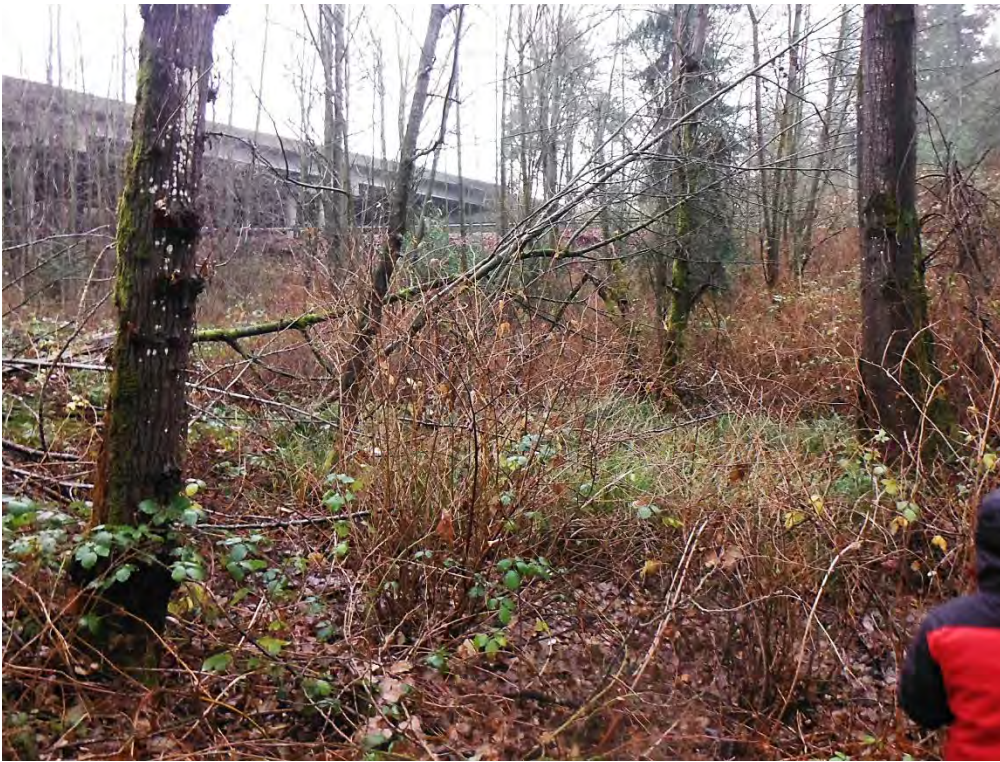
Wetland 25-2: looking south from northern end. Forested community is dominated by red alder.

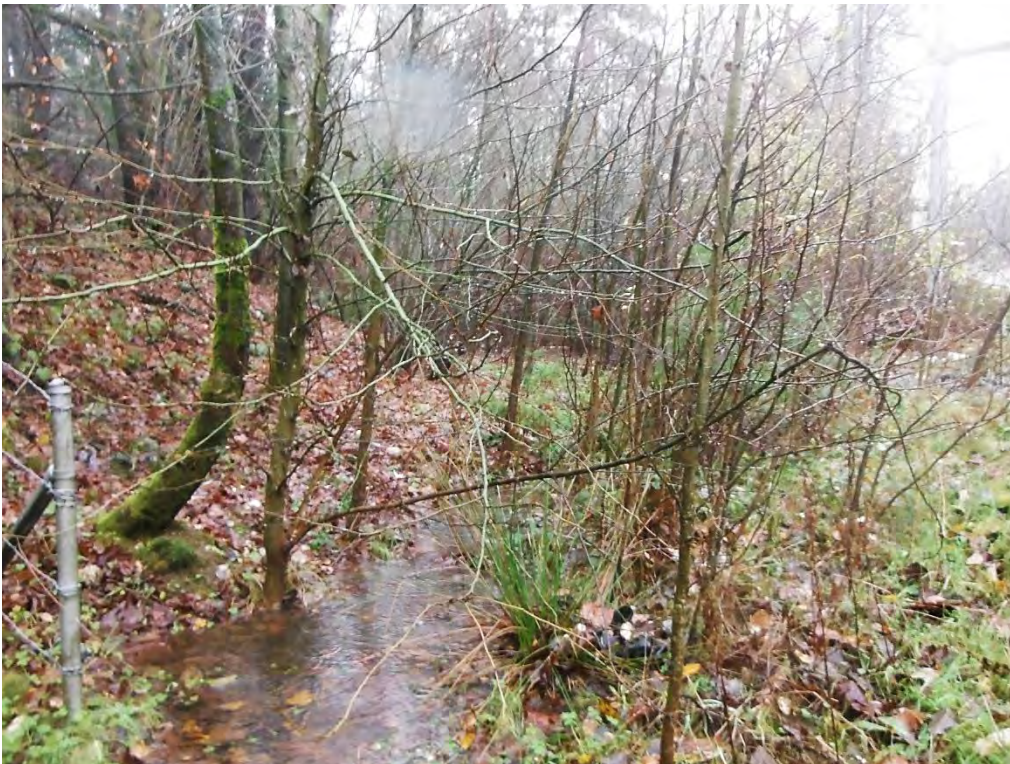
Wetland 25-2a: looking west from eastern end. Dominated by red alder saplings.

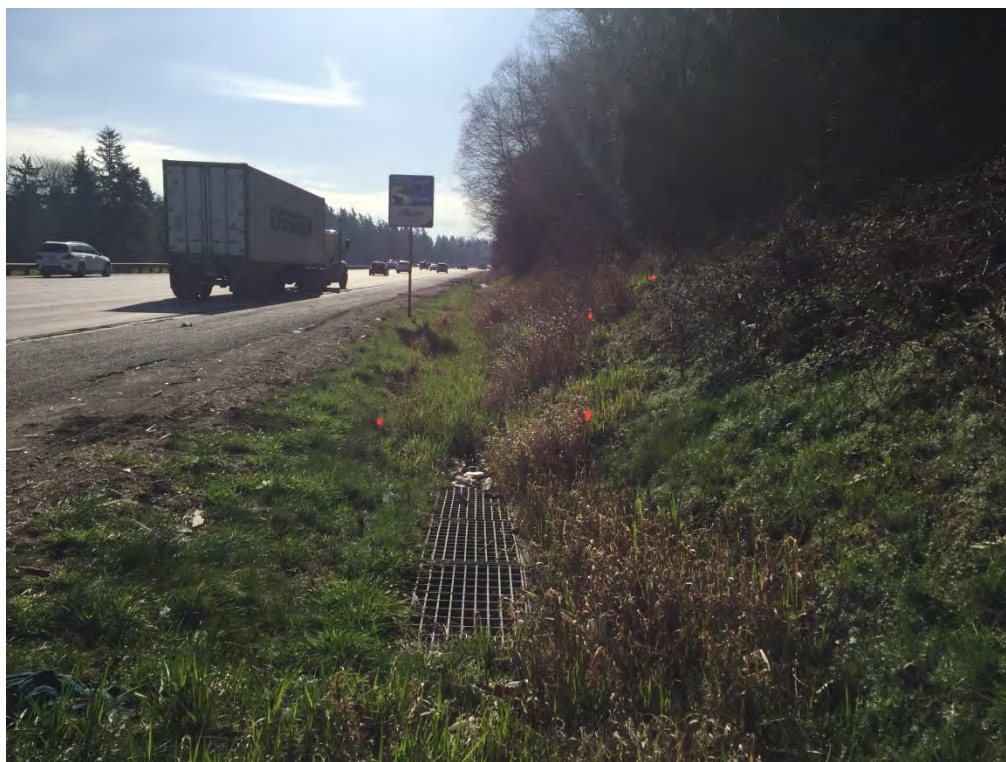
Wetland 25-5: looking south. Emergent wetland dominated by reed canarygrass

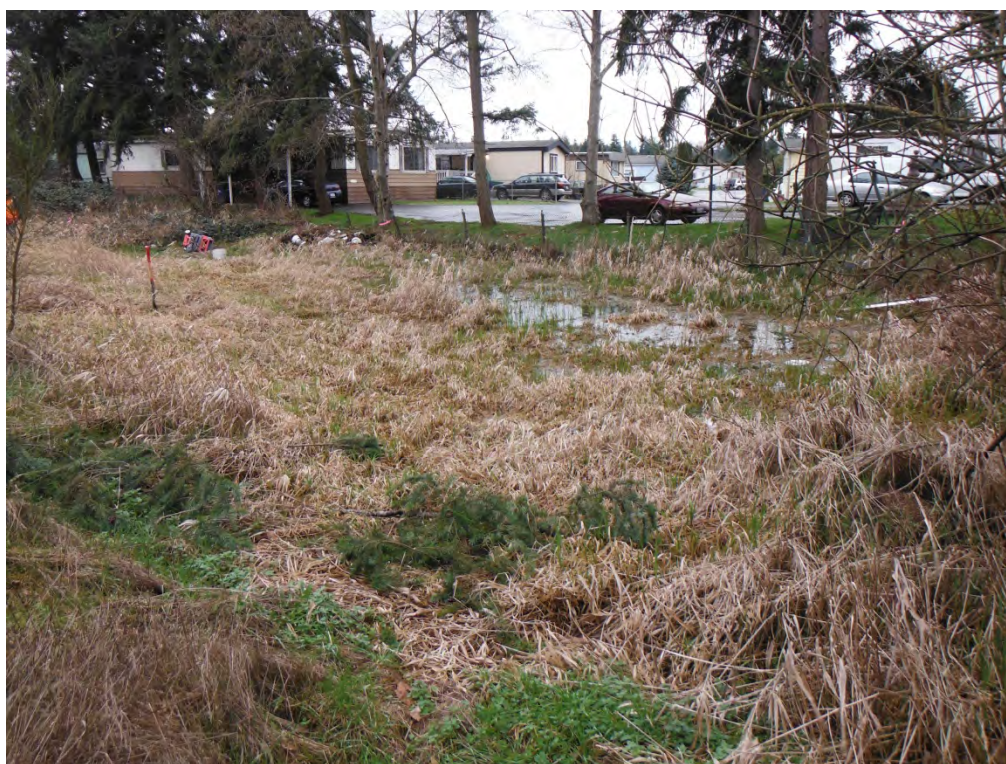
Wetland 26-1: emergent community in north portion of wetland, dominated by reed canarygrass.

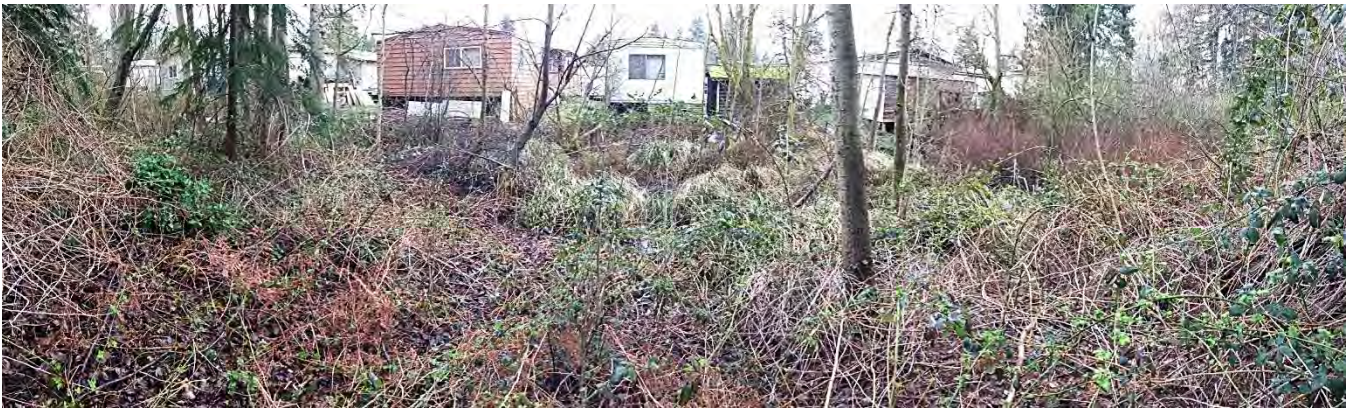
Wetland 27-1: forested community in south portion of wetland. Red alder and black cottonwood are predominant, with slough sedge and spirea understory.

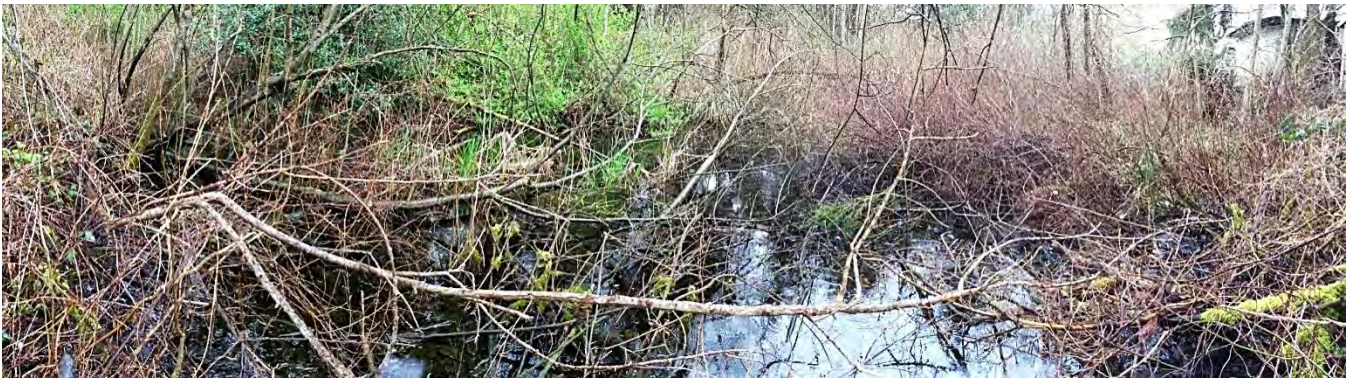
Wetland 27-1: scrub-shrub community in north portion of wetland. Spirea, willows and slough sedge are predominant. The north portion of the wetland was inundated by at least 2 feet.

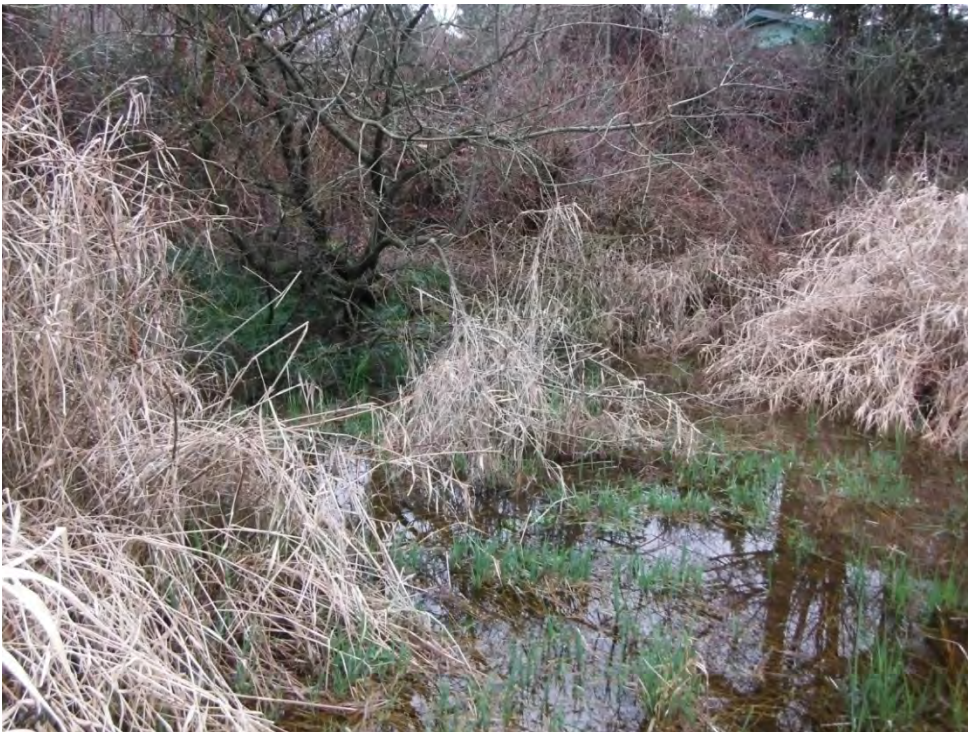
Wetland 27-2: emergent wetland dominated by reed canarygrass and slough sedge.

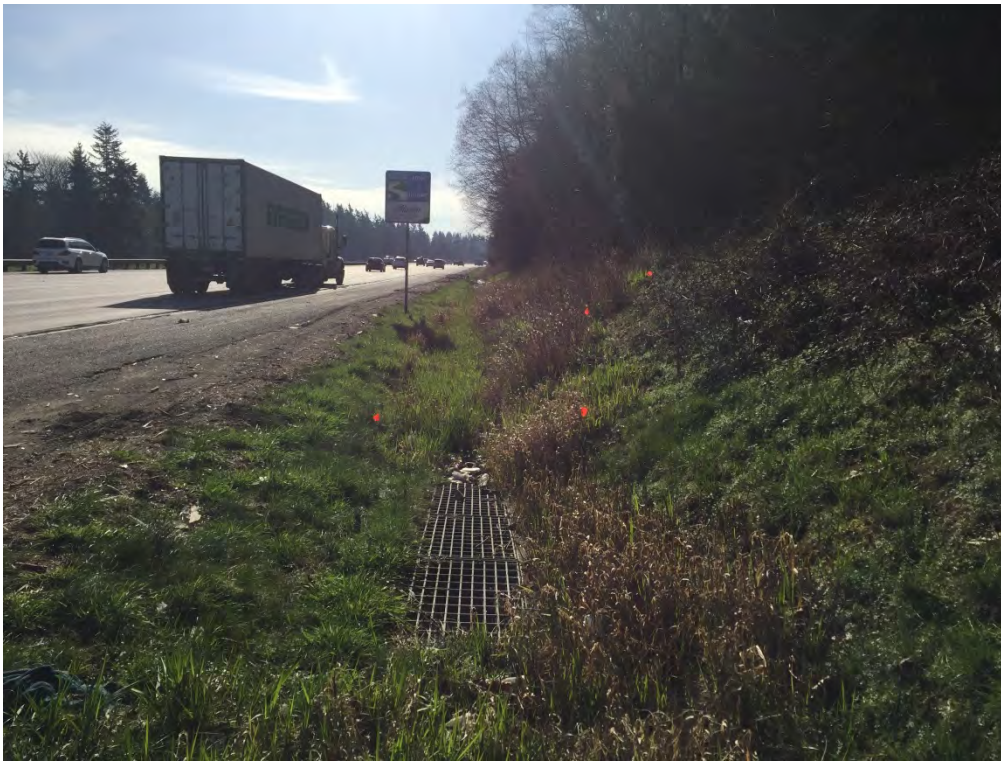
Wetland 27-2: emergent wetland dominated by reed canarygrass and soft rush.

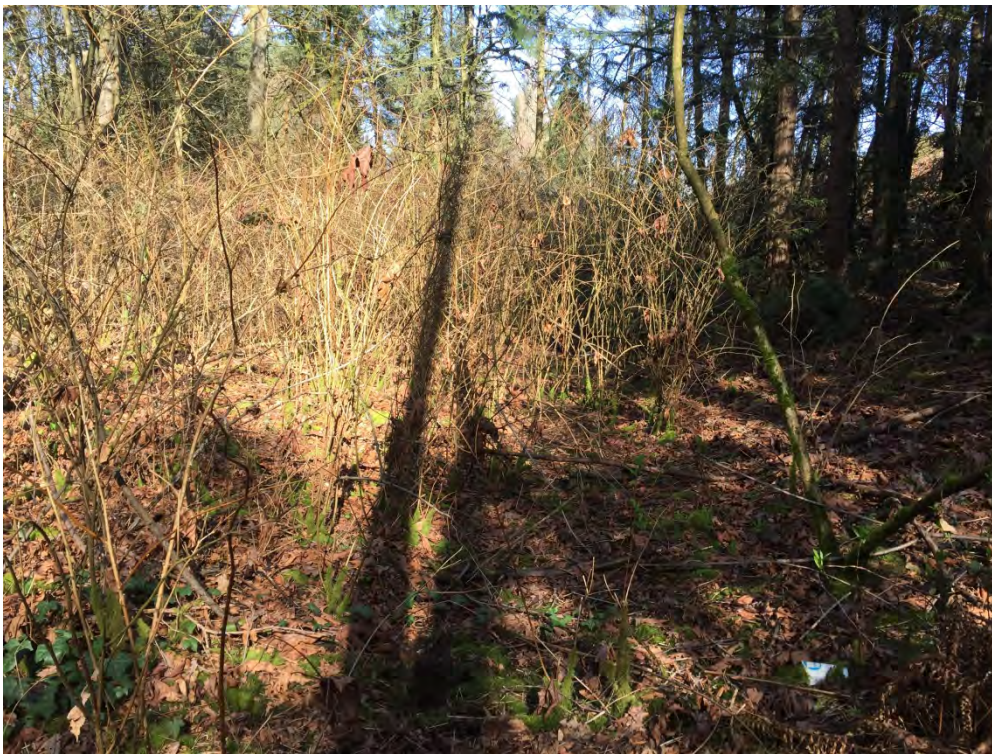
Wetland 28-2: looking south. Dominated by salmonberry

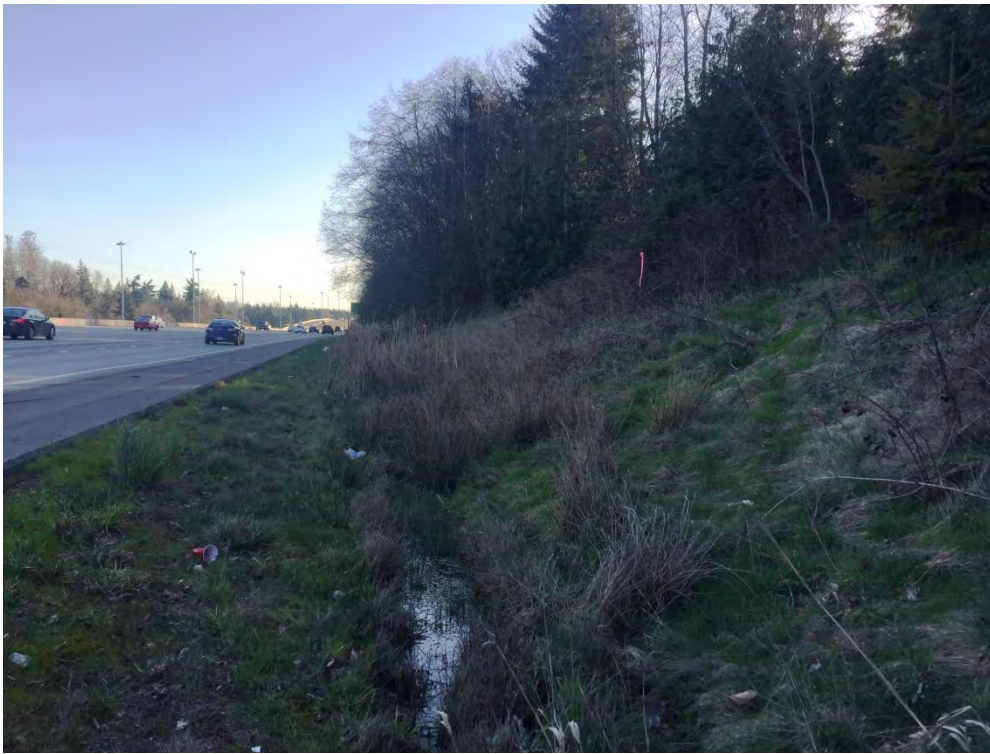
Wetland 28-3: looking south. Emergent community dominated by soft rush, and bentgrass.

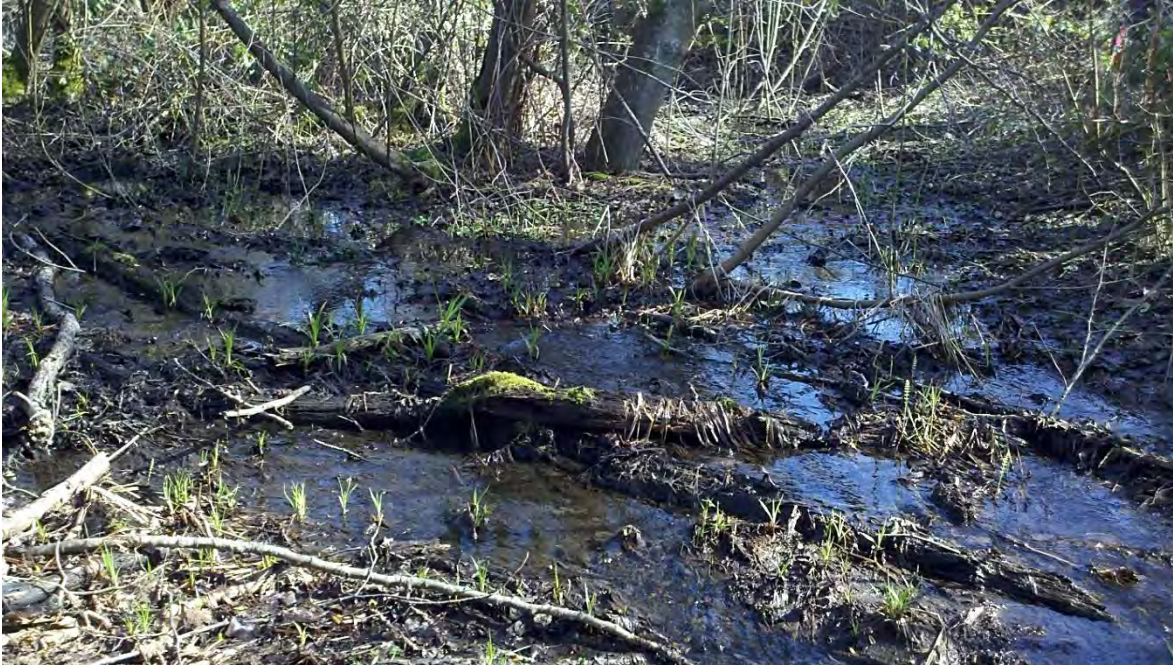
The eastern portion of Massey Creek in the study area is shallow and poorly defined with multiple channels through the wetland.

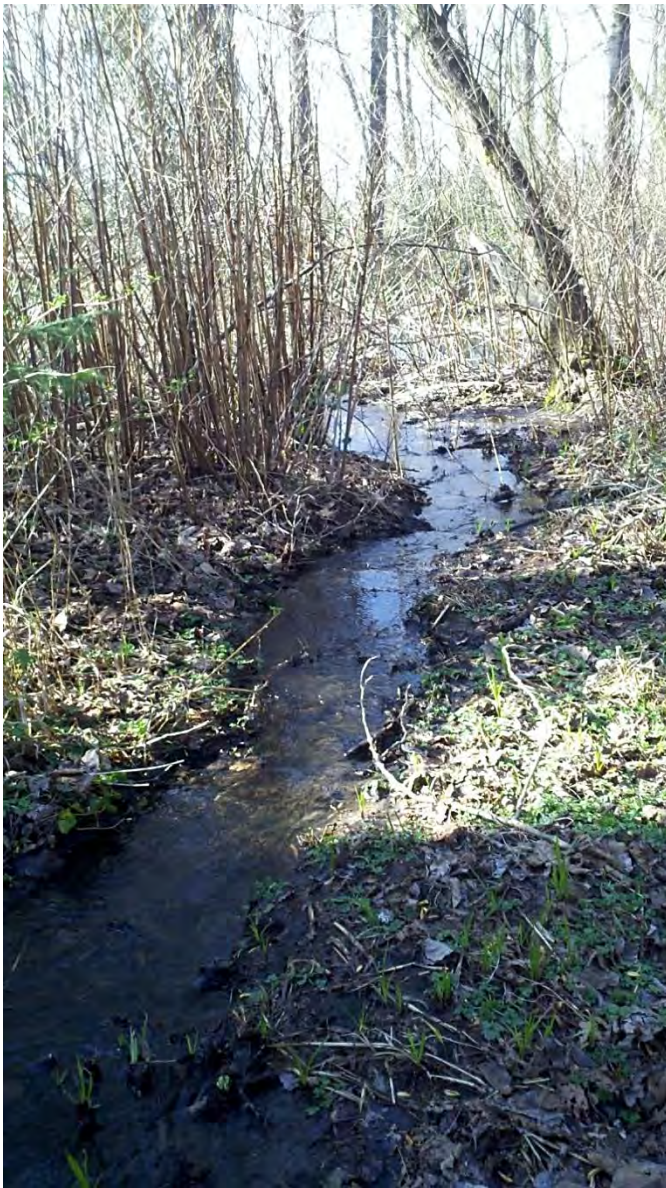
Massey Creek looking downstream where it forms a single, shallow channel with low, poorly defined banks.

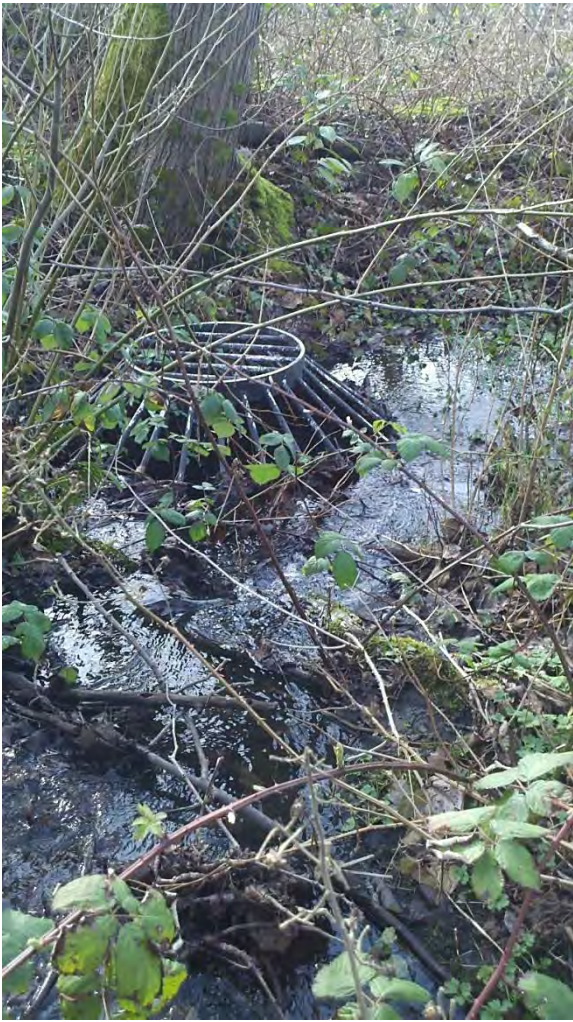
Vertical drain at the west end of the Massey Creek reach in the study area. This structure conveys the creek into a pipe system under an apartment complex and roadway and poses a complete passage barrier to fish.

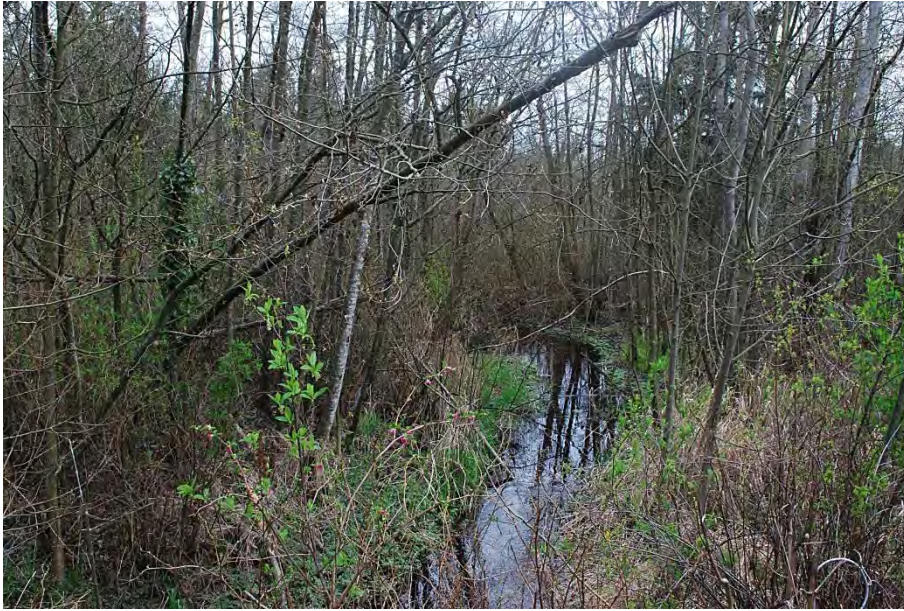
McSorley Creek looking upstream where it emerges from large forested wetland on the east side of SR 99.

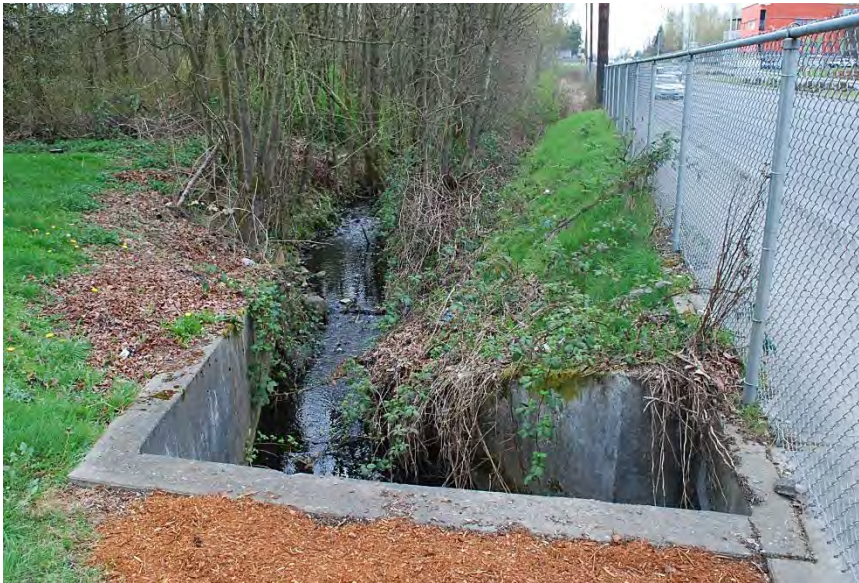
McSorley Creek alongside SR 99 where it enters a 4-foot-wide concrete box culvert under the highway.

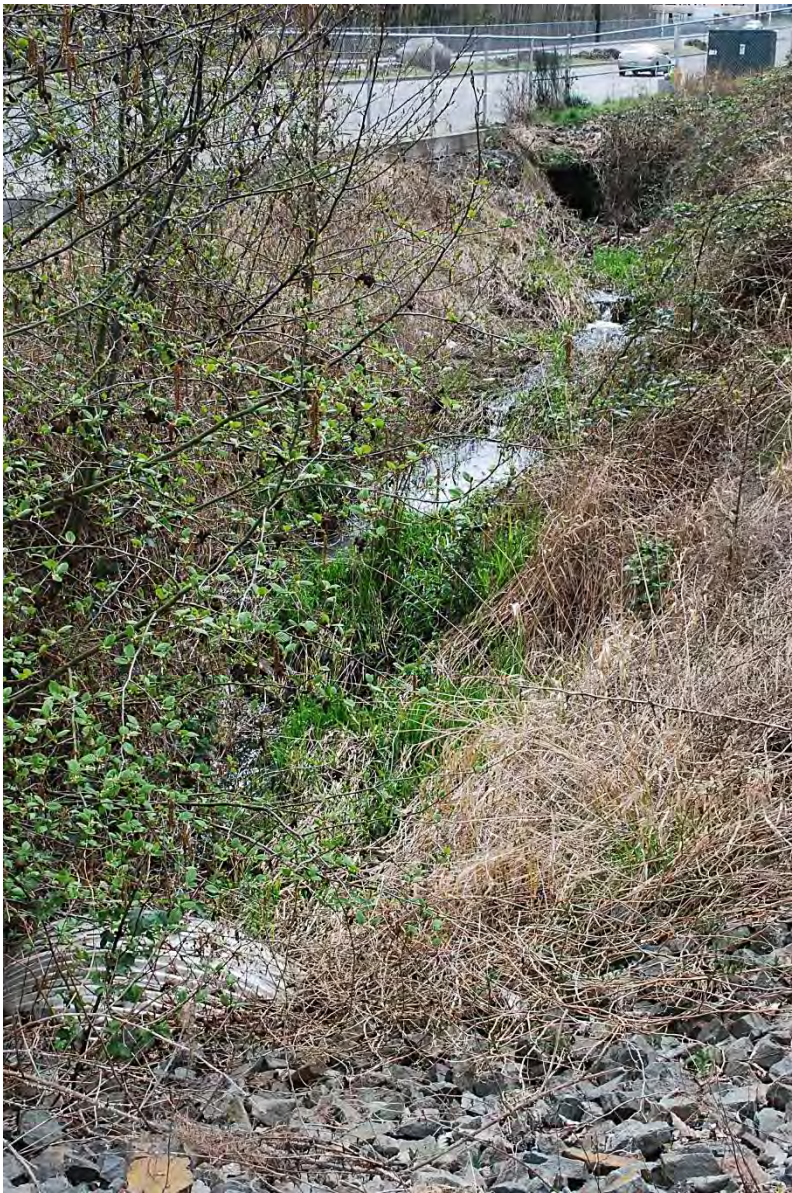
McSorley Creek looking upstream at the culvert exit on the west side of SR 99. Channel is overgrown in small area between the highway and a hotel parking lot.
