Appendix D

Wetland and Stream Photographs

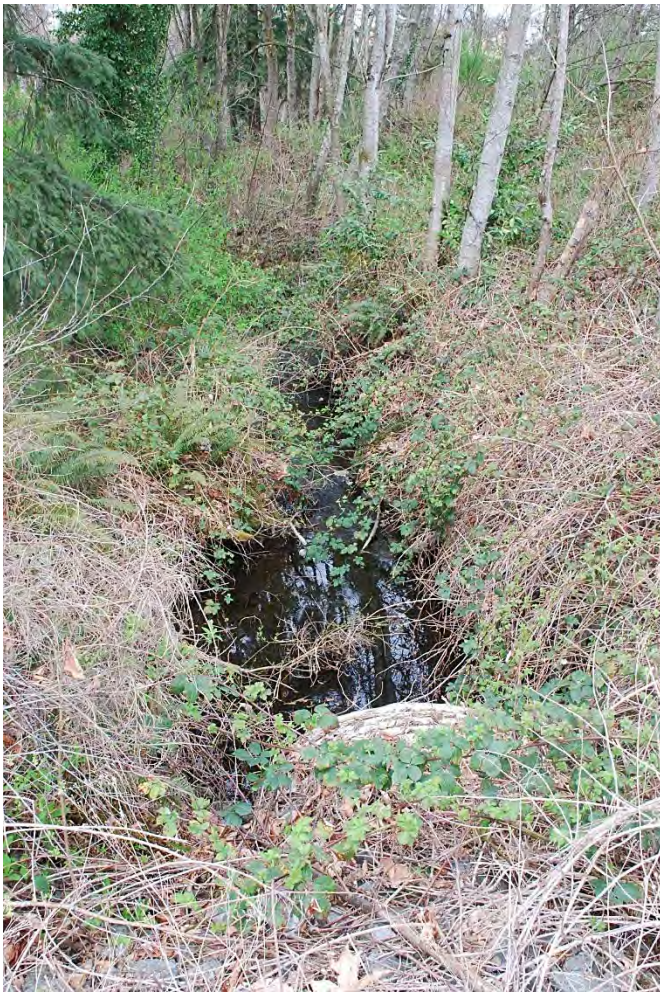
McSorley Creek looking downstream from culvert under stormwater/utility drive on west side of SR 99.

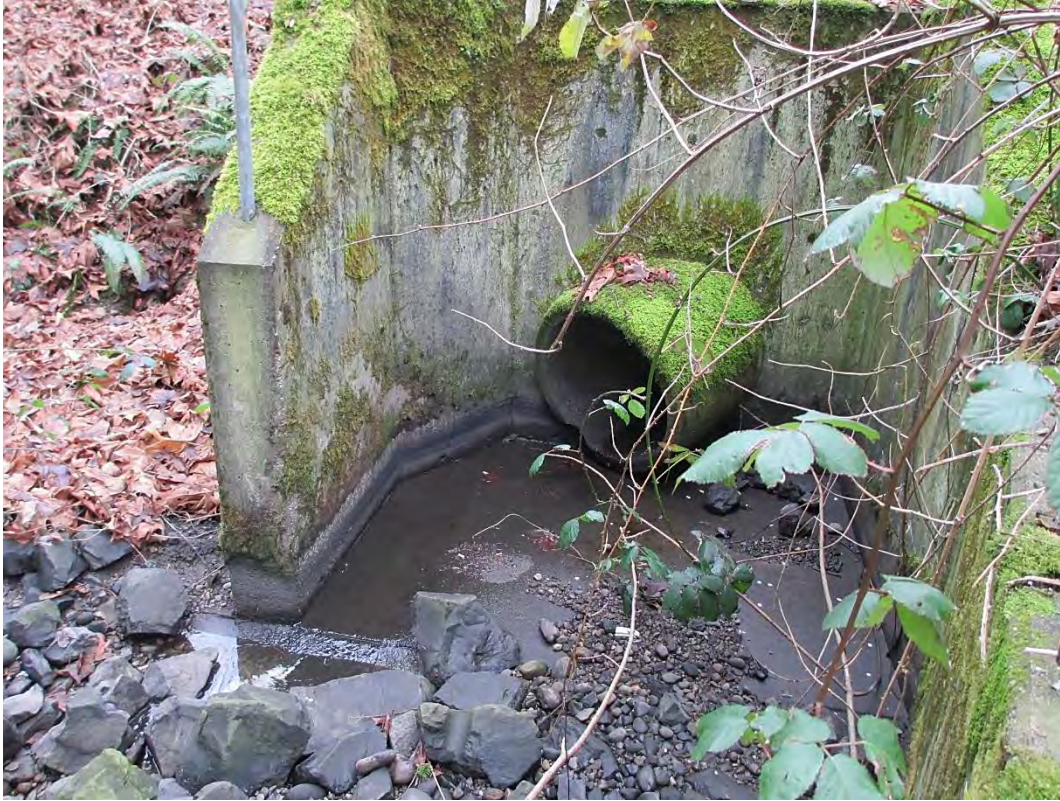
Redondo Creek exit culvert under Dash Point Road and SR 99. This culvert poses a passage barrier to fish. The photo was taken during the field visit in January 2014 when conditions were dry and flows in the creek were very low.

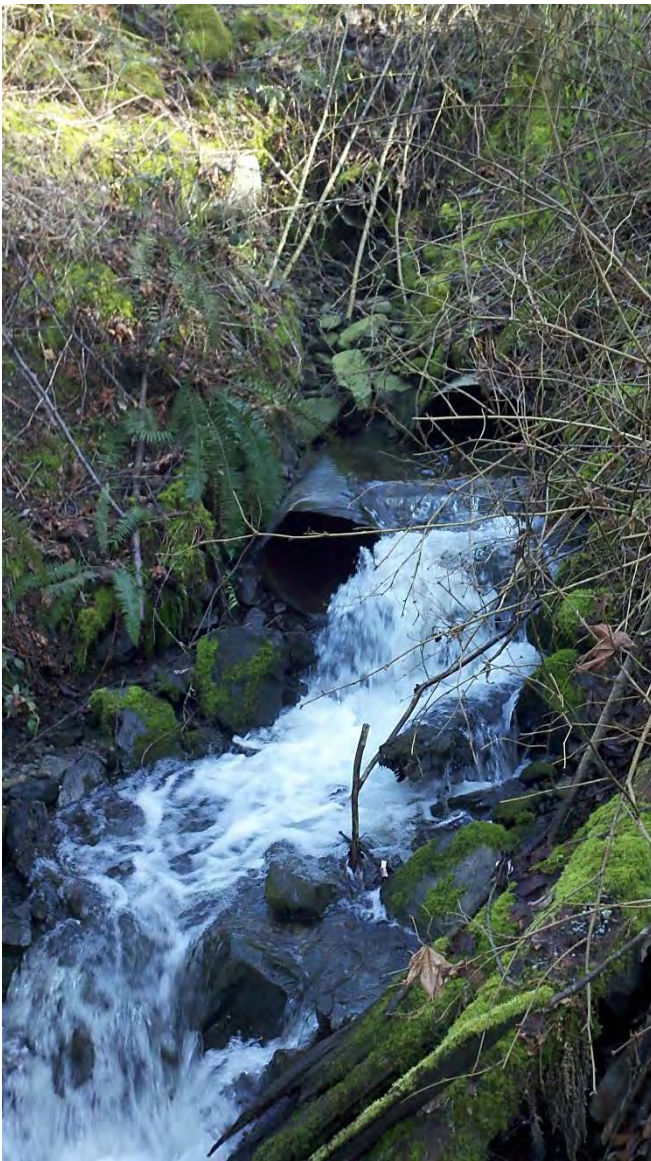
Redondo Creek exiting the culvert under the utility corridor drive. This culvert poses a fish passage barrier.

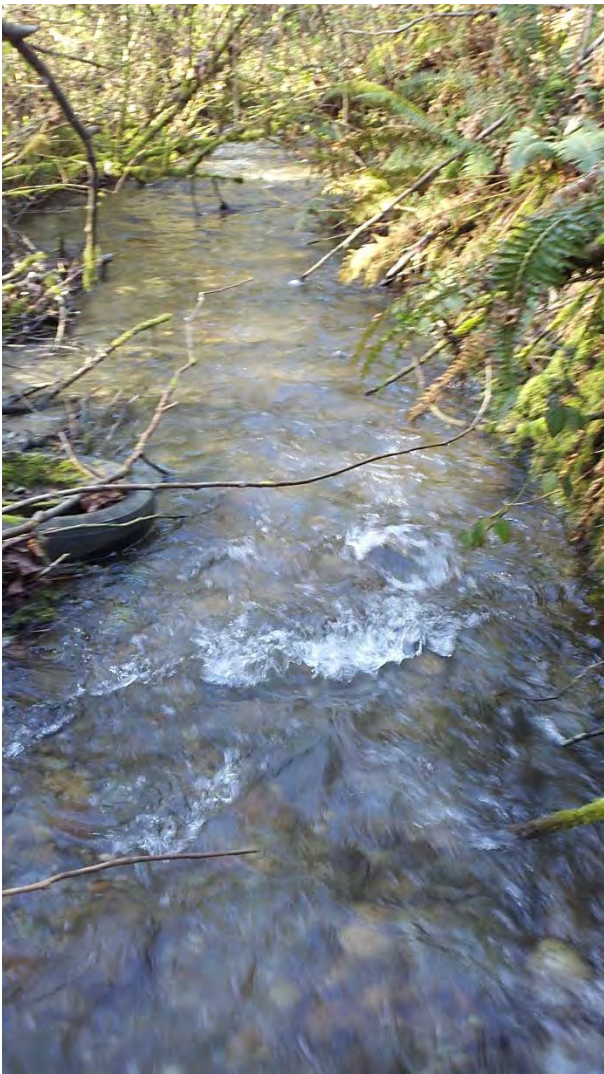
Redondo Creek downstream of utility corridor drive has good riffle habitat and gravel substrate. There is no pool habitat in this reach and the reach is isolated due to an impassable vertical drain at the downstream end where it crosses under Redondo Way.

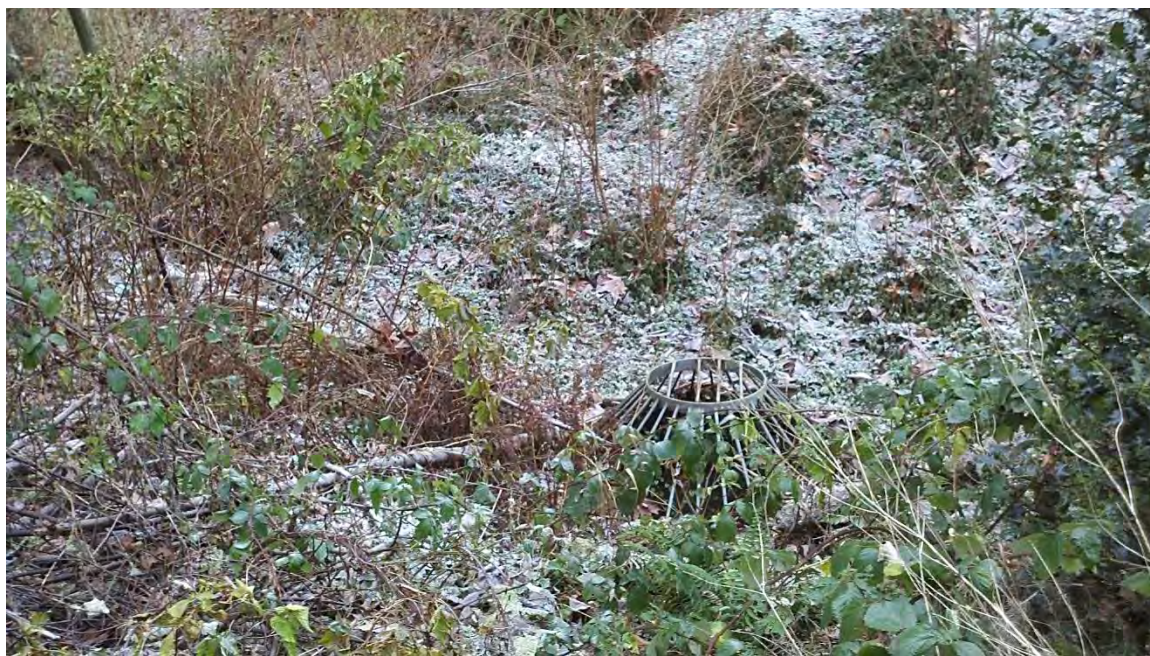
Redondo Creek grated inlet at downstream end of stream alongside Redondo Way.

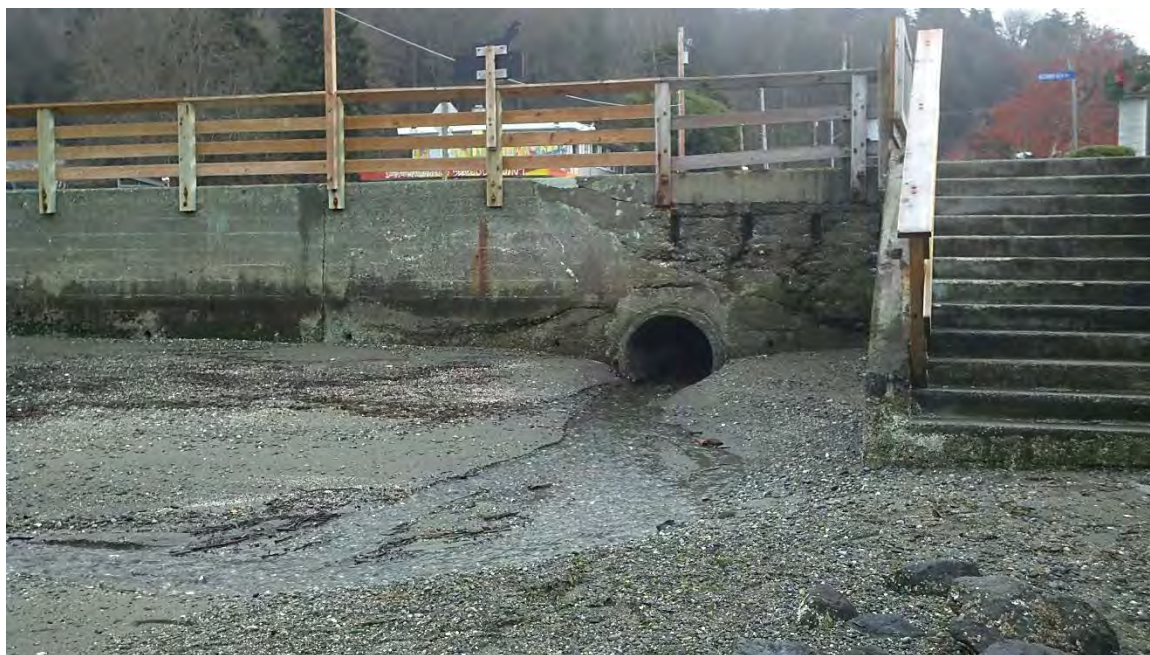
Redondo Creek exit at seawall on Puget Sound shoreline.

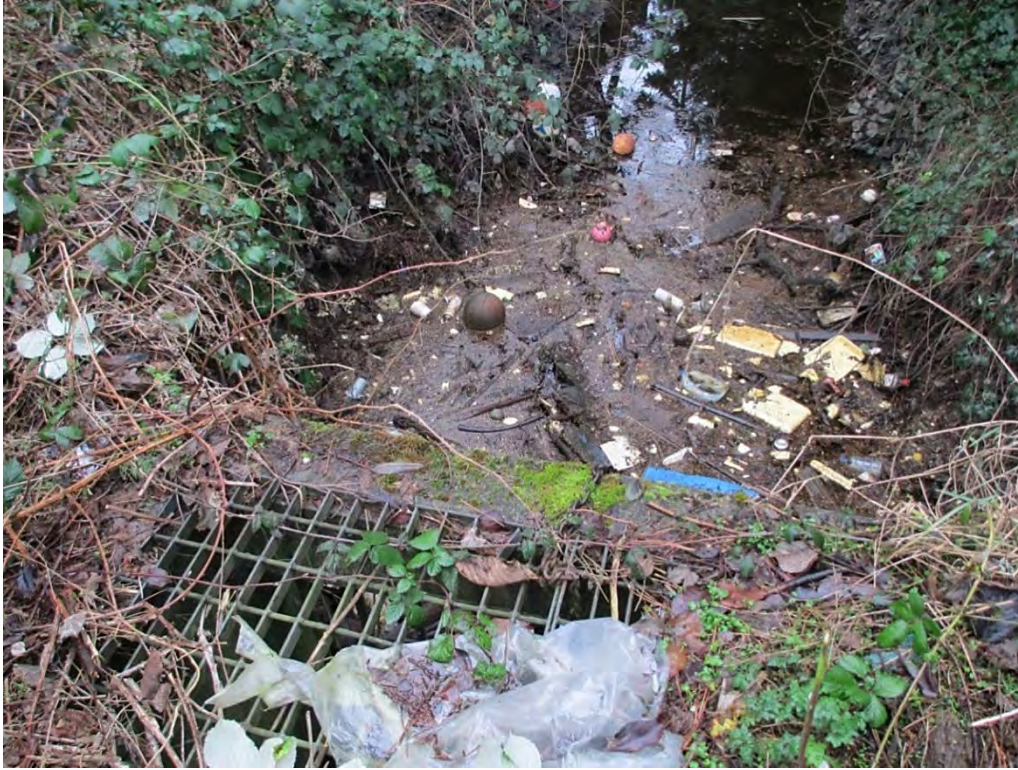
Bingaman Creek trash rack at culvert entrance on south side of S 288th Street.

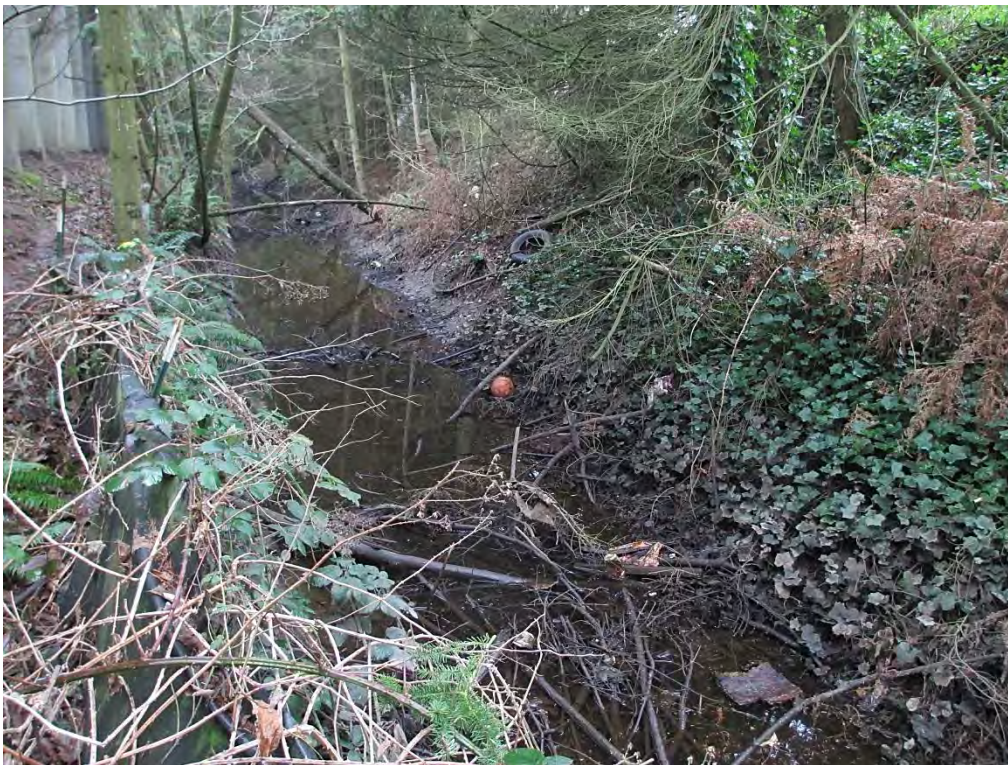
Bingaman Creek reach south of S 288th Street looking upstream. I-5 sound wall is at the left edge of the picture.

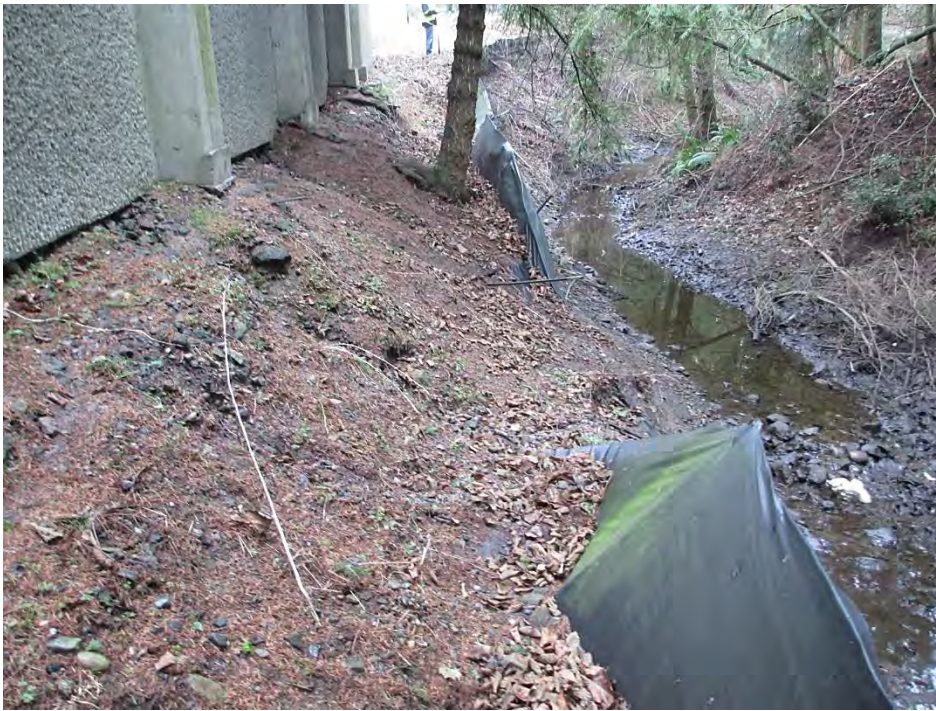
Bingaman Creek right bank eroding next to sound wall along Bingaman Creek reach south of S 288th Street.

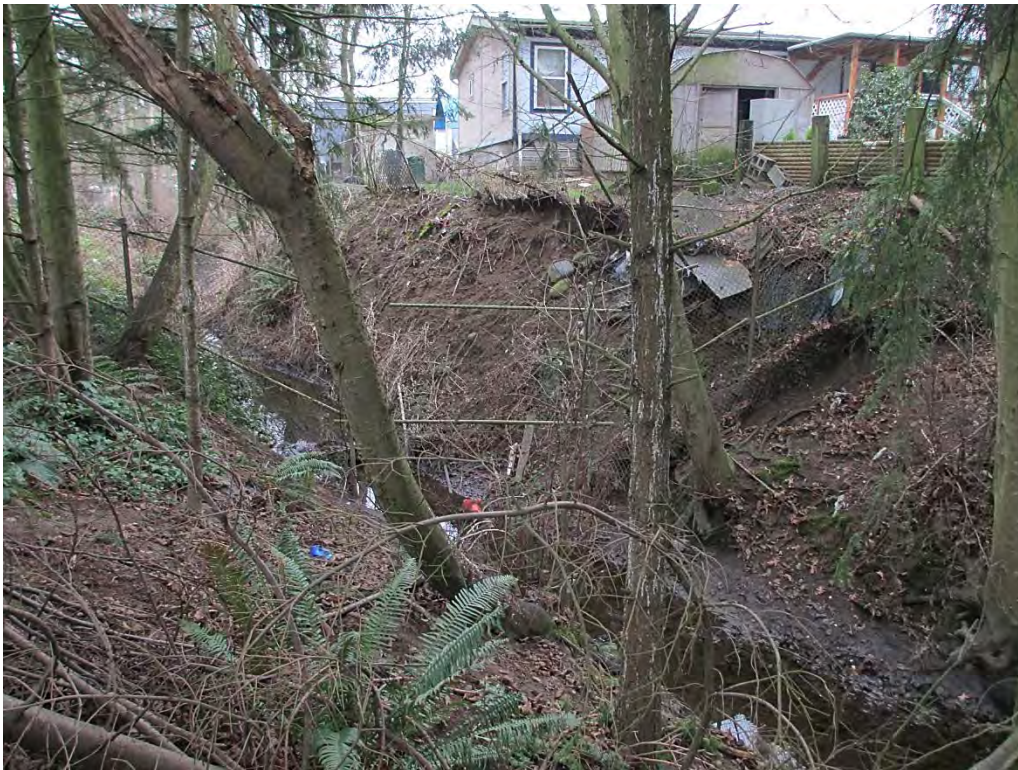
Bingaman Creek bank erosion next to mobile home park along Bingaman Creek reach south of S 288th Street.

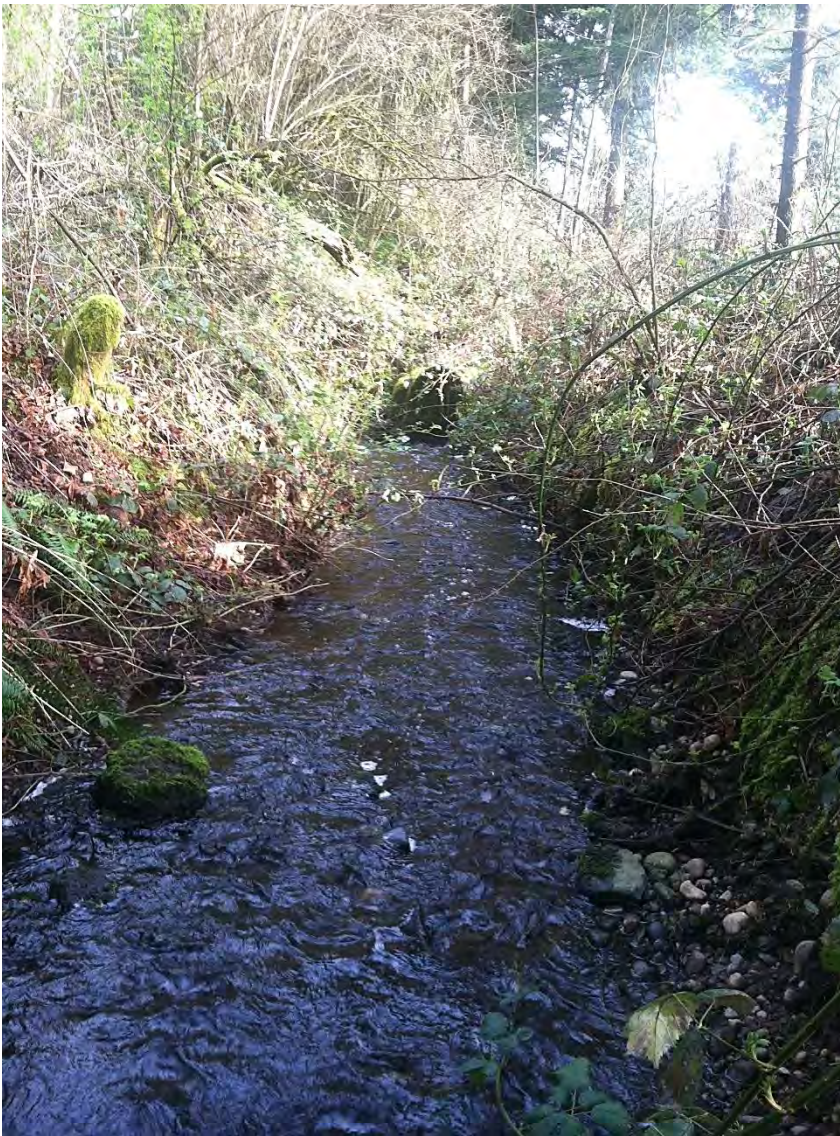
Bingaman Creek reach north of S 288th Street looking downstream to culvert under I-5.

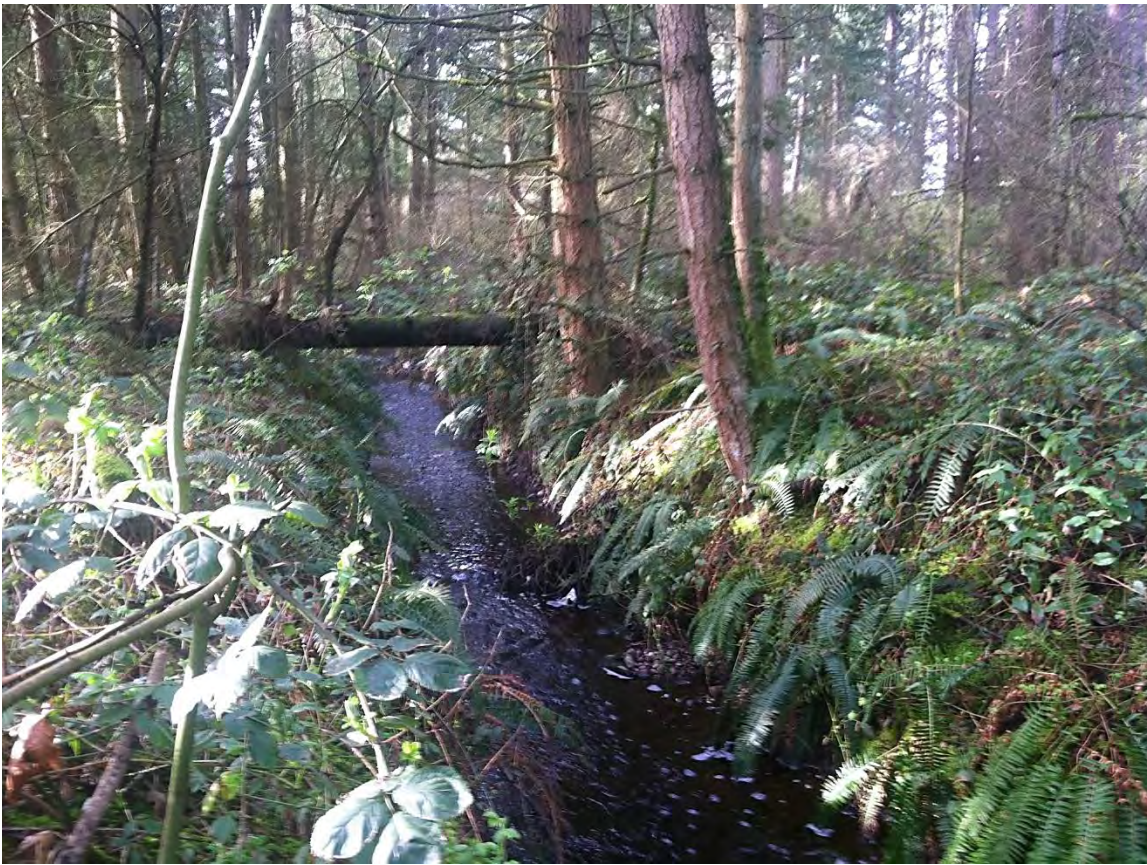
Bingaman Creek reach north of S 288th Street through forested area alongside I-5.

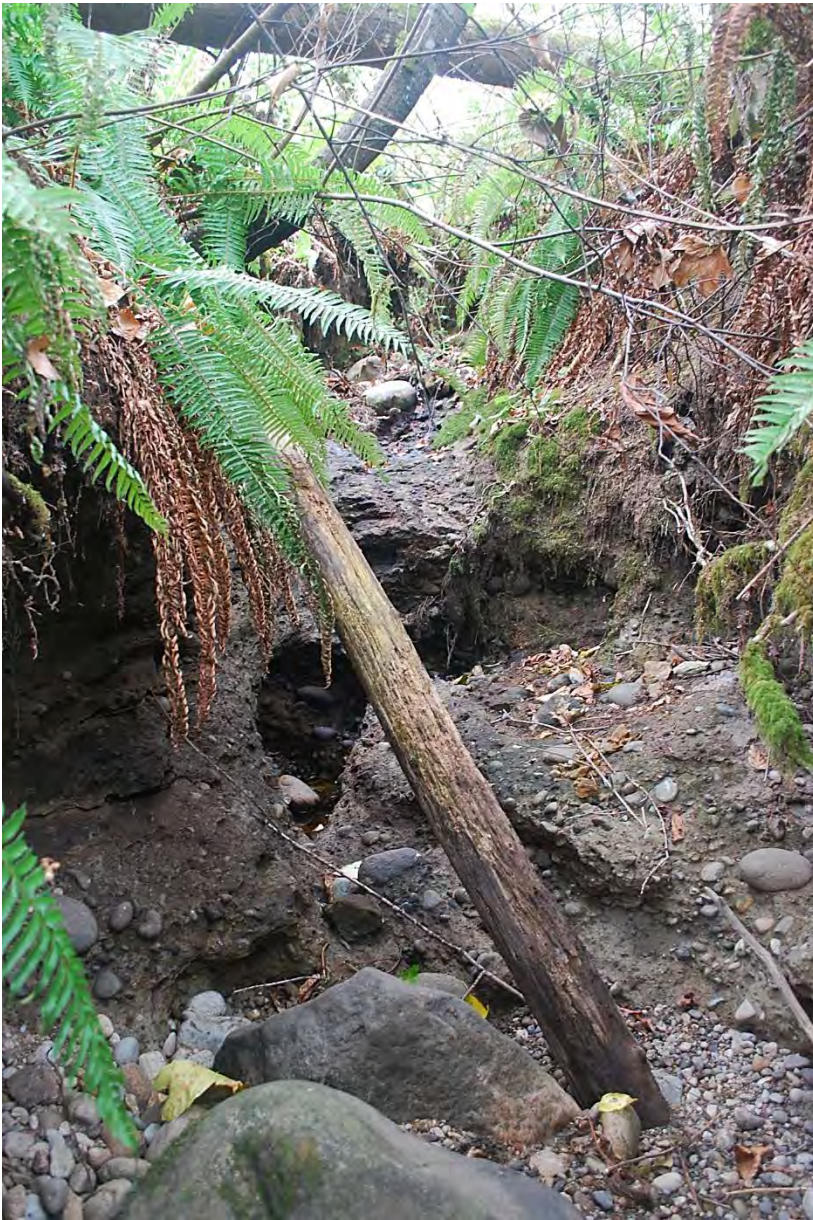
Scoured drops in the Bingaman Creek channel, downstream (east) of I-5, are 3 to 4 feet high, and form a natural fish passage barrier downstream of the project reach.

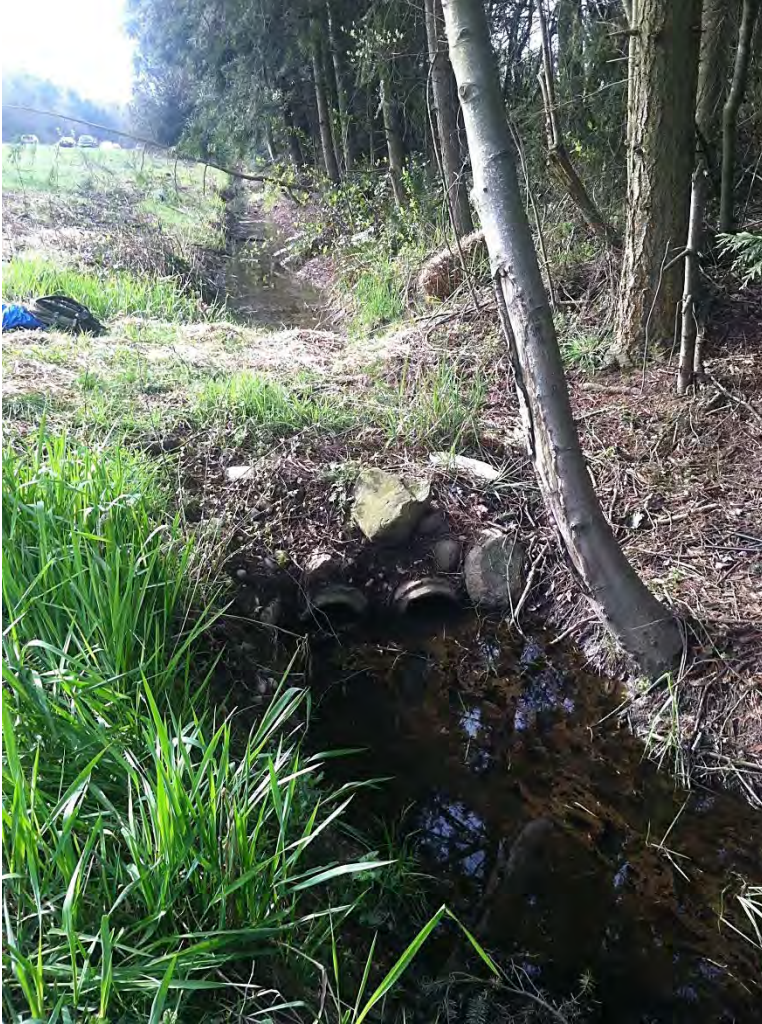
Small unnamed stream in the I-5 right-of-way south of Kent-Des Moines Road. A narrow riparian corridor of conifers is on the left bank, but vegetation has been removed on the right bank along the I-5 road prism.

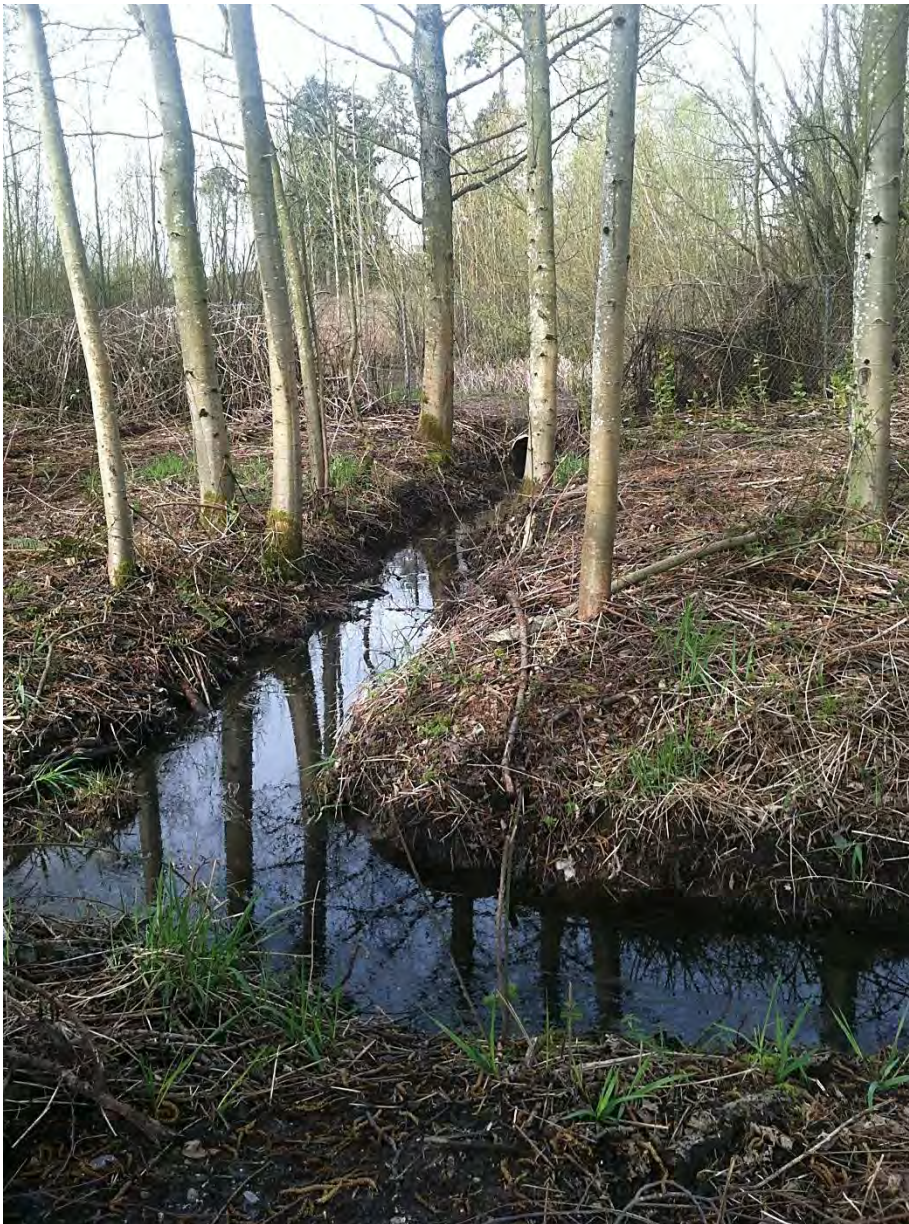
Small unnamed stream in I-5 right-of-way south of Kent-Des Moines Road. A channelized segment flows east from Wetland 20-2 next to I-5.
