Attachment N.3A
Noise Measurement Data, Site Details, and
Photographs

This attachment presents a data summary form for each noise monitoring location. Forms include the location, noise measurement equipment used, measurement data, weather observed during monitoring, and photographs of the site.

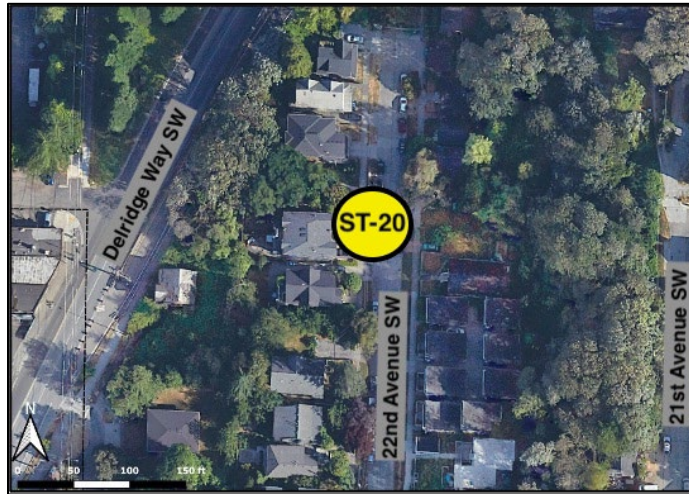
Plan View (ST-20)

Monitoring No.	ST-20
Address	3801 22nd Avenue Southwest
Segment	Duwamish
Parcel	2848700374

Date	Period ^a	Start Time	End Time	Leq dBA ^b	Ldn dBA ^c
06/06/2023	Afternoon	12:04 p.m.	12:34 p.m.	60	62

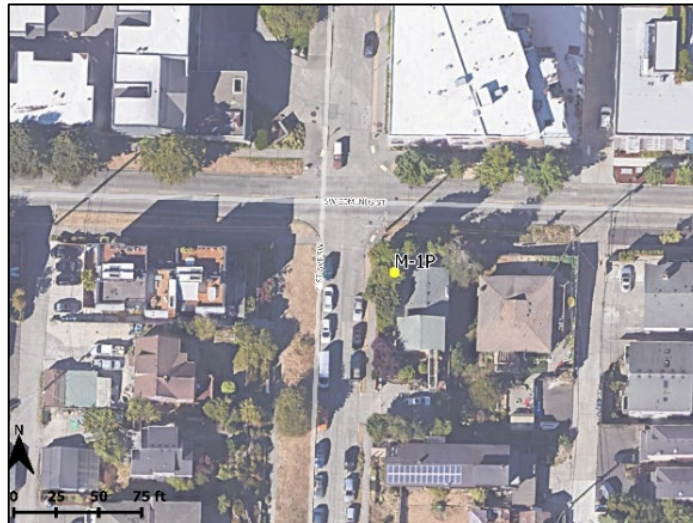
Plan View (M-1)

Monitoring No.	M-1
Address	4023 Southwest Edmunds Street
Area	West Seattle Junction
Parcel	757920-0491

Start Date	October 22, 2019
End Date	October 25, 2019
Start Time	9 a.m.
End Time	9 a.m.
Peak Hour L_{eq} sound level	62 dBA
Day-night average sound level	62 dBA

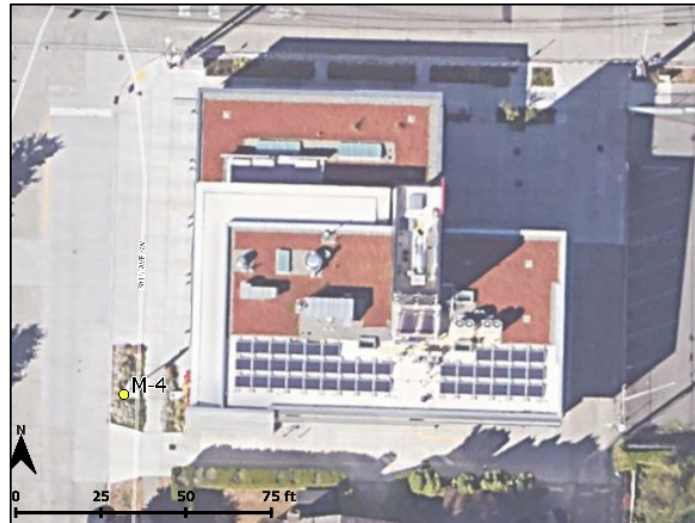
Plan View (M-4)

Monitoring No.	M-4
Address	4700 38th Avenue Southwest
Area	West Seattle Junction
Parcel	612660-0005

Start Date	December 6, 2019
End Date	December 10, 2019
Start Time	11 a.m.
End Time	1 p.m.
Peak Hour L_{eq} sound level	69 dBA
Day-night average sound level	68 dBA

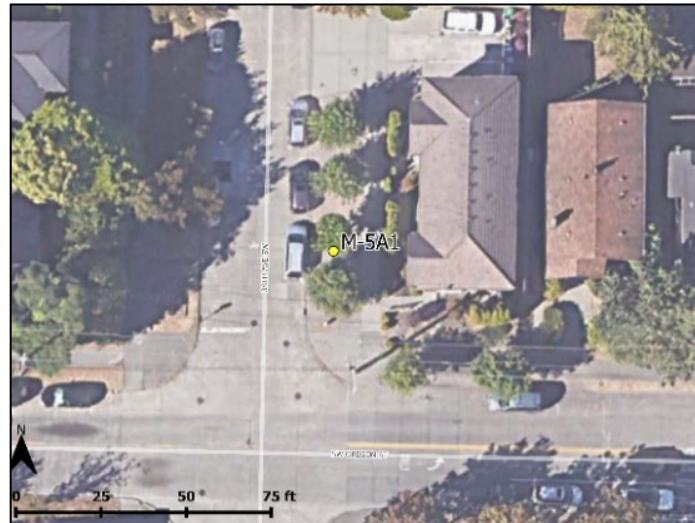
Plan View (M-5)

Monitoring No.	M-5
Address	4450 38th Avenue Southwest
Area	West Seattle Junction
Parcel	095200-4935

Start Date	February 11, 2020
End Date	February 14, 2020
Start Time	3 p.m.
End Time	9 a.m.
Peak Hour L_{eq} sound level	66 dBA
Day-night average sound level	68 dBA

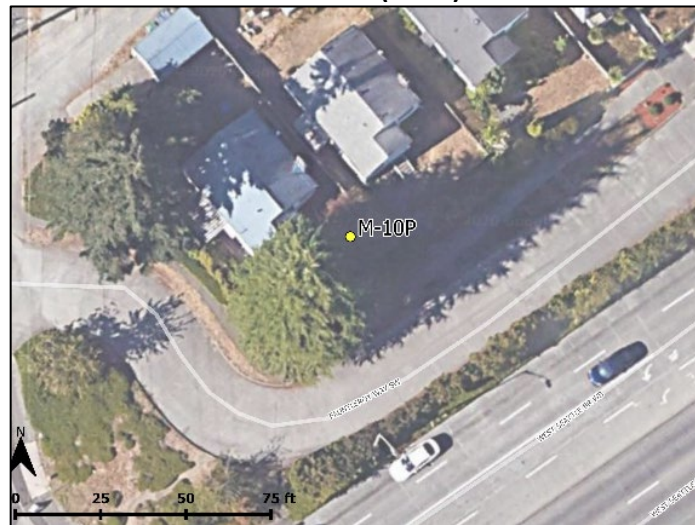
Plan View (M-10)

Monitoring No.	M-10
Address	4147 Fauntleroy Way Southwest
Area	West Seattle Junction
Parcel	929730-1525

Start Date	February 14, 2020
End Date	February 20, 2020
Start Time	9 a.m.
End Time	3 p.m.
Peak Hour L_{eq} sound level	70 dBA
Day-night average sound level	73 dBA

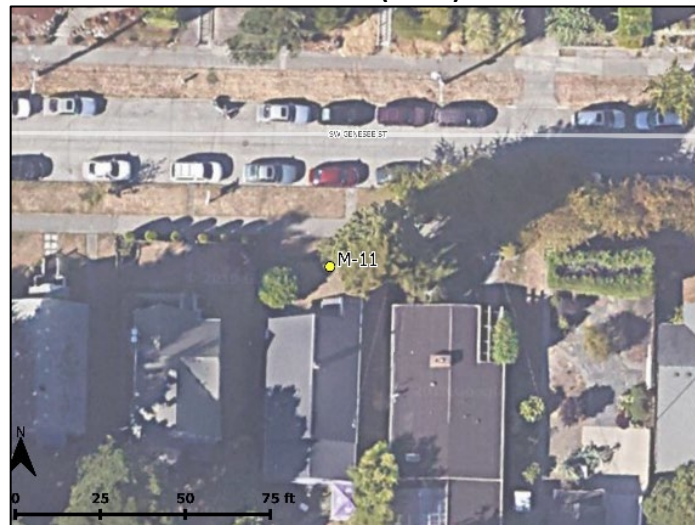
Plan View (M-11)

Monitoring No.	M-11
Address	3225 Southwest Genesee Street
Area	West Seattle Junction
Parcel	929730-1780

Start Date	November 12, 2019
End Date	November 14, 2019
Start Time	12 p.m.
End Time	1 p.m.
Peak Hour L_{eq} sound level	56 dBA
Day-night average sound level	59 dBA

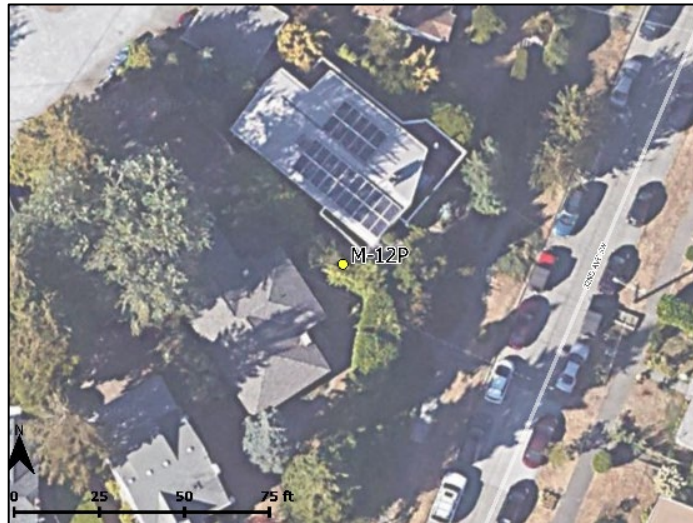
Plan View (M-12)

Monitoring No.	M-12
Address	4143 32nd Avenue Southwest
Area	West Seattle Junction
Parcel	929730-1220

Start Date	February 11, 2020
End Date	February 14, 2020
Start Time	2 p.m.
End Time	9 a.m.
Peak Hour L_{eq} sound level	53 dBA
Day-night average sound level	56 dBA

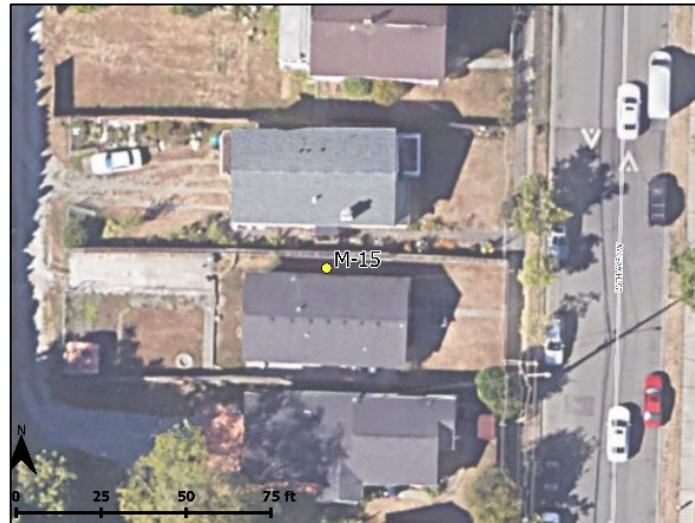
Plan View (M-15)

Monitoring No.	M-15
Address	4421 26th Avenue Southwest
Area	Delridge
Parcel	177260-0710

Start Date	December 6, 2019
End Date	December 10, 2019
Start Time	10 a.m.
End Time	1 p.m.
Peak Hour L_{eq} sound level	51 dBA
Day-night average sound level	53 dBA

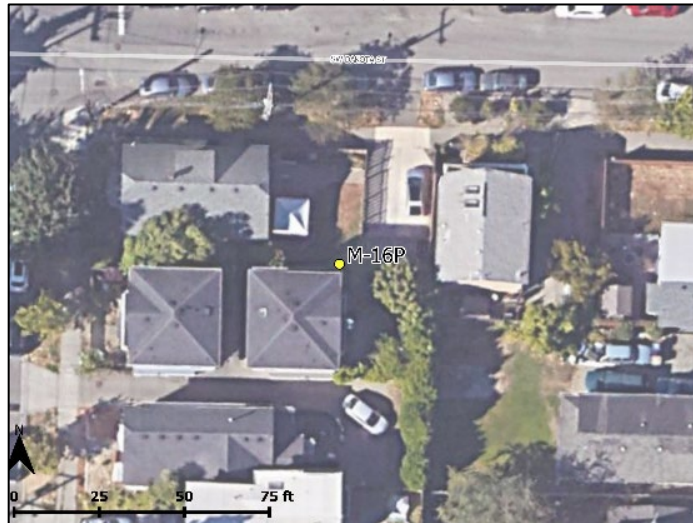
Plan View (M-16)

Monitoring No.	M-16
Address	4106 26th Avenue Southwest
Area	Delridge
Parcel	789160-0017

Start Date	January 16, 2020
End Date	January 22, 2020
Start Time	9 a.m.
End Time	10 a.m.
Peak Hour L_{eq} sound level	52 dBA
Day-night average sound level	54 dBA

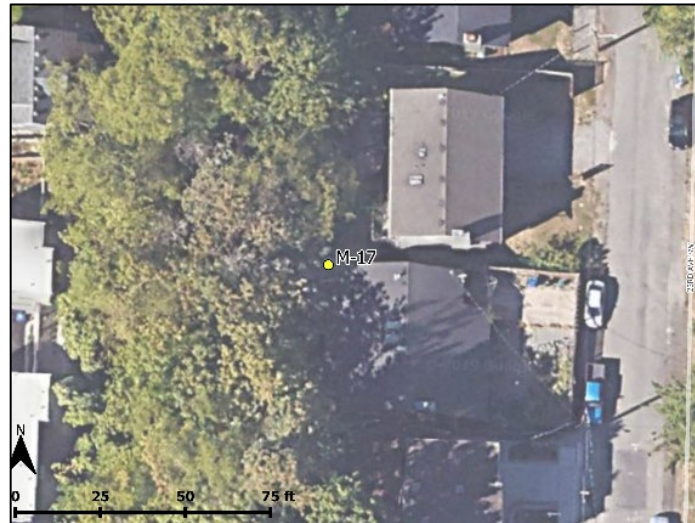
Plan View (M-17)

Monitoring No.	M-17
Address	4143 23rd Avenue Southwest
Area	Delridge
Parcel	789210-0020

Start Date	November 12, 2019
End Date	November 14, 2019
Start Time	11 a.m.
End Time	1 p.m.
Peak Hour L_{eq} sound level	59 dBA
Day-night average sound level	62 dBA

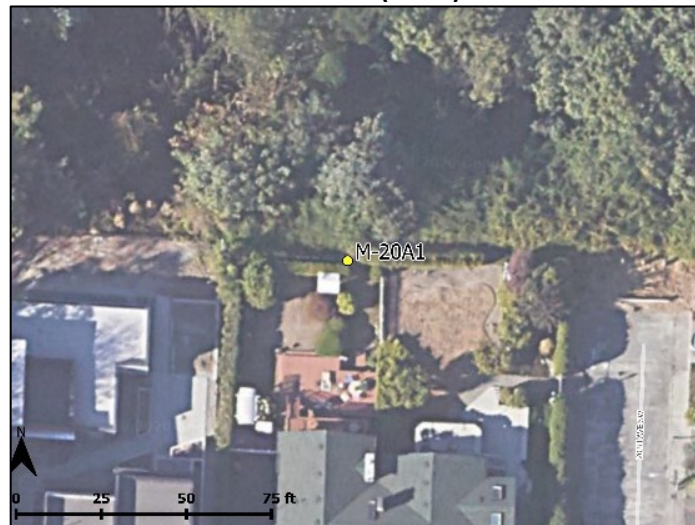
Plan View (M-20)

Monitoring No.	M-20
Address	3709 20th Avenue Southwest
Area	Duwamish
Parcel	934990-0080

Start Date	January 16, 2020
End Date	January 22, 2020
Start Time	10 a.m.
End Time	11 a.m.
Peak Hour L_{eq} sound level	72 dBA
Day-night average sound level	75 dBA

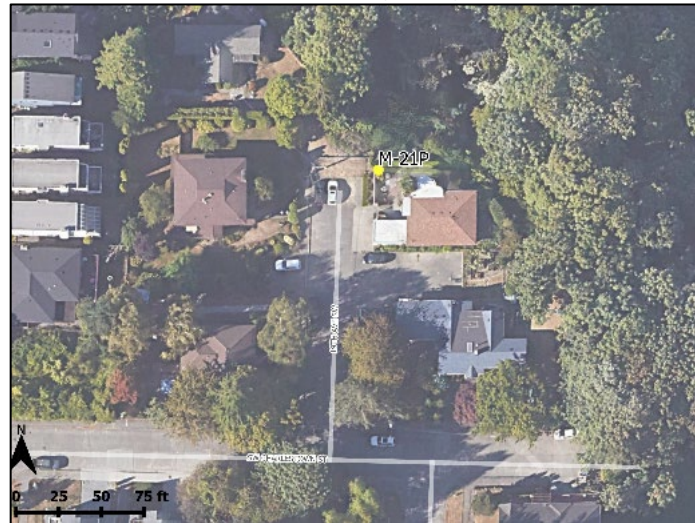
Plan View (M-21)

Monitoring No.	M-21
Address	3712 19th Avenue Southwest
Area	Duwamish
Parcel	934990-0225

Start Date	October 22, 2019
End Date	October 25, 2019
Start Time	10 a.m.
End Time	9 a.m.
Peak Hour L_{eq} sound level	72 dBA
Day-night average sound level	75 dBA

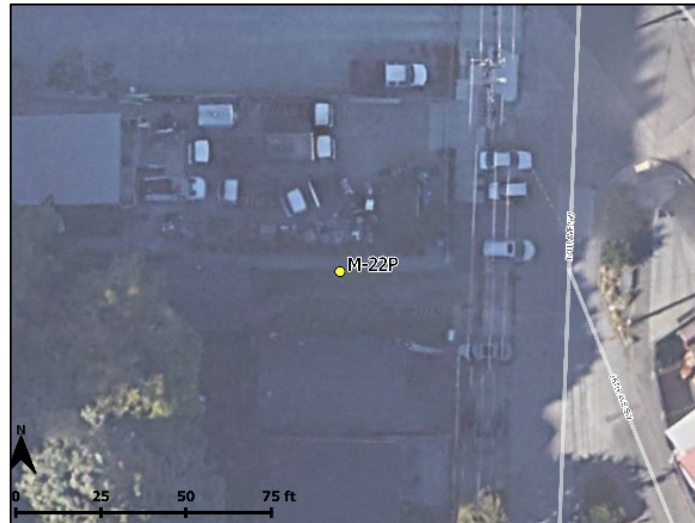
Plan View (M-22)

Monitoring No.	M-22
Address	3823 17th Avenue Southwest
Area	Duwamish
Parcel	754730-0940

Start Date	November 7, 2019
End Date	November 14, 2019
Start Time	12 p.m.
End Time	1 p.m.
Peak Hour L_{eq} sound level	67 dBA
Day-night average sound level	69 dBA

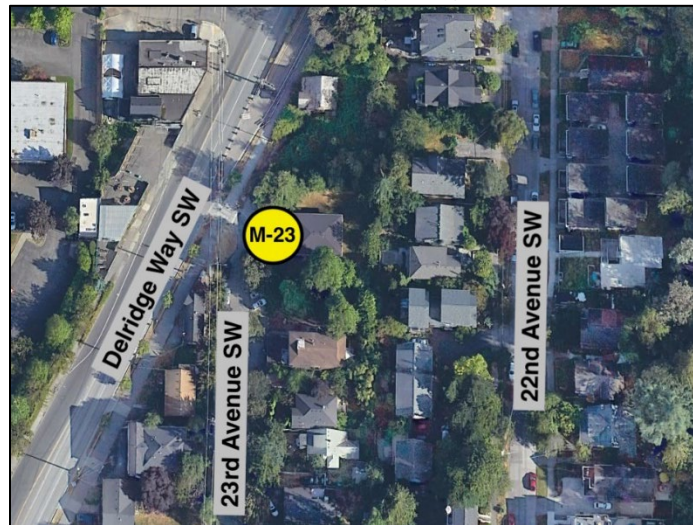
Plan View (M-23)

Monitoring No.	M-23
Address	3816 23rd Avenue Southwest
Segment	Duwamish
Parcel	2848700160

Start Date	November 8, 2022
End Date	November 10, 2022
Start Time	11 a.m.
End Time	9 a.m.
Peak Hour Leq dBA Sound Level	68 dBA
Day-Night Average Sound Level Ldn dBA	69 dBA

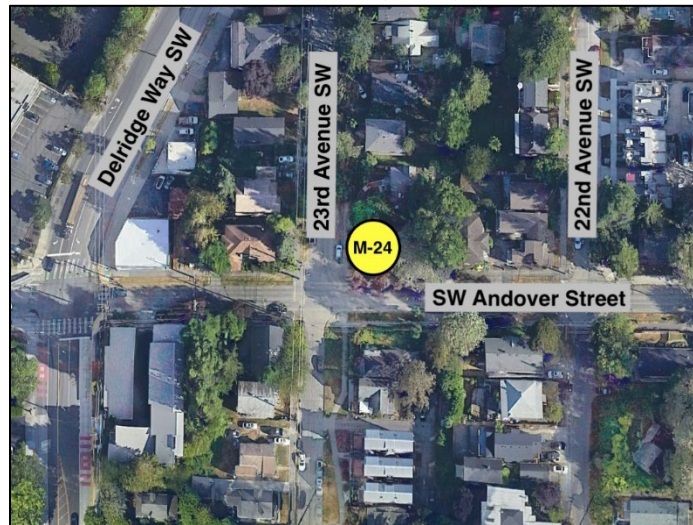
Plan View (M-24)

Monitoring No.	M-24
Address	3856 23rd Avenue Southwest
Segment	Duwamish
Parcel	2848700230

Start Date	November 8, 2022
End Date	November 10, 2022
Start Time	11 a.m.
End Time	9 a.m.
Peak Hour Leq dBA Sound Level	68 dBA
Day-Night Average Sound Level Ldn dBA	64 dBA

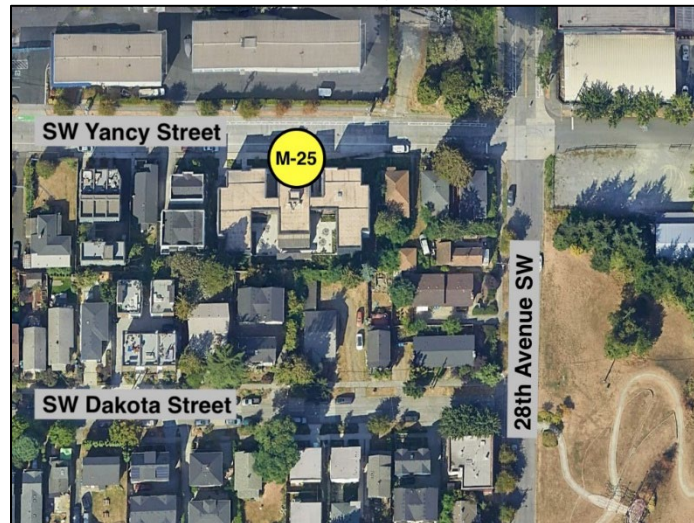
Plan View (M-25)

Monitoring No.	M-25
Address	2821 Southwest Yancy Street
Segment	Delridge
Parcel	9358000515

Start Date	January 24, 2023
End Date	January 27, 2023
Start Time	12 p.m.
End Time	10 a.m.
Peak Hour Leq dBA Sound Level	68 dBA
Day-Night Average Sound Level Ldn dBA	64 dBA

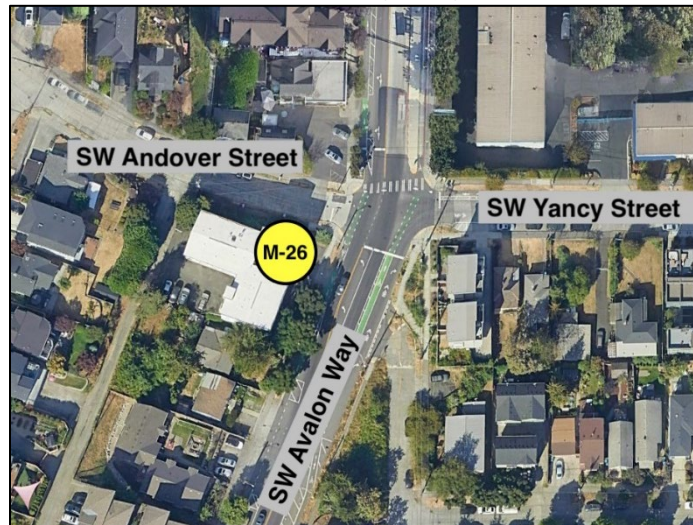
Plan View (M-26)

Monitoring No.	M-26
Address	3000 Southwest Avalon Way
Segment	Delridge
Parcel	7732800000

Start Date	January 29, 2023
End Date	February 1, 2023
Start Time	1 p.m.
End Time	12 p.m.
Peak Hour Leq dBA Sound Level	72 dBA
Day-Night Average Sound Level Ldn dBA	70 dBA

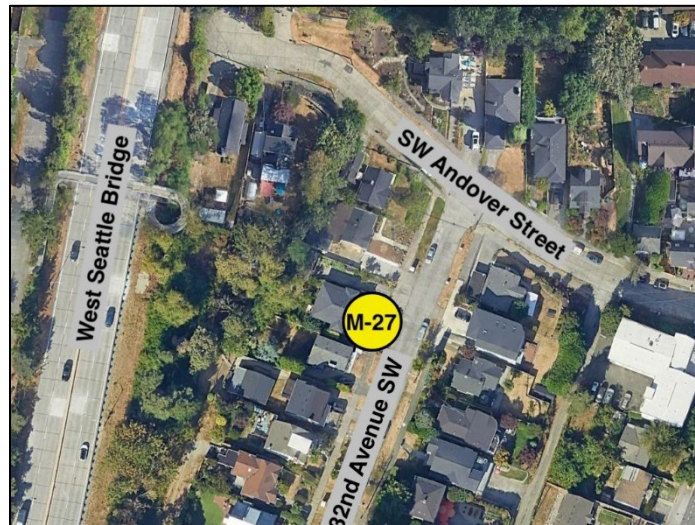
Plan View (M-27)

Monitoring No.	M-27
Address	4009 32nd Avenue Southwest
Segment	Delridge
Parcel	9297301106

Start Date	January 24, 2023
End Date	January 27, 2023
Start Time	11 a.m.
End Time	10 a.m.
Peak Hour Leq dBA Sound Level	60 dBA
Day-Night Average Sound Level Ldn dBA	57 dBA

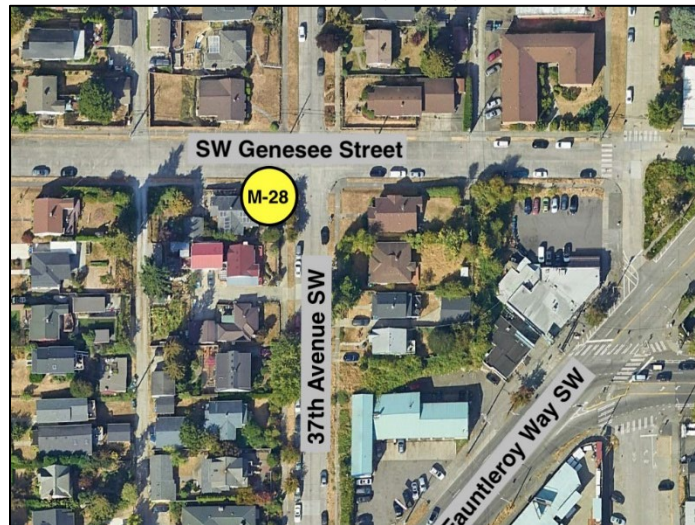
Plan View (M-28)

Monitoring No.	M-28
Address	4403 37th Avenue Southwest
Segment	West Seattle Junction
Parcel	0952004705

Start Date	November 8, 2022
End Date	November 10, 2022
Start Time	11 a.m.
End Time	9 a.m.
Peak Hour Leq dBA Sound Level	62 dBA
Day-Night Average Sound Level Ldn dBA	62 dBA

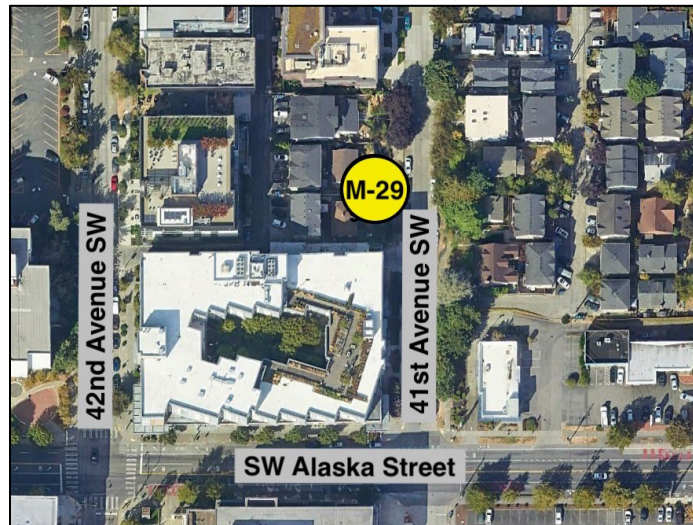
Plan View (M-29)

Monitoring No.	M-29
Address	4537 41st Avenue Southwest
Segment	West Seattle Junction
Parcel	0952006725

Start Date	November 8, 2022
End Date	November 10, 2022
Start Time	10 a.m.
End Time	9 a.m.
Peak Hour Leq dBA Sound Level	67 dBA
Day-Night Average Sound Level Ldn dBA	61 dBA

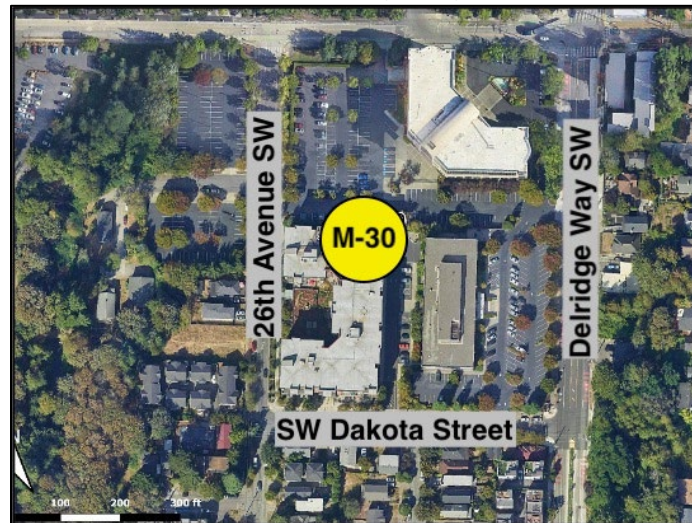
Plan View (M-30)

Monitoring No.	M-30
Address	4040 26th Avenue Southwest
Segment	Delridge
Parcel	2444600025

Start Date	06/08/2023
End Date	06/13/2023
Start Time	10 a.m.
End Time	11 a.m.
Peak Hour Leq dBA Sound Level	63 dBA
Day-Night Average Sound Level Ldn dBA	64 dBA

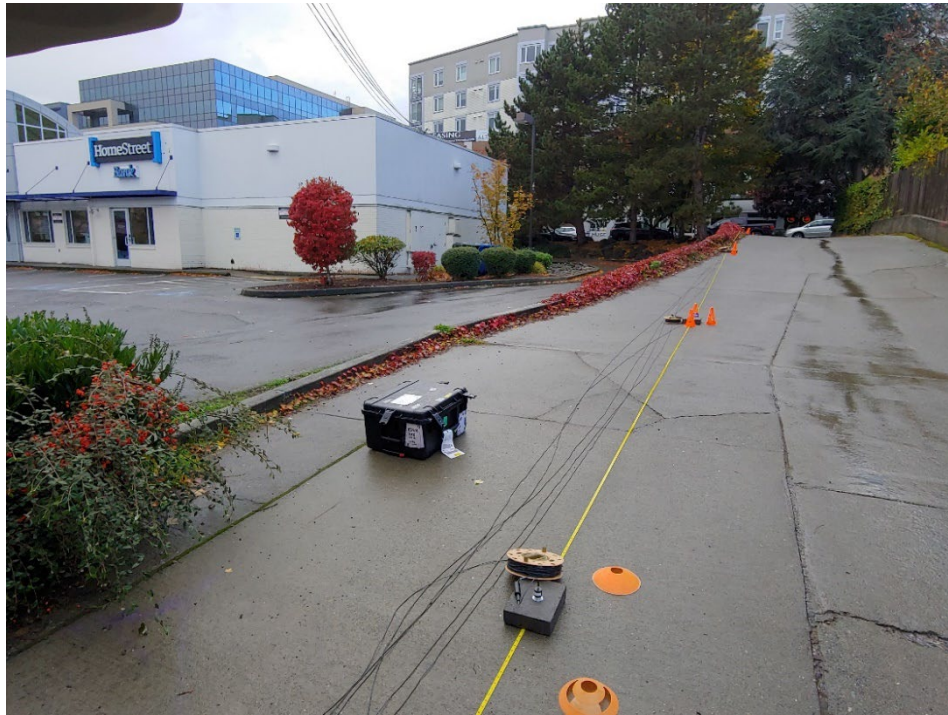
Figure N.3B-1. Photograph of Vibration Propagation Measurement Site V-A –
Alley off of 41st Avenue at Alaska Way

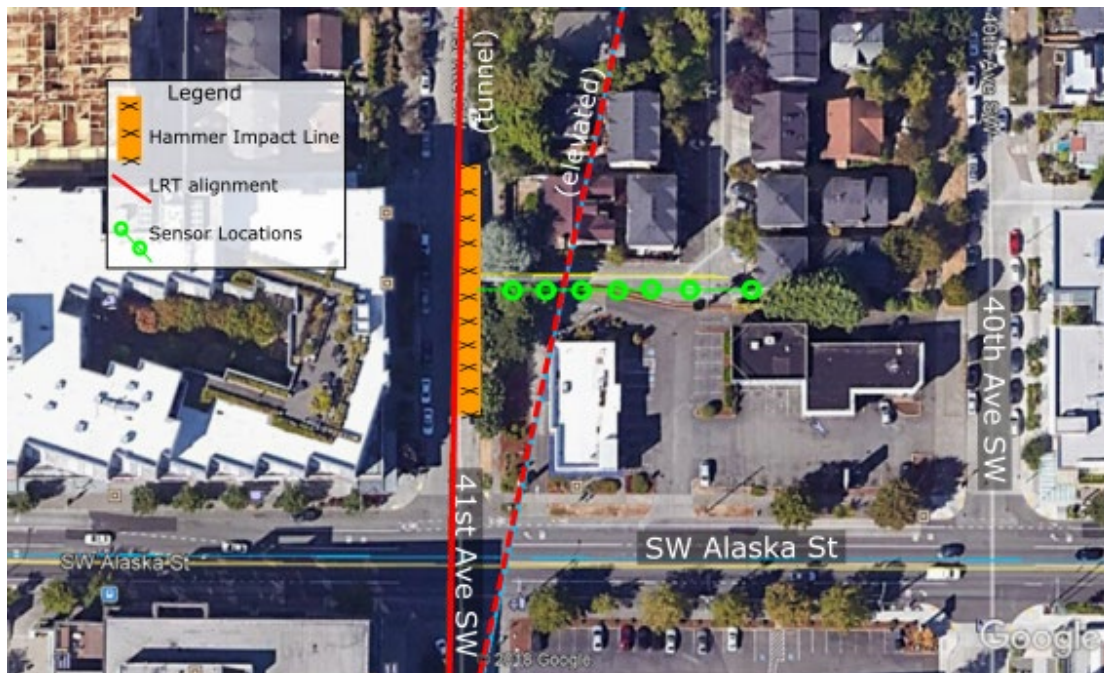
Figure N.3B-2. Aerial View of Vibration Propagation Measurement Site V-A –
Alley off of 41st Avenue at Alaska Way

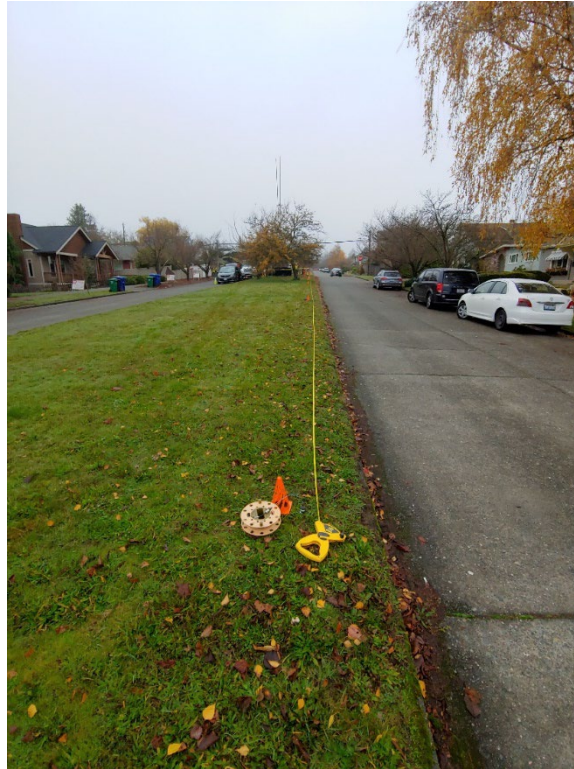
Figure N.3B-3. Photograph of Borehole Vibration Propagation Measurement Site V-2 – 39th Avenue Southwest at Southwest Genesee Street

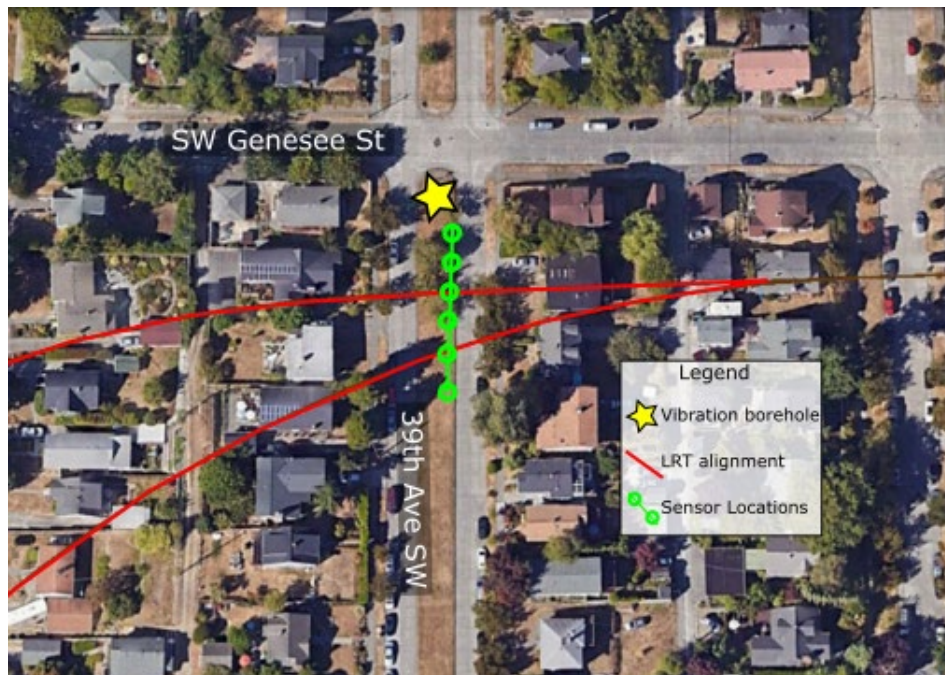
Figure N.3B-4. Aerial View of Borehole Vibration Propagation Measurement Site V-2 – 39th Avenue Southwest at Southwest Genesee Street

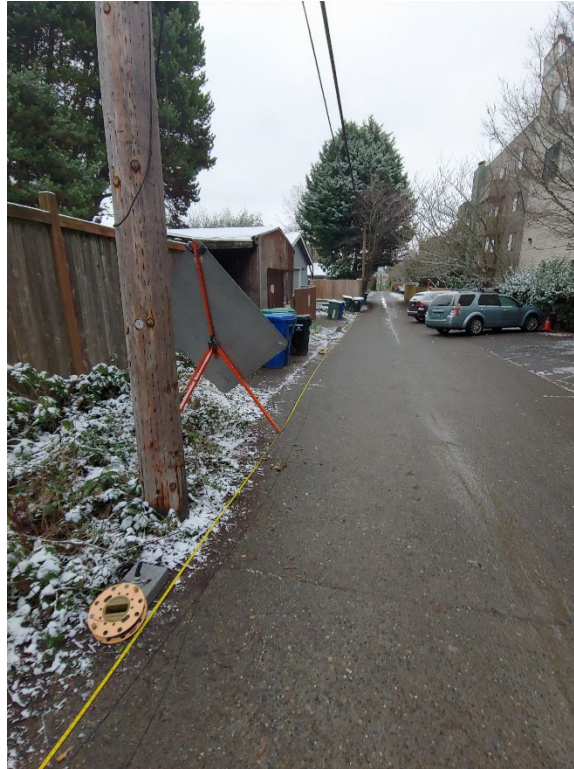
**Figure N.3B-5. Photograph of Borehole Vibration Propagation Measurement Site
V-3 – 32nd Avenue Southwest at Southwest Genesee Street**

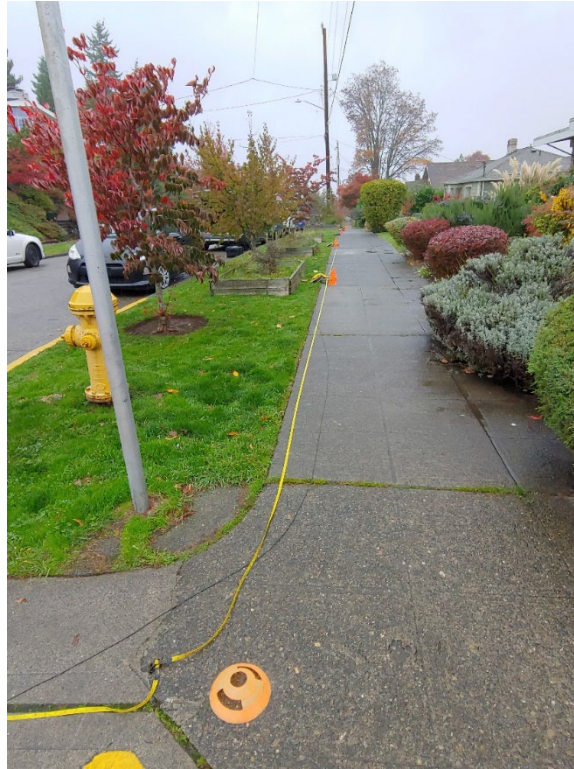
Figure N.3B-7. Photograph of Vibration Propagation Measurement Site V-B – Southwest Genesee Street at 32nd Avenue Southwest

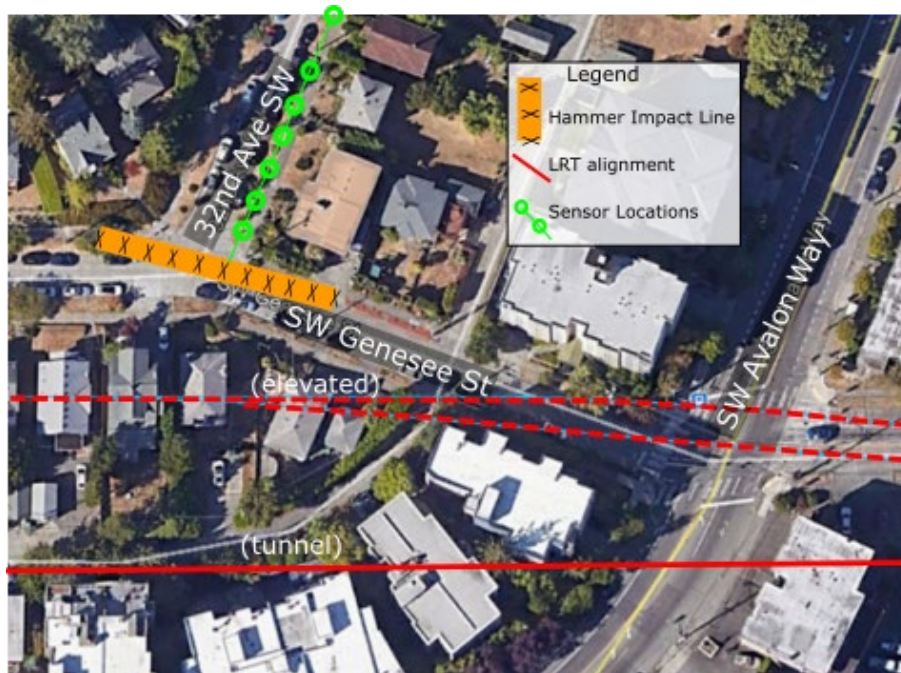
Figure N.3B-8. Aerial View of Vibration Propagation Measurement Site V-B – Southwest Genesee Street at 32nd Avenue Southwest

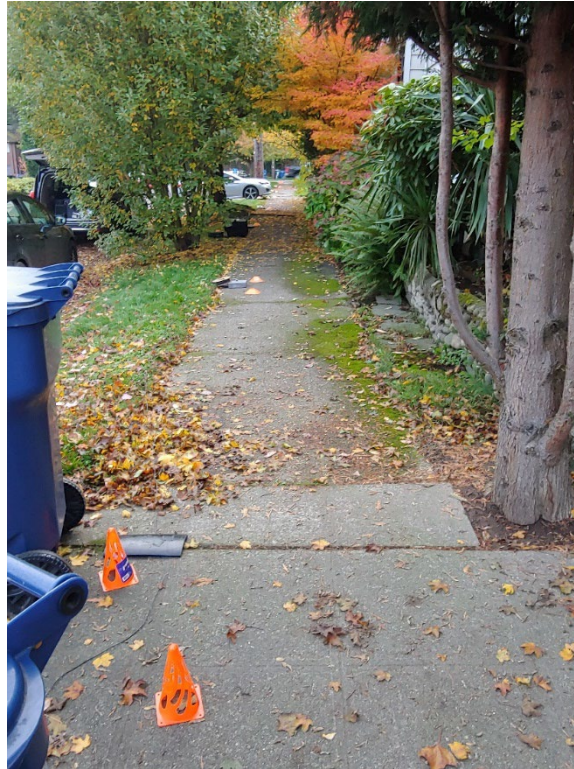
**Figure N.3B-9. Photograph of Vibration Propagation Measurement Site V-C –
Dakota Street at 25th Avenue Southwest**

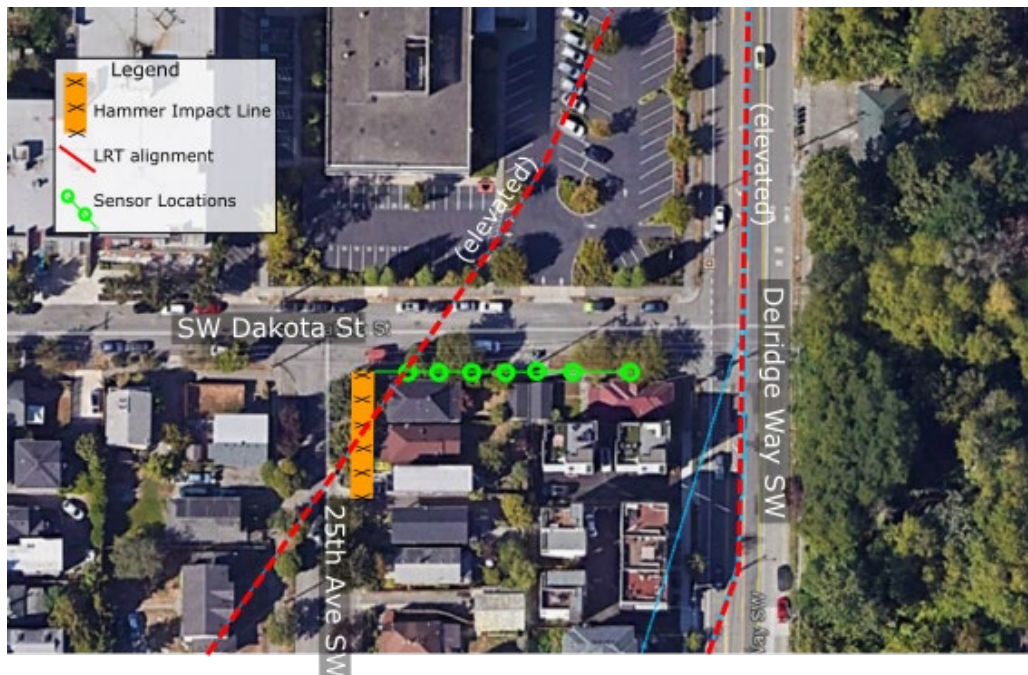
**Figure N.3B-10. Aerial View of Vibration Propagation Measurement Site V-C –
Dakota Street at 25th Avenue Southwest**

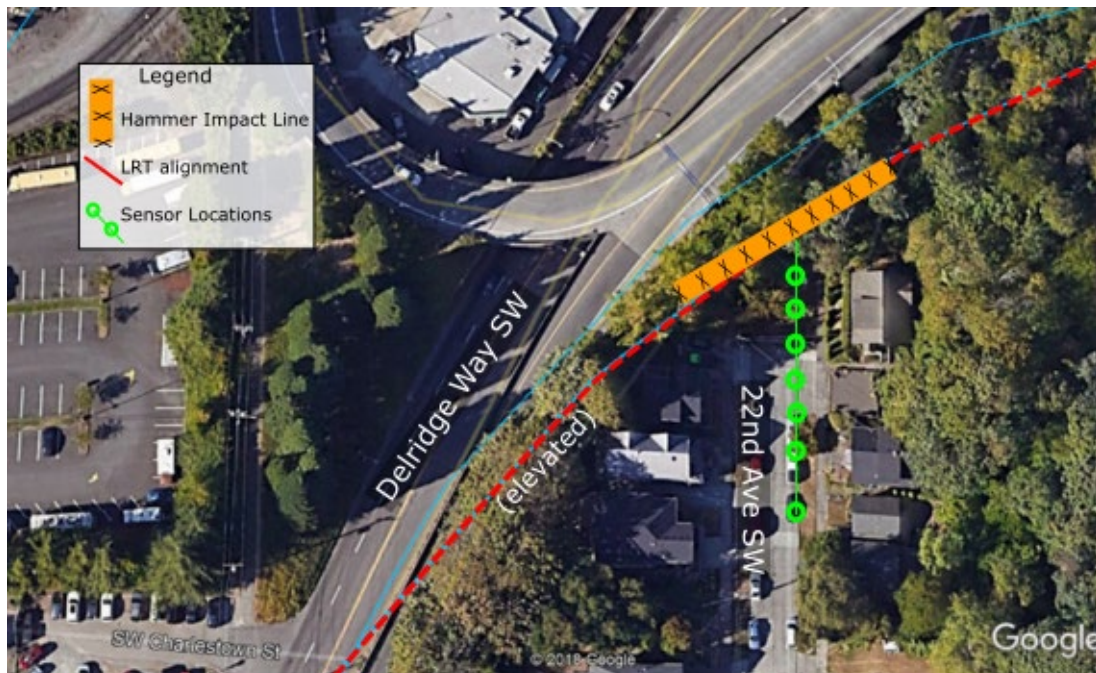
Figure N.3B-12. Aerial View of Vibration Propagation Measurement Site V-D – Bike Path at 22nd Avenue Southwest near West Seattle Bridge

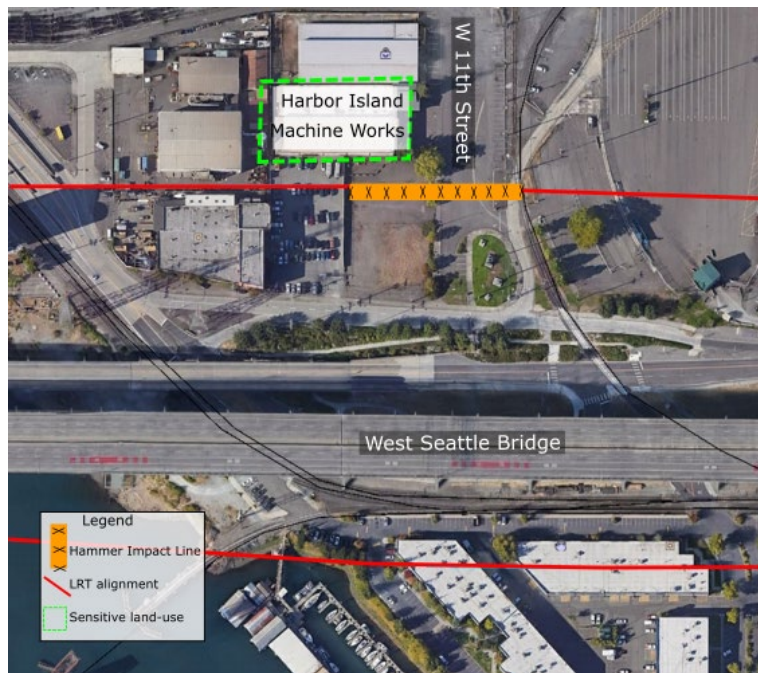
Figure N.3B-14. Aerial View of Vibration Propagation Measurement Site V-E – Harbor Island Machine Works, 3431 11th Avenue Southwest
