APPENDIX D2

## **Winters House Landscape Report**

# Winters House Landscape Report

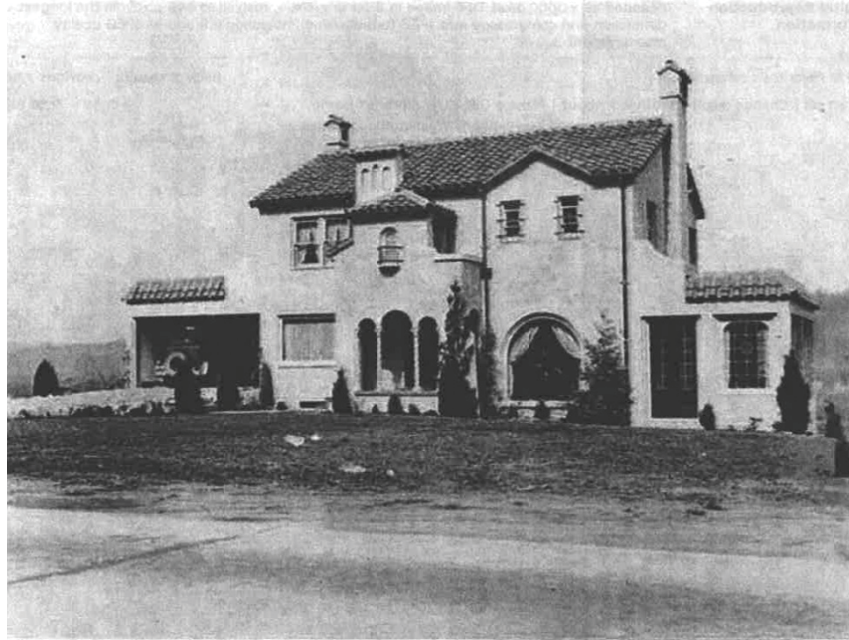
Figure 1. *Winters House – circa 1935 (Collections of Eastside Heritage Center)*

The landscapes shown in figures 1 and 2, from the mid- to late-1930s, consist of an open area adjacent to the road and a buffer of small conifers against the front of the house. Figure 3 illustrates a plan view interpretation by Nakano Associates of this time period.

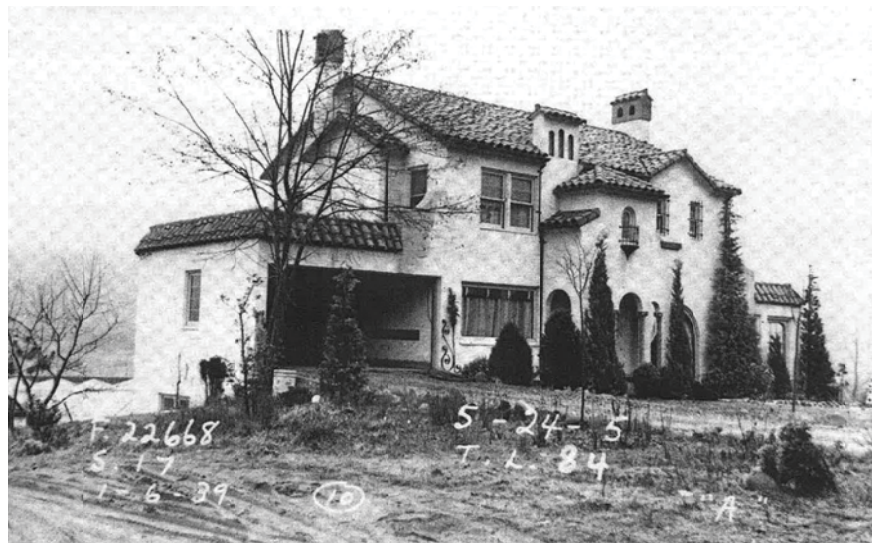
Figure 2. *Winters House – 1939*

The landscapes in figures 4 and 5 show the addition of deciduous trees and shrubs. The largest conifer seen in front of the house in figure 2 had been removed by the time the photos in figures 4 and 5 were taken in 1945.

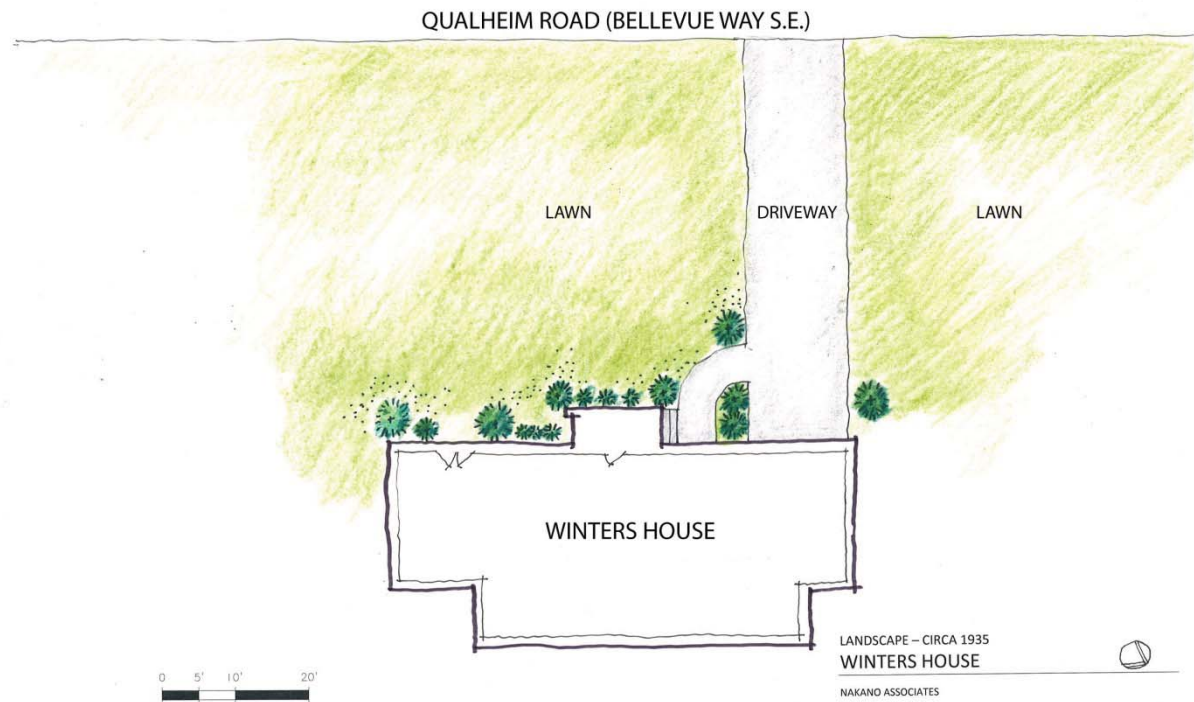
Figure 3. *Landscape Plan: Winters House— circa 1935, Nakano Associates interpretation*

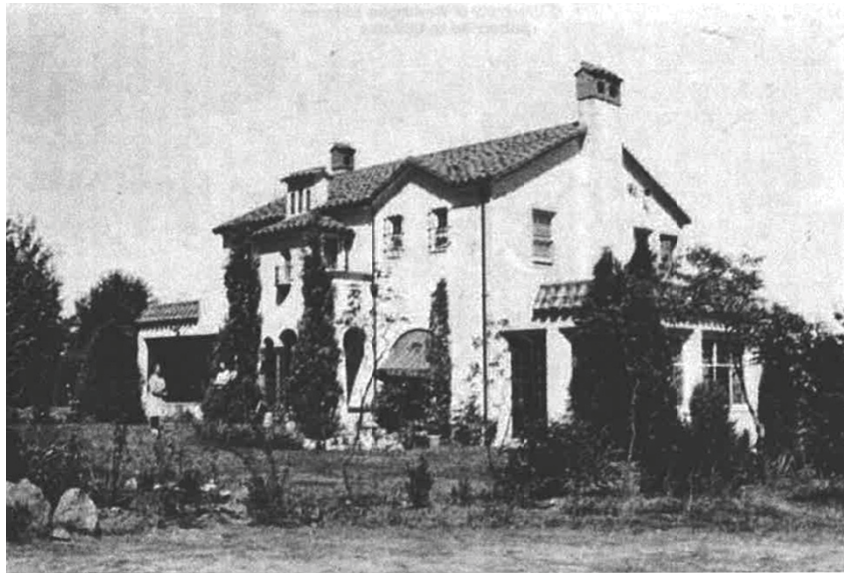
Figure 4. *Winters House – circa. 1945 (Collections of Eastside Heritage Center)*

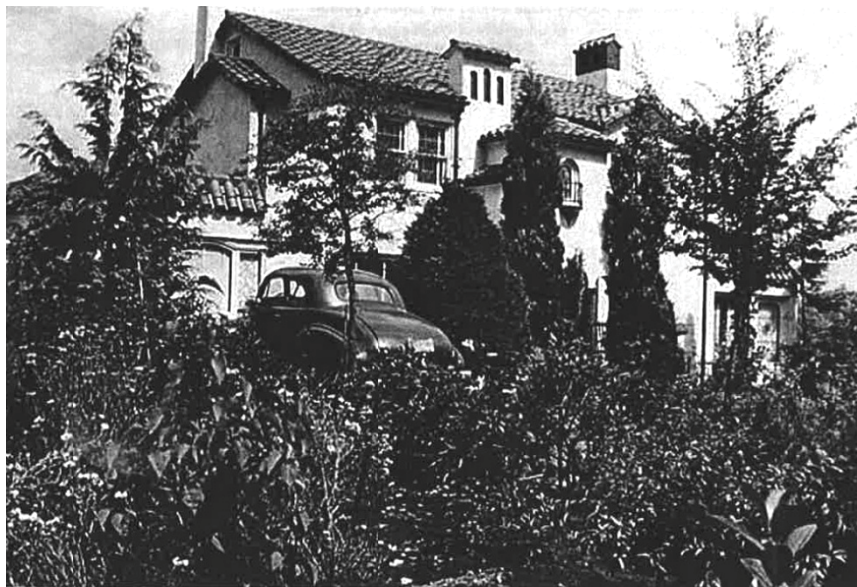
Figure 5. *Winters House – circa 1945 (Collections of Eastside Heritage Center)*

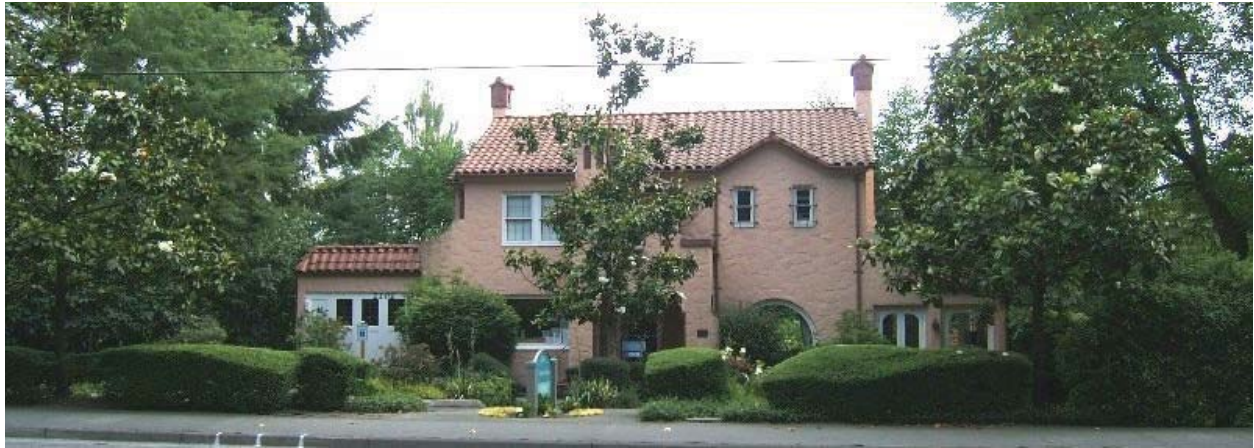
Figure 9. Winters House – existing landscape photograph

The existing landscape in the location of the proposed lid structure includes a number of rhododendrons and azaleas, as well as several magnolia trees and a mature walnut tree. There is no radiating layout of silk trees (as had been shown in the 1993 landscape plan shown in figure 8.) Massings of witch hazel (*Hammamelis*) and burning bush (*Euonymus*) exist today and likely contribute significantly to a display of fall color. Figures 9-13 illustrate shrub borders and trees separating the lawn and house from the street.

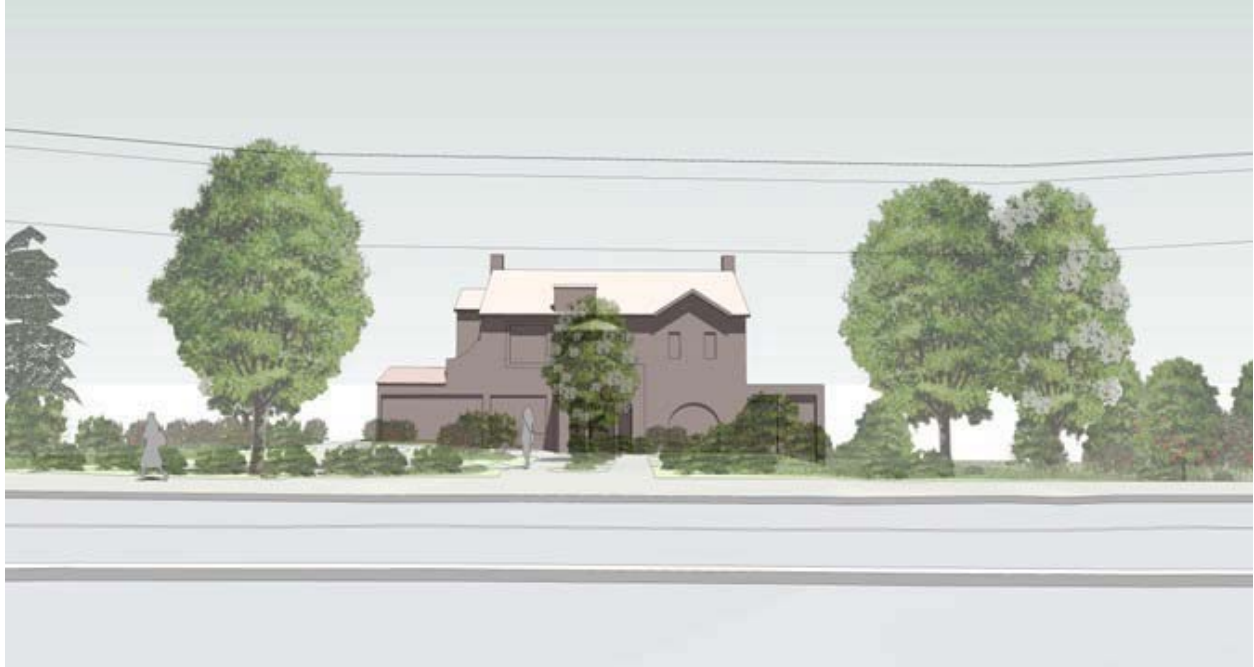
Figure 11. *Winters House – existing landscape street view, looking east*

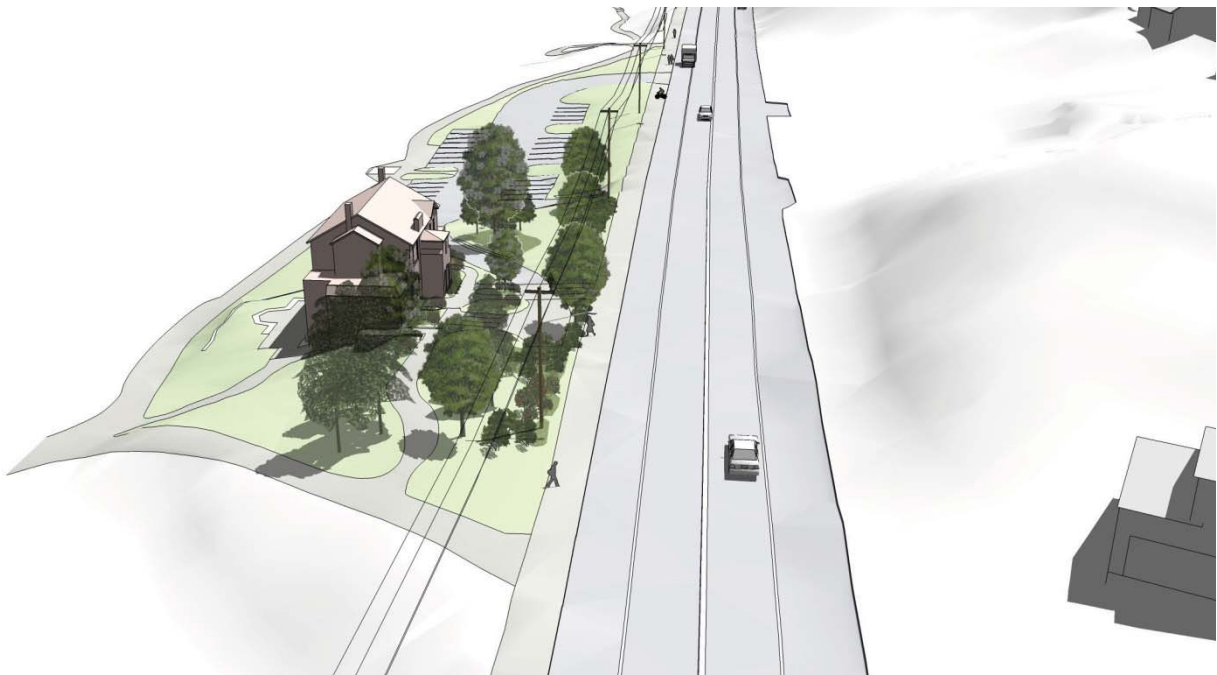
Figure 12. *Existing aerial view, looking south*

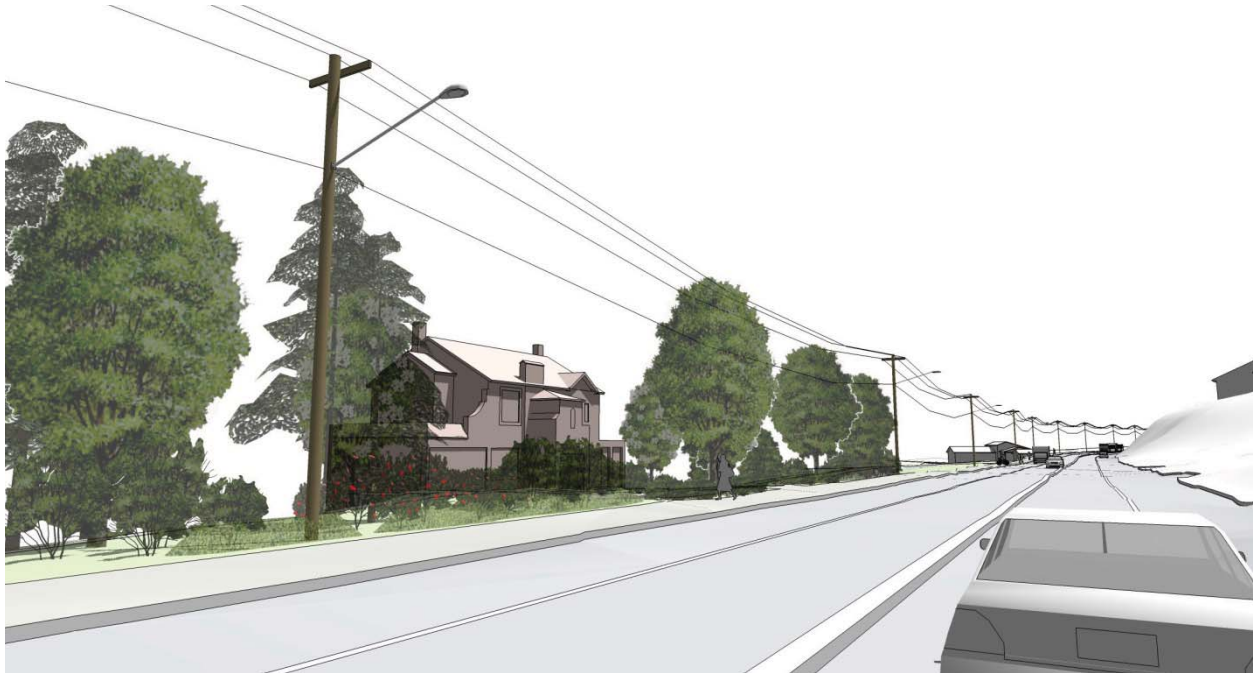
Figure 13. *Existing street level view, looking south*

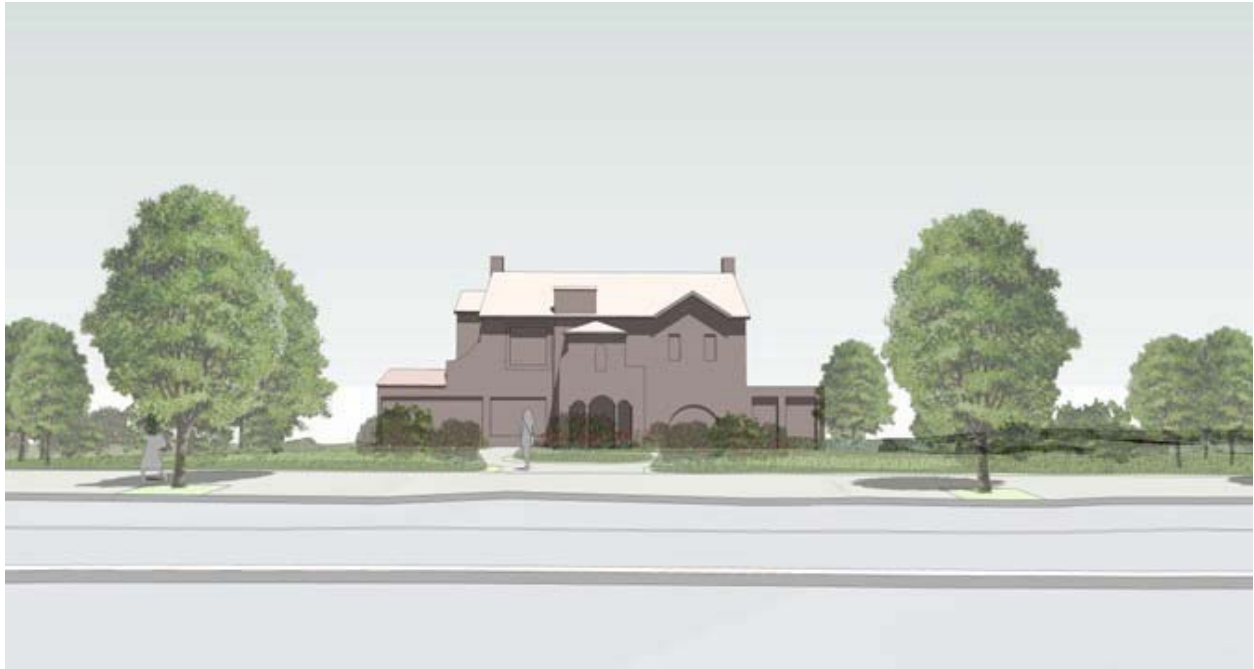
Figure 16. *Winters House – proposed landscape street view - looking east*

A six-foot wide walkway along the north edge of the lid and along the front of the house allows for direct pedestrian access to the trail system below. With the raising of the parking lot elevation, walkways to the house will be graded for accessible entry at the street level and the lower level entry on the east side of the house. Figures 16-18 illustrate three views of the front of the Winters House, and the general layout and massing of the proposed landscape.

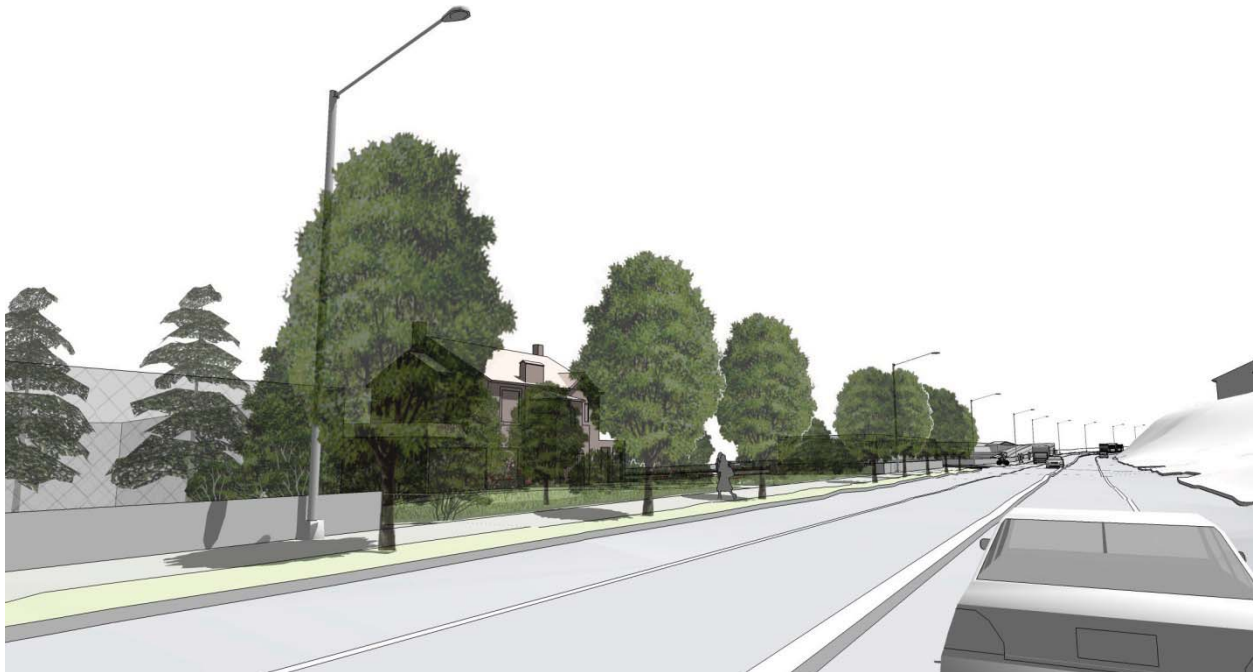
Figure 18. *Proposed street level view - looking south*
