**DRAFT Internal Audit Report:**

**Link Light Rail Service Event  
from November 26, 2021**

Report #: 2021-19

**Sound Transit Audit Division**

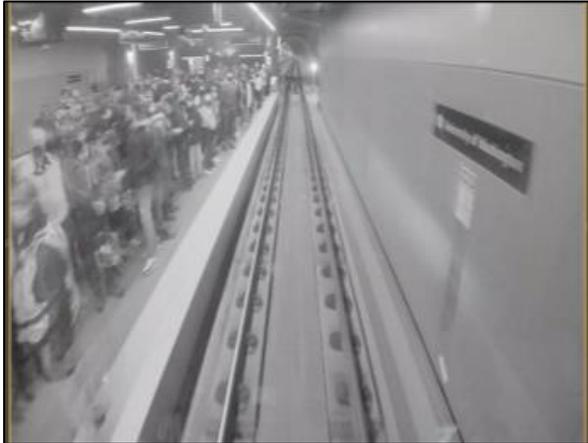
At 8:19 p.m. on Nov. 26, 2021, a four-car Series 2 train (Train 6, including cars 264, 259, 225 and 246) departed northbound from UW Station toward U District Station (see figures 3 and 4). All trains in service that night had one operator, provided by King County Metro.

**Figure 3.** Photograph from Train 6 (Car 246) arriving at UW Station.

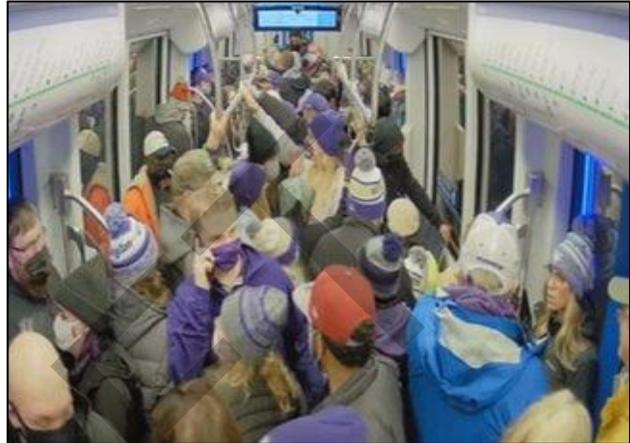
**Figure 4.** Photograph from inside Train 6 (Car 246) leaving UW Station for U District Station.

At 8:20, about 1,000 feet into the northbound tunnel, the train appeared to have struck an object in the trackway, stalled and came to an abrupt stop. It lost all power, including HVAC and presumably all communication capabilities with passengers (see figures 5 and 6). There were no injuries.

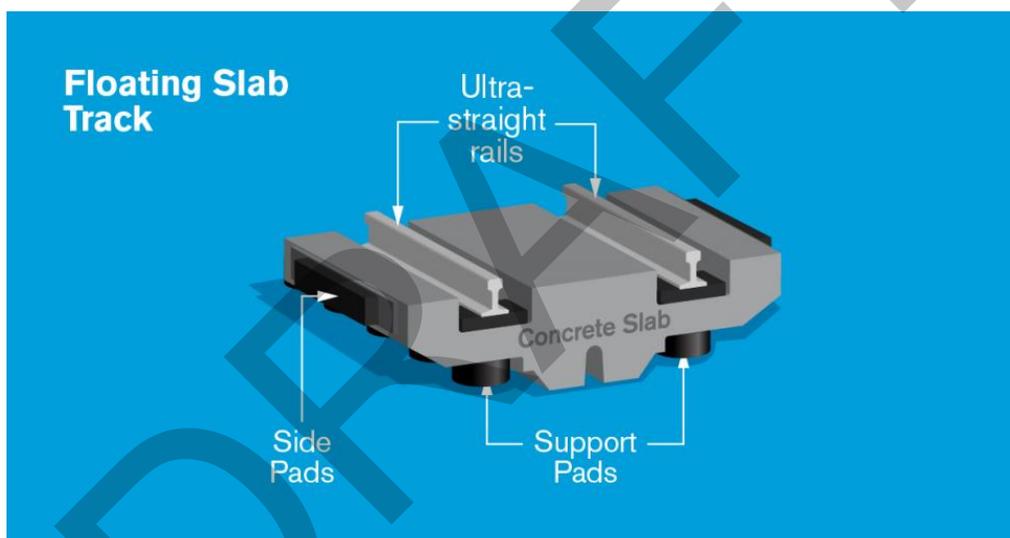
Sound Transit designed and oversaw the construction of the section of tunnel under the University of Washington. Part of that design included 7,500 feet (3,800 in each tunnel bore) of floating concrete slab (see Figure 12) that reduces vibration and electromagnetic interference that normally comes from running light rail trains.

**Figure 12.** Illustration of the “floating slab” like the one installed between the University of Washington and U District stations.

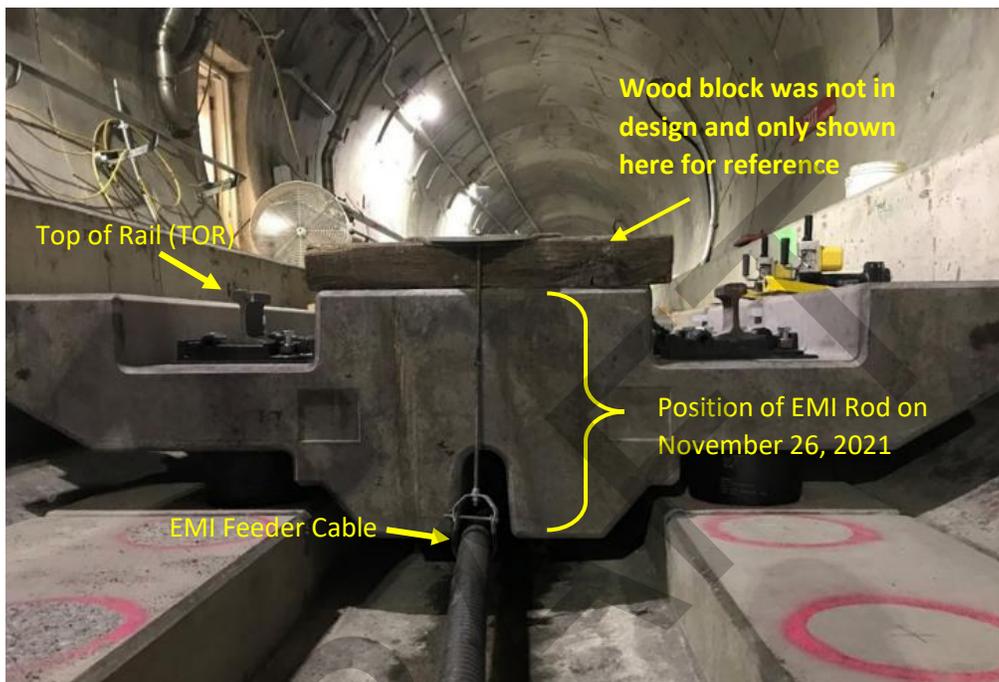
**Figure 13.** Photograph of the Northgate Link floating slab (Source: Rajaram and Nelson paper, modified by Audit Division)

As part of the design of the Northgate Link Extension, along with the floating slab design also included an EMI feeder power cable (see Figure 13) that was intended to cancel magnetic fields produced by the traction power currents from the overhead power to the LRVs; also allowing for easier maintenance than embedding the conduit in the concrete.

The design, however, had two indicated concerns that were not found until after the November 26, 2021 event, shown below in this shop drawing: (a) that the rod and bolt holding the EMI feeder cable protruded the top of rail (TOR), and (b) that the top of the rod was to be field cut. How much to be cut was not specified on this shop drawing.

**Finding a.2.** It was noted on shop drawings of the Northgate Link Extensions' (NGLE) electromagnetic interference (EMI) conduit hanger that the rods which hold the EMI hangers on the floating slab had 1) protruded above the TOR in design, and 2) that the EMI "Top of Rod was to be field cut"; however, it was unclear on the shop drawing where to make the cut.

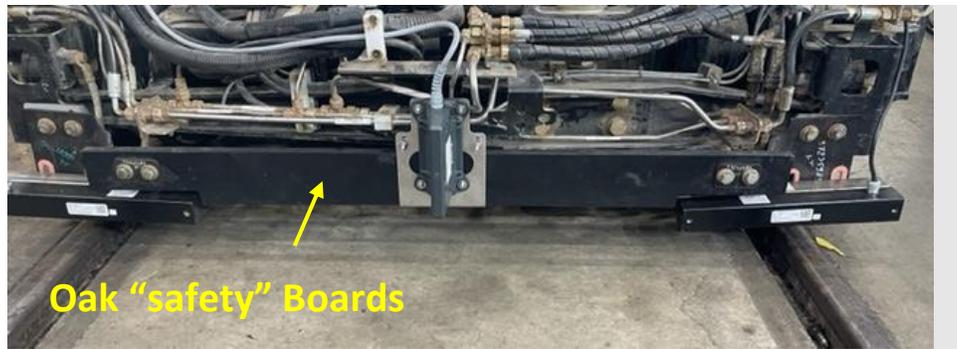
**Figure 18.** Photograph of a removed truck from Series 2 vehicle, and arrow pointing to an undamaged Oak "safety" Board

Prior to November 26, 2021, King County Metro vehicle maintenance staff were discovering Link vehicles being damaged on their oak boards, also known as Safety Boards, which help prevent people or objects from rolling under the train. As shown below, there is a large crack and gouge taken out of the board, denoting the train had struck an object at a considerable speed

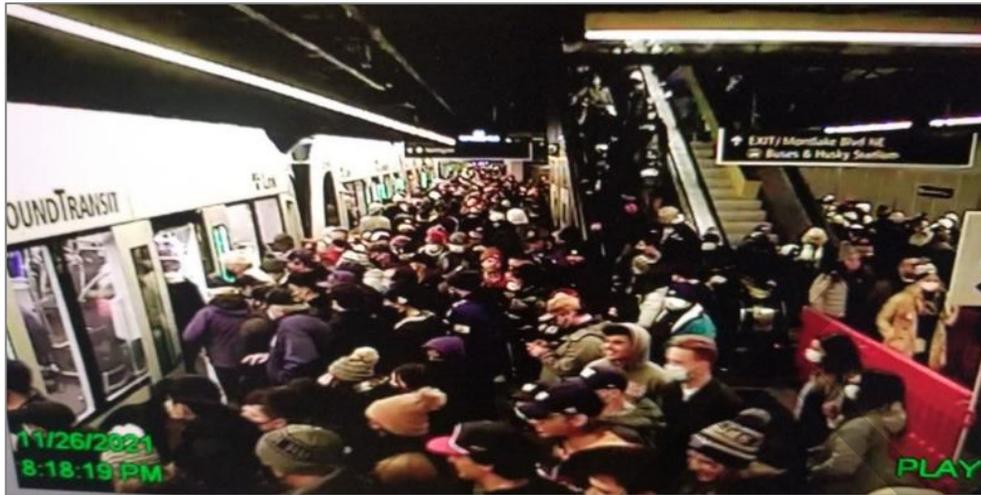
When the incident occurred, there were an estimated 800 people waiting on the UW Station platform.

**Figure 20.** Photograph of UW Station Platform crowded with passengers boarding Train #6 on November 26, 2021.

Staff who dealt with crowd control found it difficult to hear and understand communication from the various communications channels (i.e., LCC or SOC).
