Internal Audit Report:

**Link Light Rail Service Event
from November 26, 2021**

Report #: 2021-19

Sound Transit Audit Division

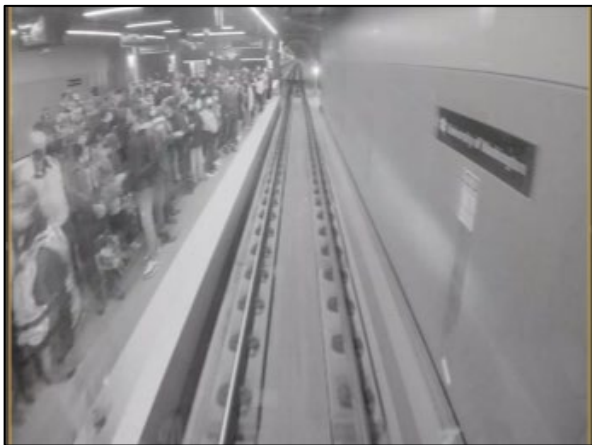
At 8:19 p.m. on Nov. 26, 2021, a four-car Series 2 train (Train 6, including cars 264, 259, 225 and 246) departed northbound from UW Station toward U District Station (see figures 3 and 4). All trains in service that night had one operator, provided by King County Metro.

Figure 3. Photograph from Train 6 (Car 246) arriving at UW Station.

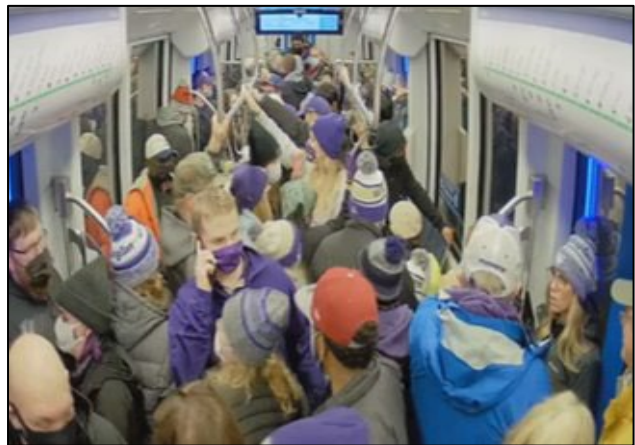
Figure 4. Photograph from inside Train 6 (Car 246) leaving UW Station for U District Station.

At 8:20, about 1,000 feet into the northbound tunnel, the train appeared to have struck an object in the trackway, stalled and came to an abrupt stop. It appeared to have lost all power, including HVAC and presumably all communication capabilities with passengers (see figures 5 and 6). There were no injuries.

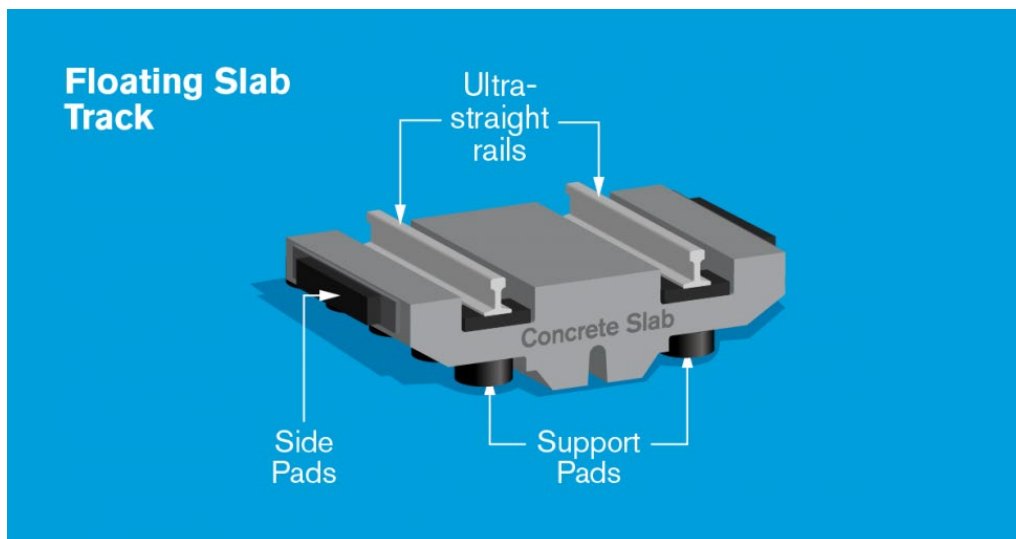
Sound Transit and their consultants designed and oversaw the construction of the section of tunnel under the University of Washington. Part of that design included 7,500 feet (3,800 in each tunnel bore) of floating concrete slab (see Figure 12) that reduces vibration and electromagnetic interference that normally comes from running light rail trains.

Figure 12. Illustration of the “floating slab” like the one installed between the University of Washington and U District stations.

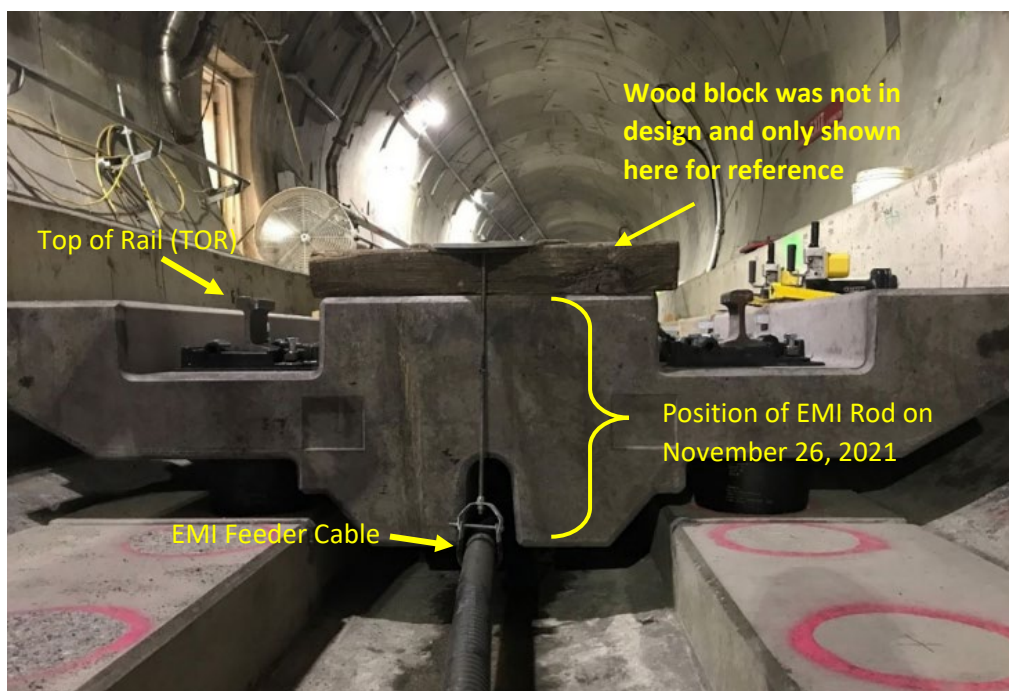
Figure 13. Photograph of the Northgate Link floating slab (Source: Rajaram and Nelson paper, modified by Audit Division)

As part of the design of the Northgate Link Extension, along with the floating slab design also included an EMI feeder power cable (see Figure 13) that cancels magnetic fields produced by the traction power currents from the overhead power to the LRVs; also allowing for easier maintenance than embedding the conduit in the concrete.

The design, however, had two indicated concerns that were not found until after the November 26, 2021 event, shown below in this shop drawing: (a) that the rod and bolt holding the EMI feeder cable protruded above the top of rail (TOR), and (b) that the top of the rod was to be field cut. How much to be cut was not specified on this shop drawing.

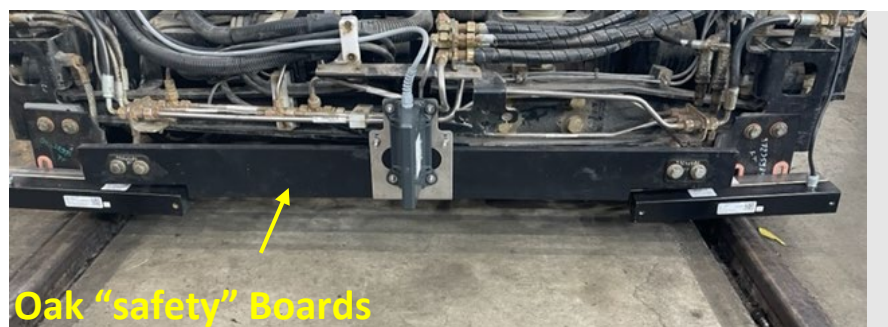
Figure 18. Photograph of a removed truck from Series 2 vehicle, and arrow pointing to an undamaged Oak "safety" Board

Prior to November 26, 2021, King County Metro vehicle maintenance staff were discovering Link vehicles being damaged on their oak boards, also known as Safety Boards, which help prevent people or objects from rolling under the train. As shown below, there is a large crack and gouge taken out of the board, denoting the train had struck an object at a considerable speed

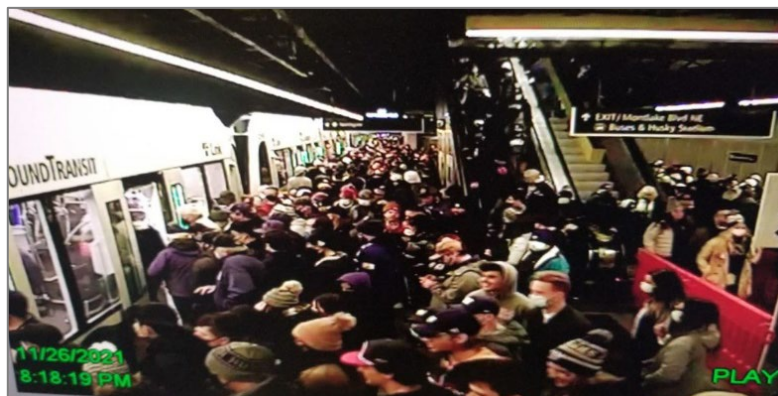
Figure 20. Photograph of UW Station Platform crowded with passengers boarding Train #6 on November 26, 2021.

Staff who dealt with crowd control found it difficult to hear and understand communication from the various communications channels (i.e., LCC or SOC).
