Federal Way Link Extension

ECOSYSTEMS TECHNICAL REPORT

Appendix G2

Wetland and Stream Photographs

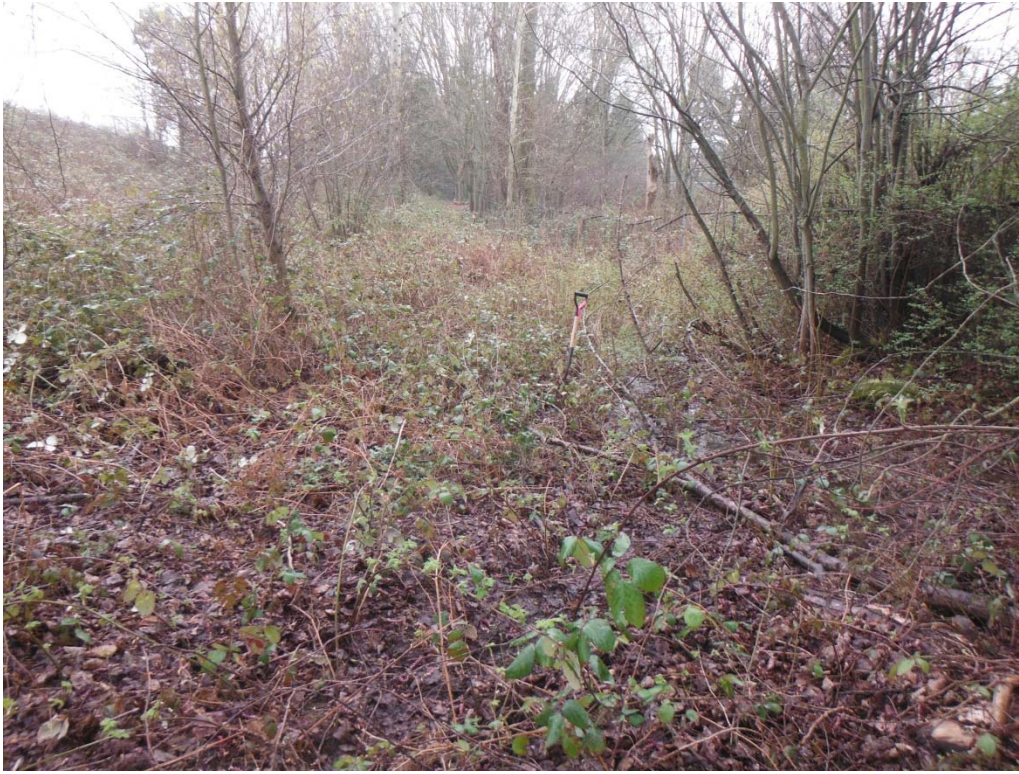
Wetland 5-1: north end of wetland in I-5 right-of-way (ROW), looking south. Himalayan blackberry is overgrowing wetland; scattered willows and American brooklime is also present.

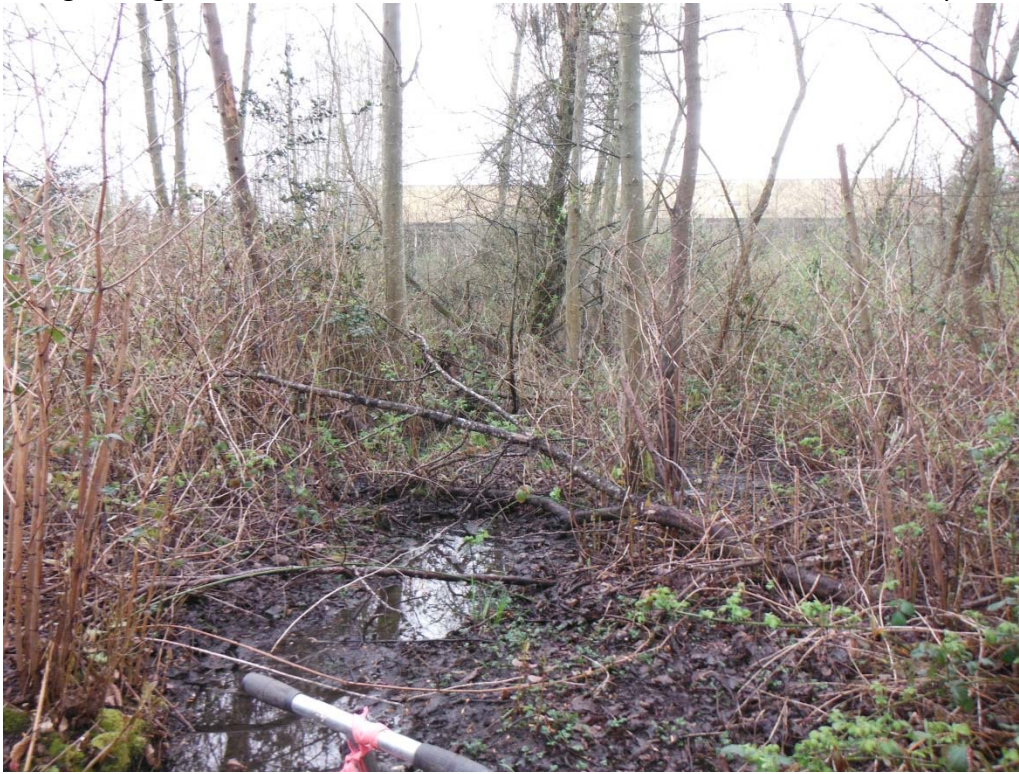
Wetland 6-2: northeast end of the wetland near the outlet of Massey Creek, looking east. Vegetation consists of young black cottonwood trees, blackberry, and salmonberry.

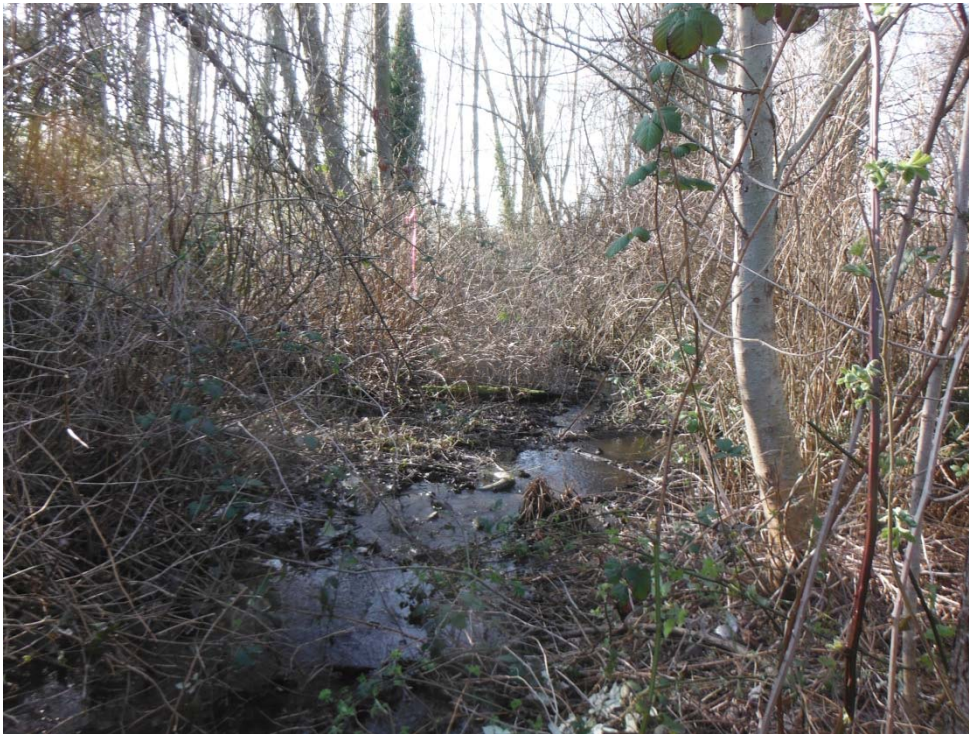
Wetland 6-2: east end of the wetland near the outlet of Massey Creek, looking west. Vegetation consists of young black cottonwood trees, blackberry, and salmonberry.

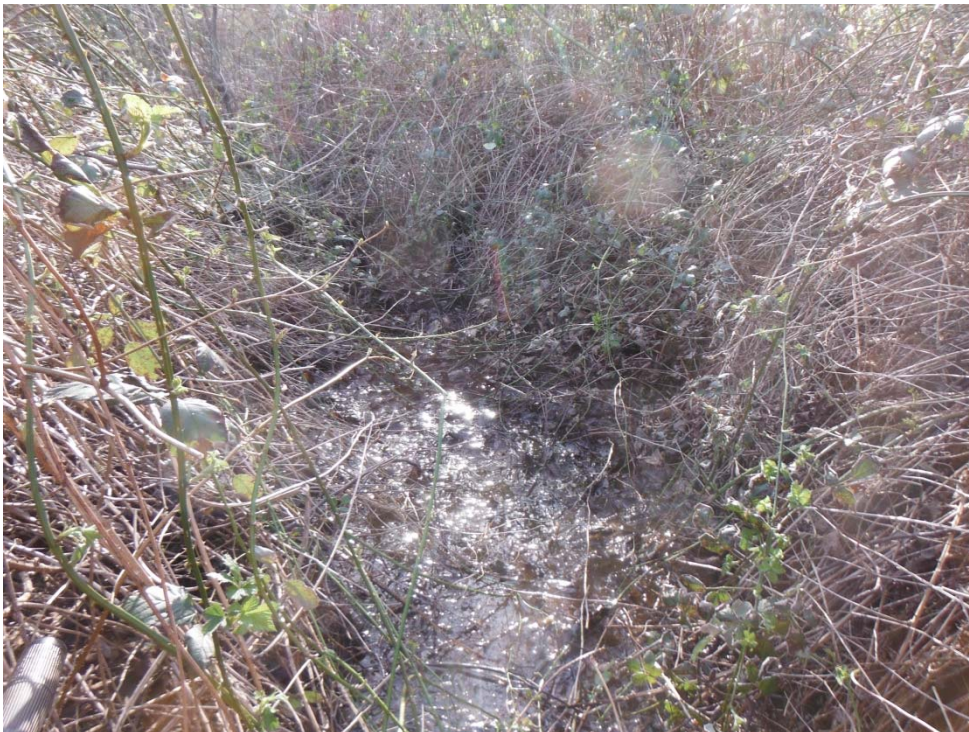
Wetland 6-3 looking south. Small depression that was sparsely vegetated during March 2014 site visit. Himalayan blackberry fringes the perimeter.

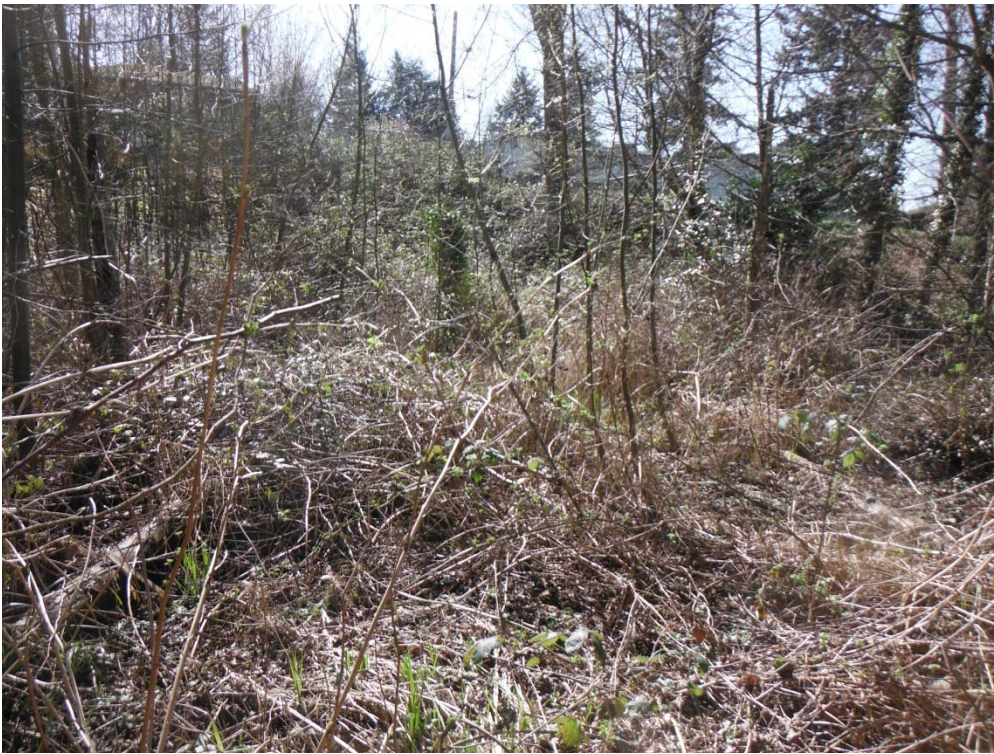
Wetland 6-4: eastern portion of wetland looking south. Forested vegetation community comprised of young red alder, Himalayan blackberry, and reed canarygrass.

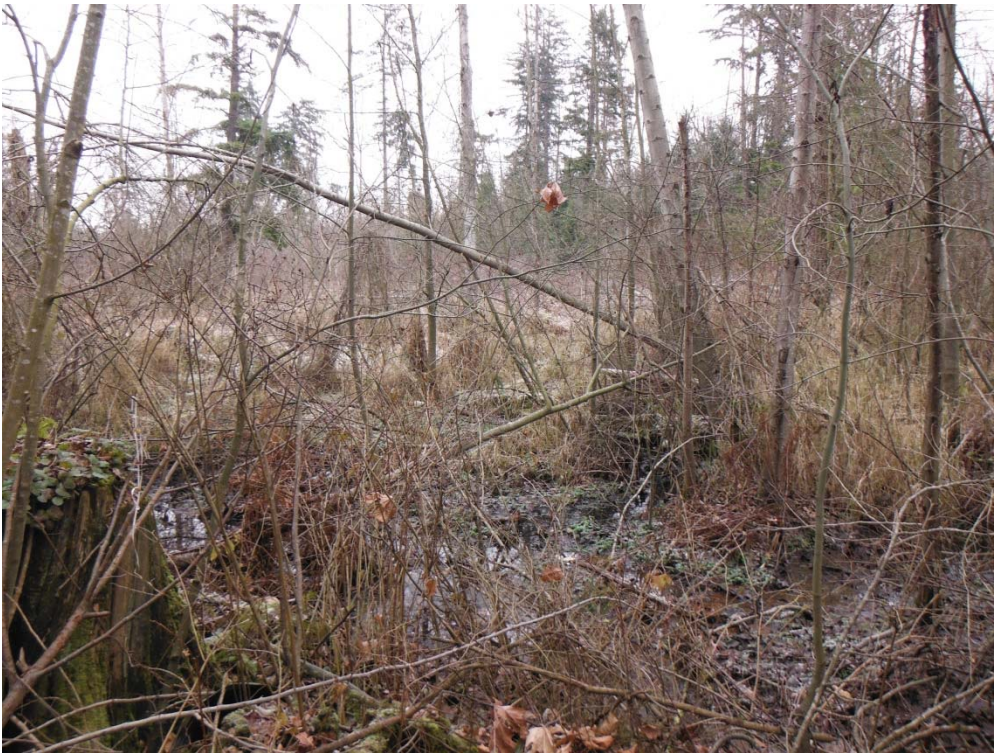
Wetland 12-1: representative conditions in south portion of McSorley Creek wetland outside of FWLE alternatives. Mature forest consisting of black cottonwood, Sitka spruce, and red alder is predominant. See McSorley Creek stream photos for wetland conditions at McSorley Creek on east side of SR 99.

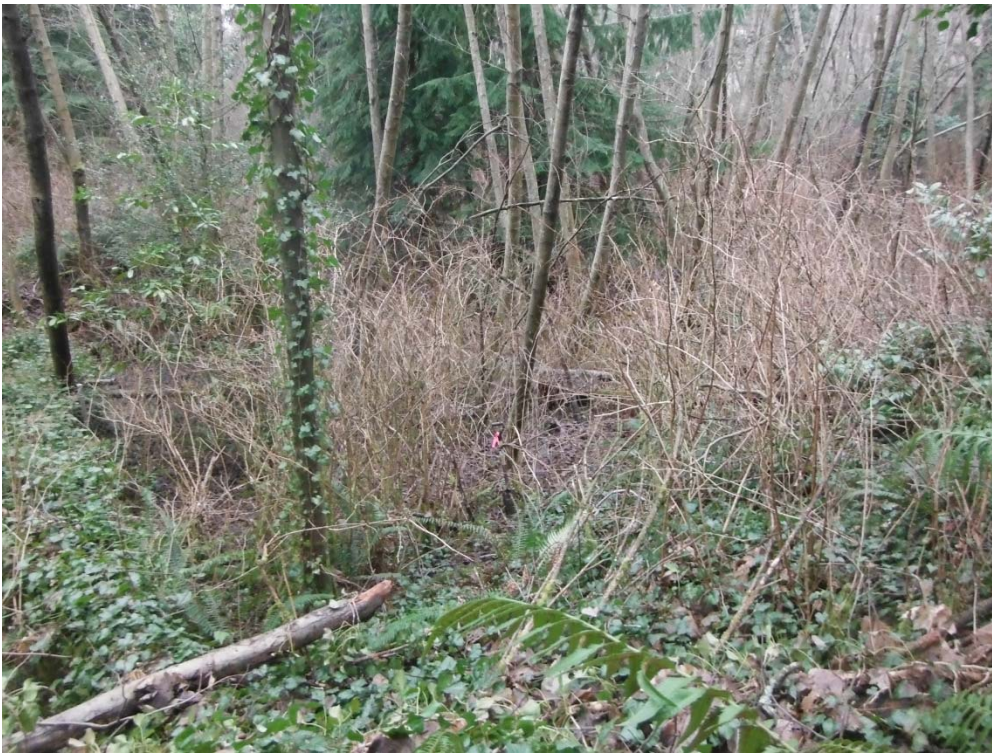
Wetland 12-1 (McSorley Creek Wetland): southeast corner of wetland in I-5 ROW. Vegetation in ROW is primarily red alder and salmonberry. Sitka spruce/western hemlock forest is in interior of wetland, west of the I-5 ROW.

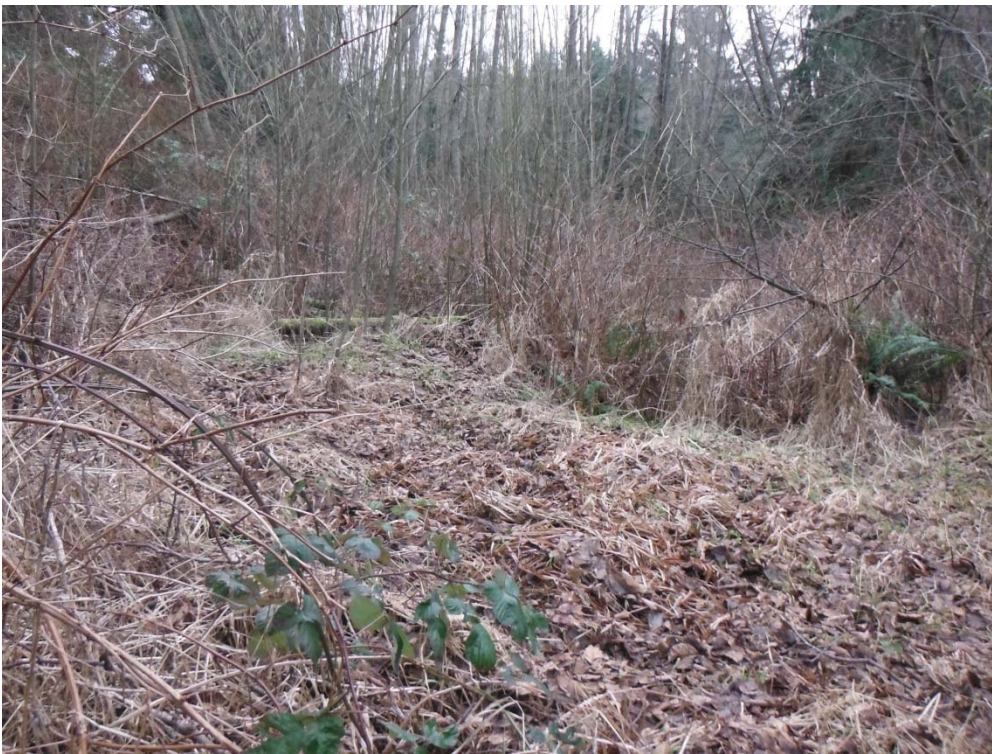
Wetland 12-1 (McSorley Creek Wetland): north portion wetland in I-5 ROW, looking south. Vegetation in this portion of the wetland is predominantly small-fruited bulrush, reed canarygrass, and young alder saplings.

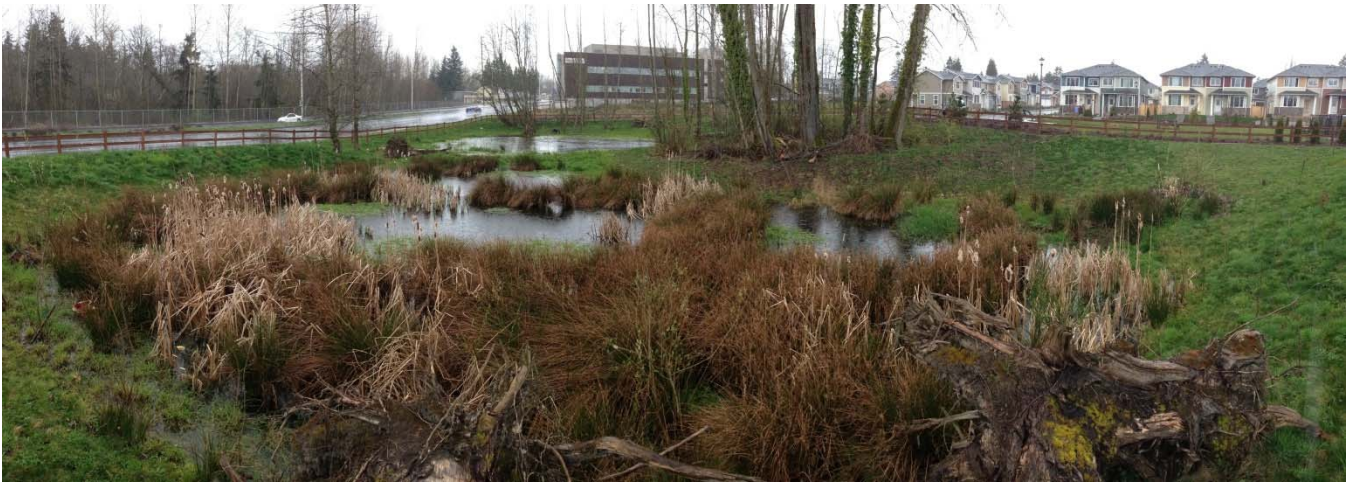
Wetland 12-2: overview of wetland looking south from north boundary. Emergent community consists of soft rush, glyceria and cattail. Red alder and cottonwood trees surround the perimeter. Surface water drains from the wetland via vertical drain in photo background.

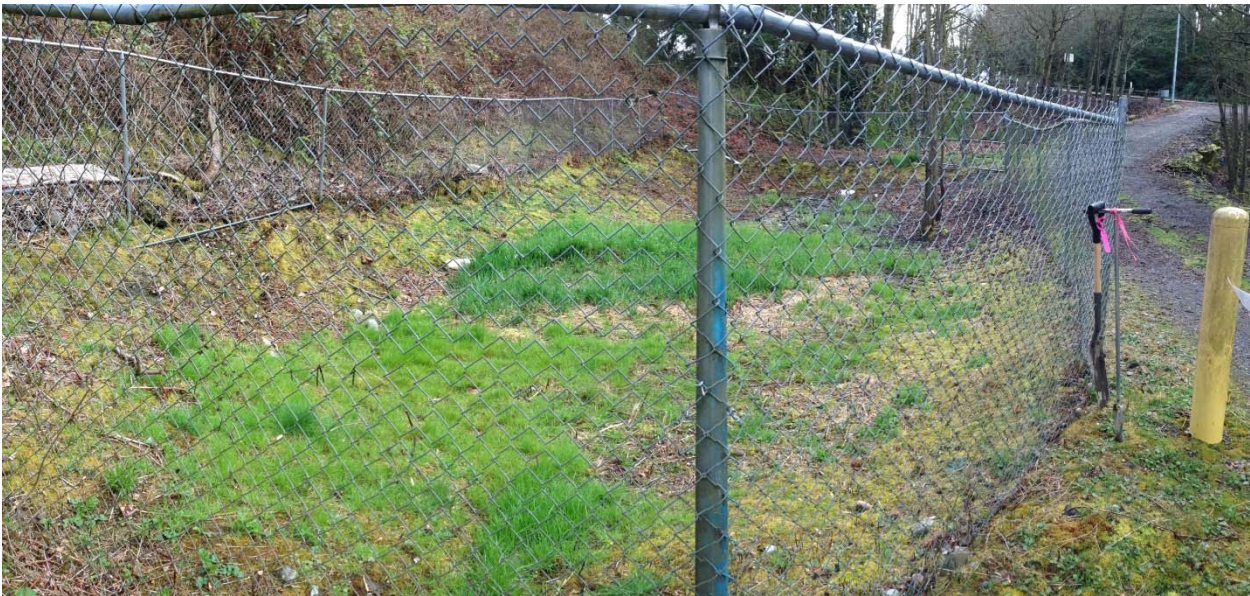
Wetland 16-1 looking south. Excavated feature dominated by reed canarygrass. Inlet in background discharges to Redondo Creek.

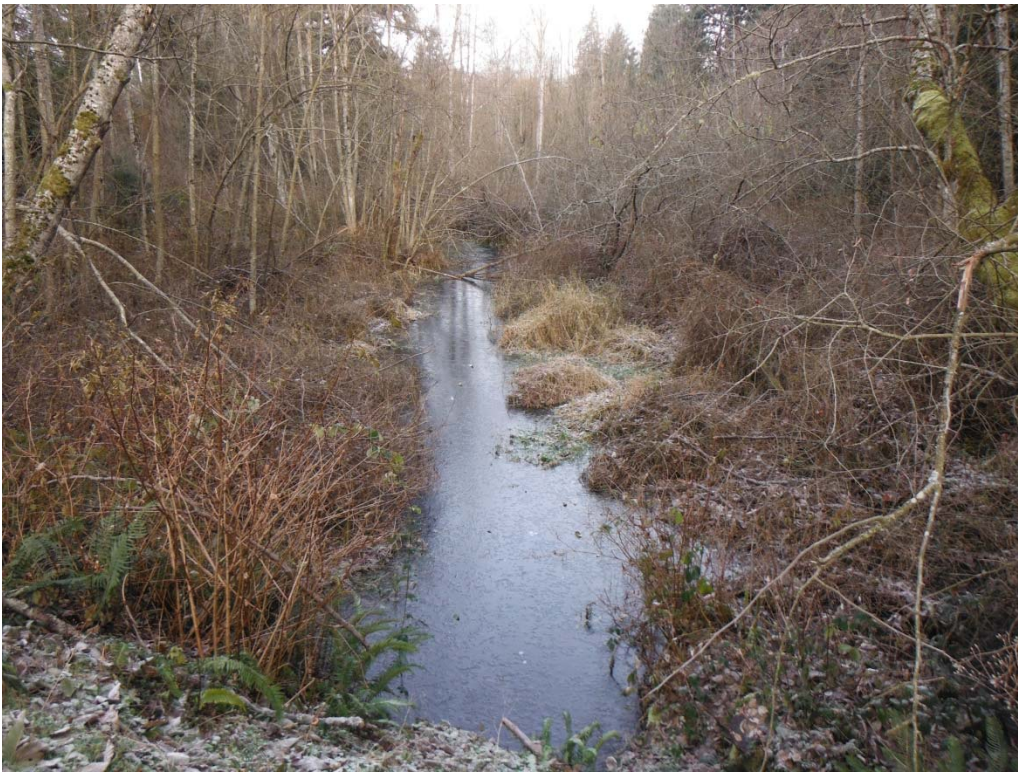
Wetland 17-2: looking south from S 304th Street. Forested community is dominated by red alder. Redondo Creek flows through wetland.

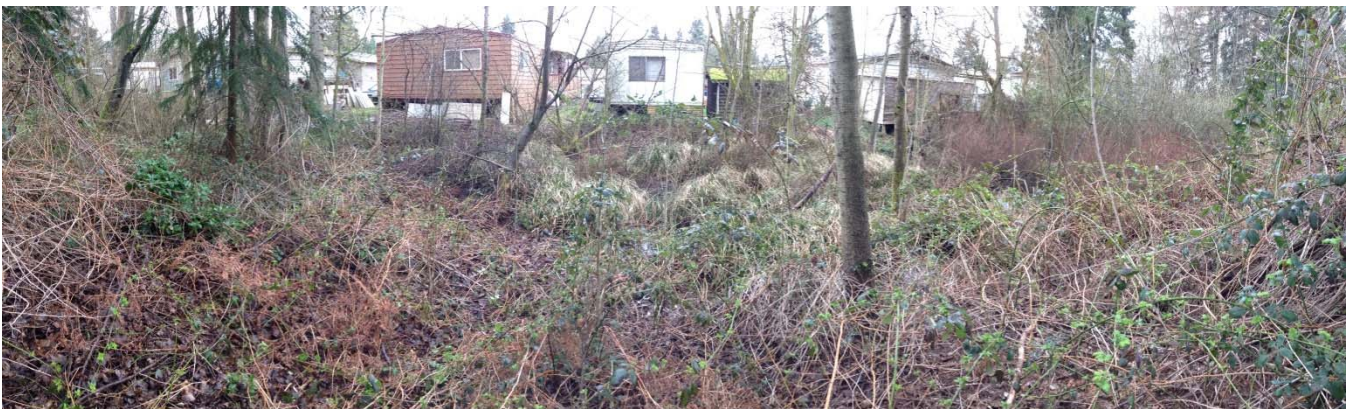
Wetland 27-1: forested community in south portion of wetland. Red alder and black cottonwood are predominant, with slough sedge, spirea understory.

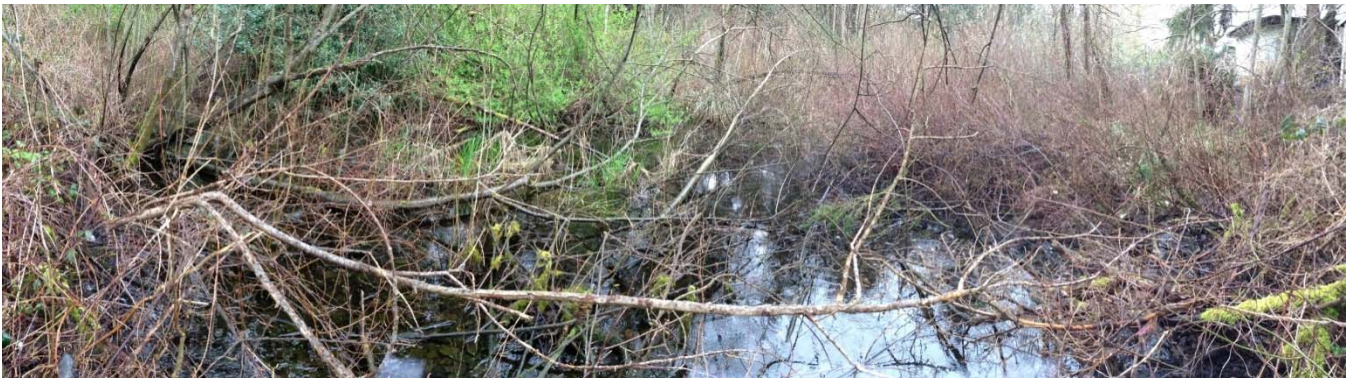
Wetland 27-1: scrub-shrub community in north portion of wetland. Spirea, willows and slough sedge are predominant. The north portion of the wetland was inundated to at least 2 feet.

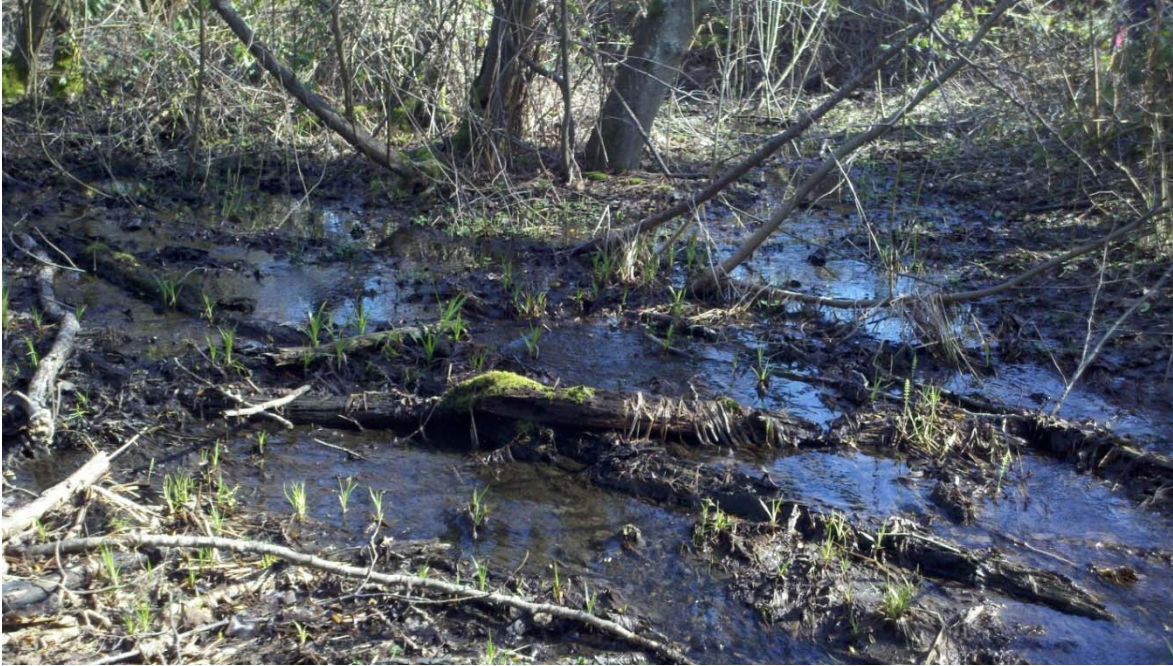
The eastern portion of Massey Creek in the study area is shallow and poorly defined with multiple channels through the wetland.

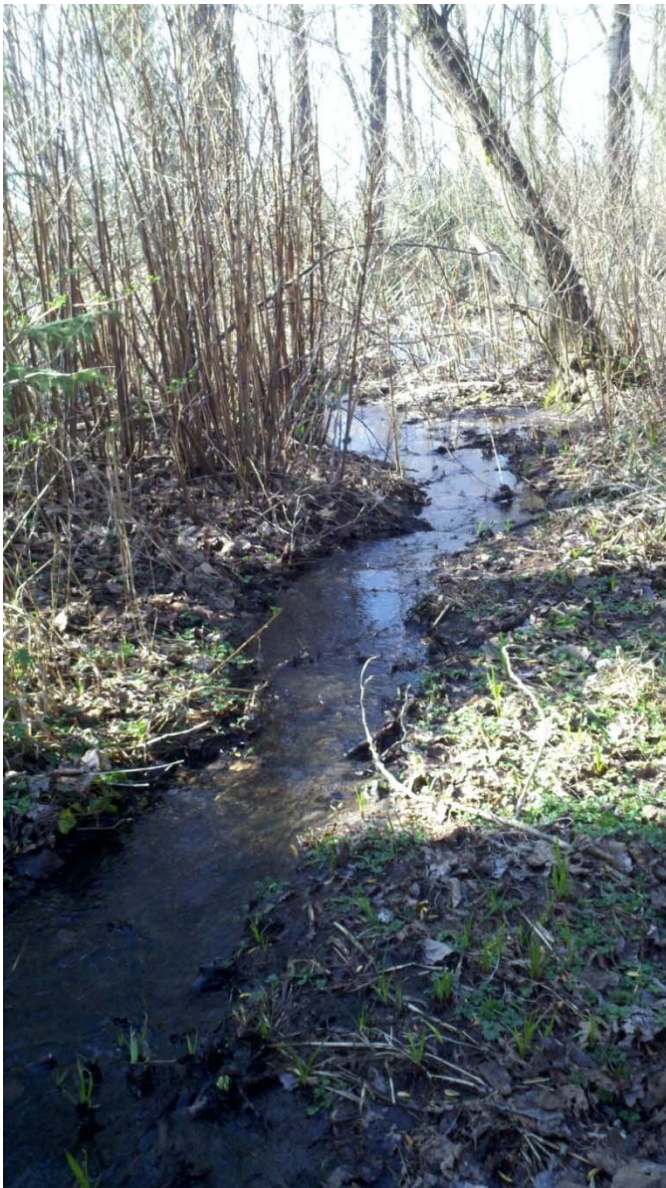
Massey Creek looking downstream where it forms a single, shallow channel with low, poorly defined banks.

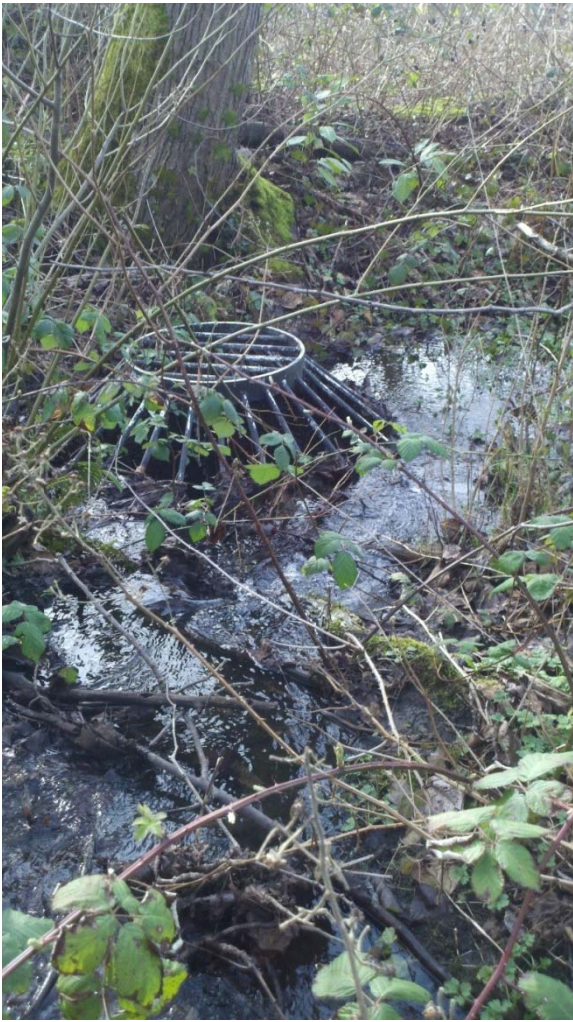
Vertical drain at the west end of the Massey Creek reach in the study area. This structure conveys the creek into a pipe system under an apartment complex and roadway and poses a complete passage barrier to fish.

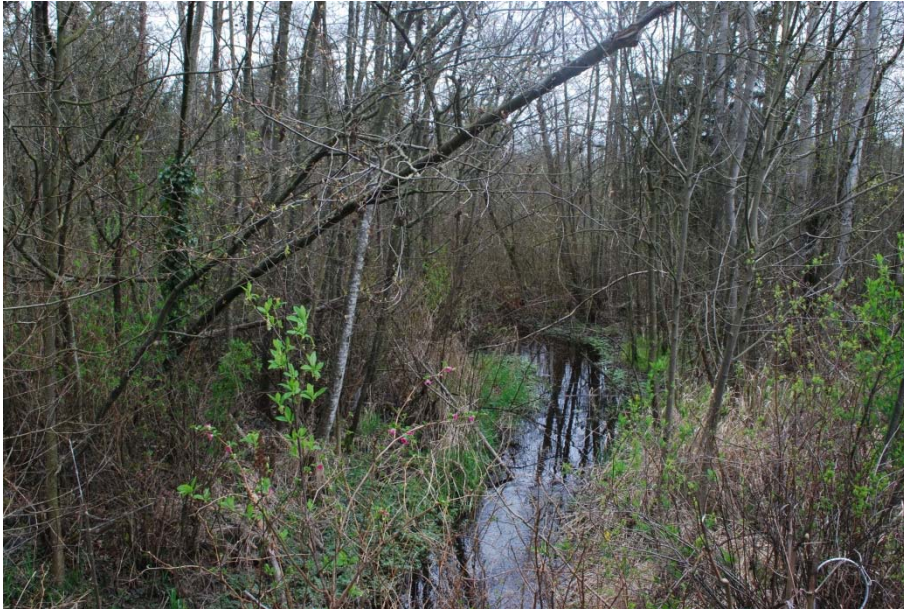
McSorley Creek looking upstream where it emerges from large forested wetland on the east side of SR 99.

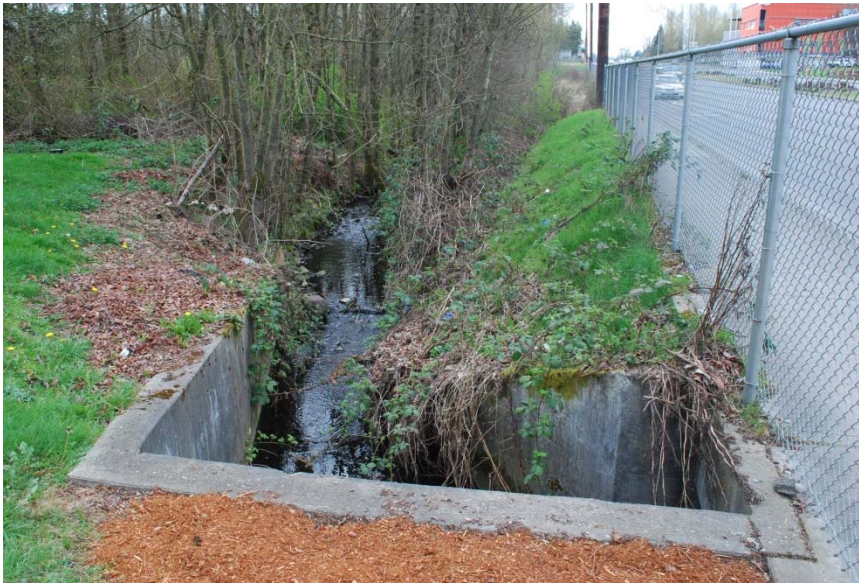
McSorley Creek alongside SR 99 where it enters a 4-foot-wide concrete box culvert under the highway.

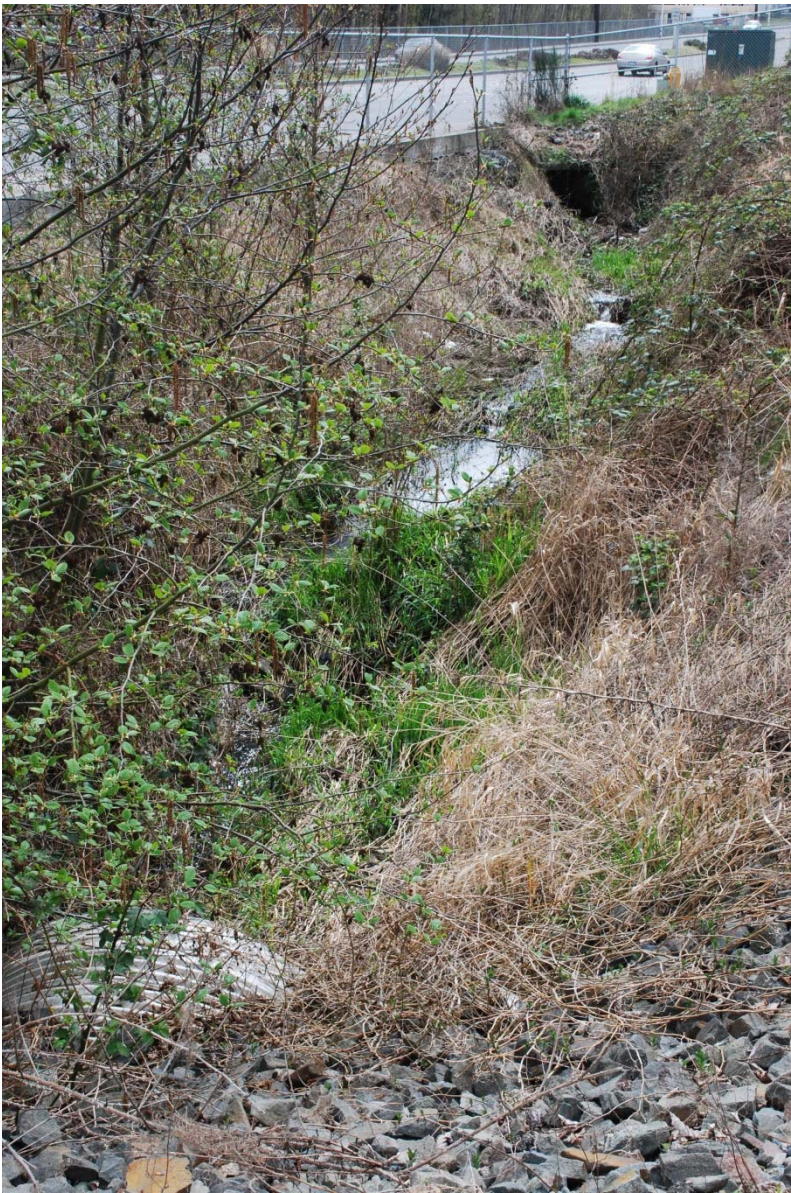
McSorley Creek looking upstream at the culvert exit on the west side of SR 99. Channel is overgrown in small area between the highway and a hotel parking lot.

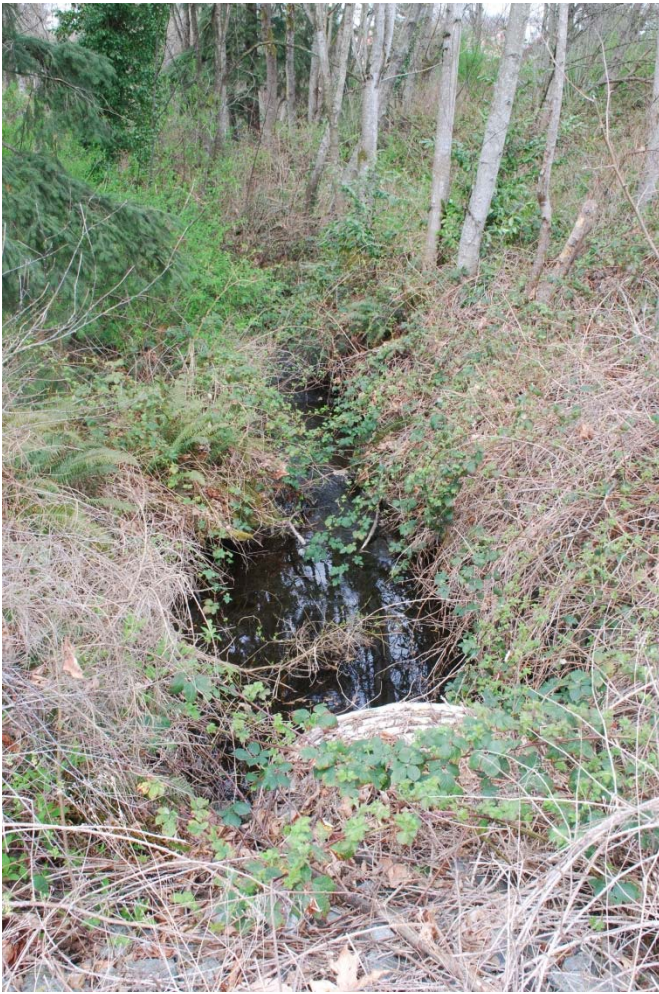
McSorley Creek looking downstream from culvert under stormwater/utility drive on west side of SR 99.

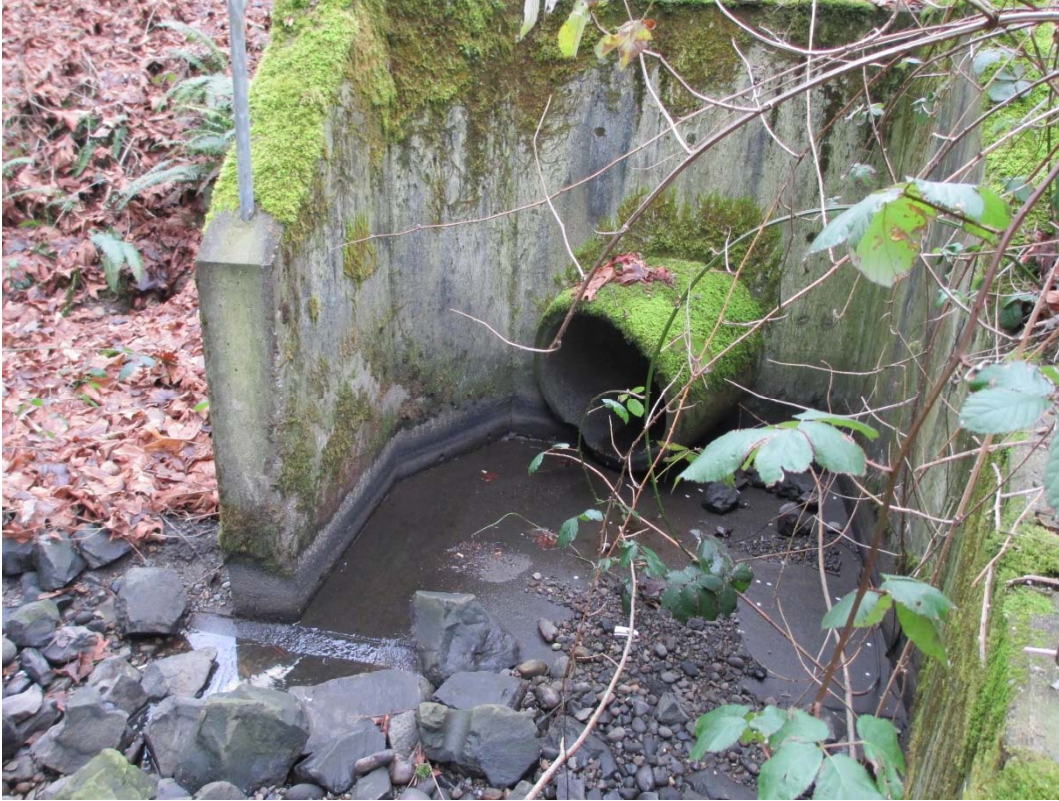
Redondo Creek culvert exit from under Dash Point Road and SR 99. This culvert poses a passage barrier to fish. The photo was taken during the field visit in January when conditions were dry and flows in the creek were very low.

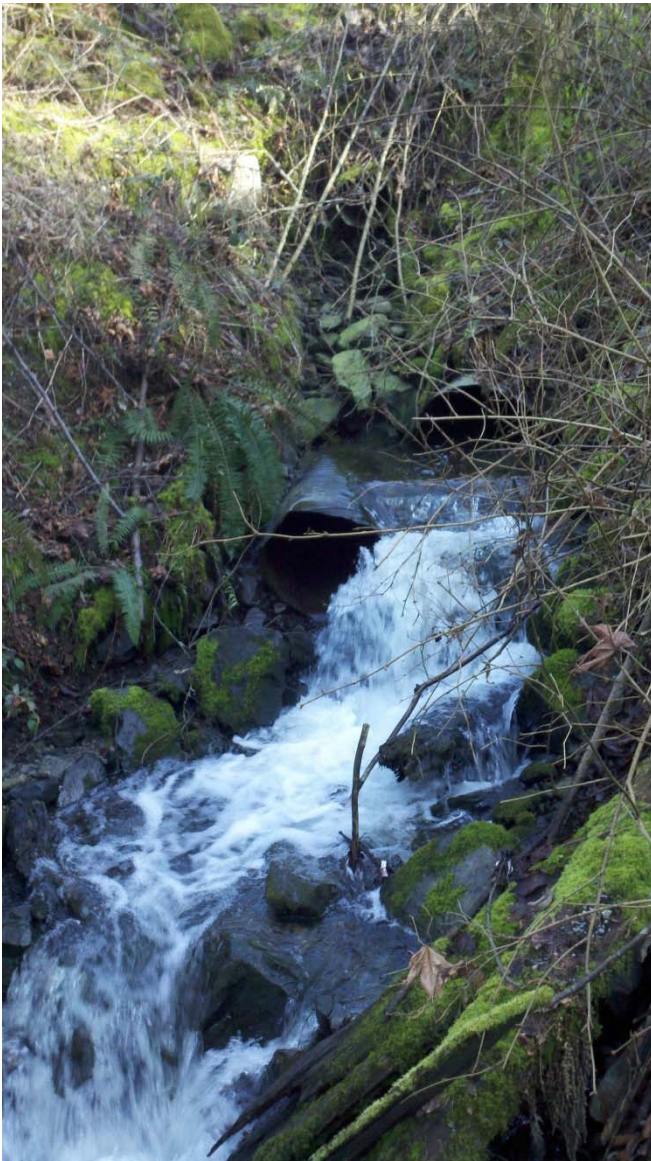
Redondo creek exiting the culvert under the utility corridor drive. This culvert poses a complete fish passage barrier.

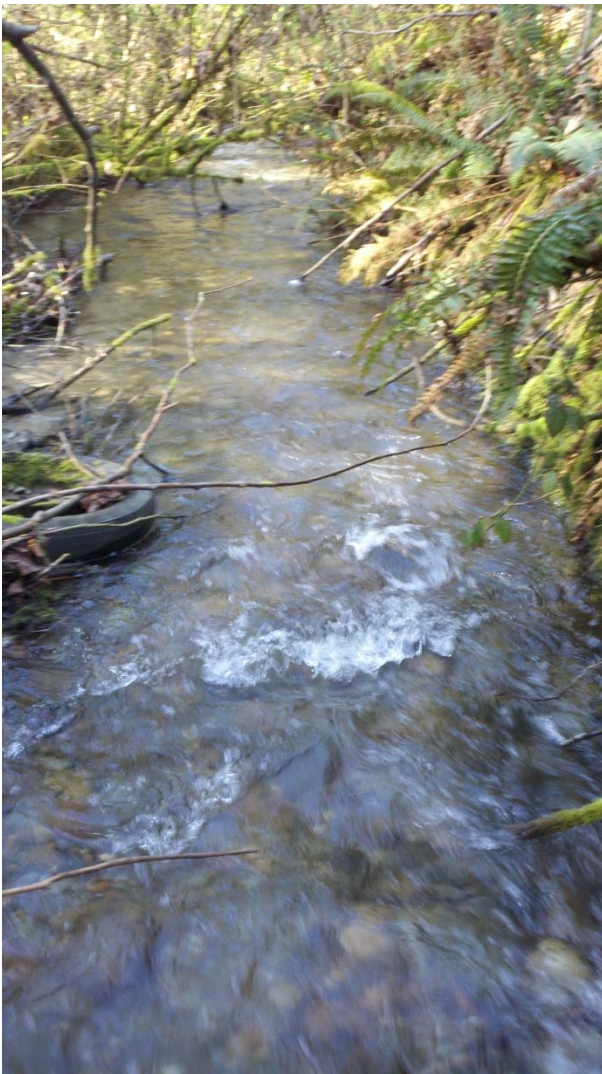
Redondo Creek downstream of utility corridor drive has good riffle habitat and gravel substrate. There is no pool habitat in this reach and the reach is isolated due to an impassable vertical drain at the downstream end where it crosses under Redondo Way.

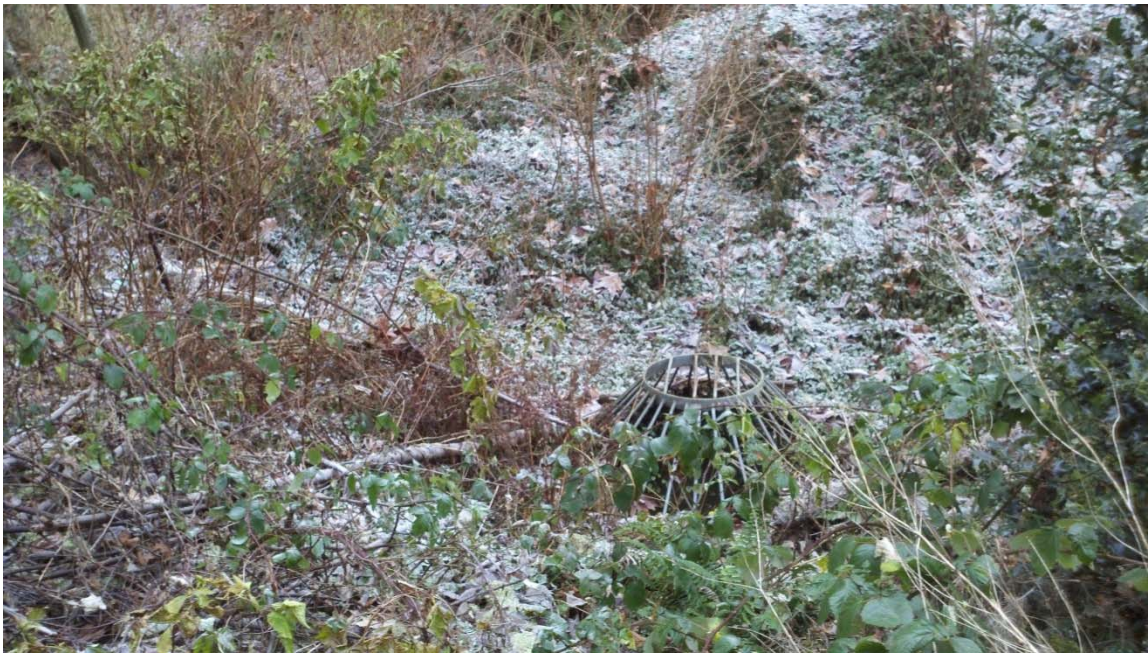
Redondo Creek grated inlet at downstream end of stream alongside Redondo Way.

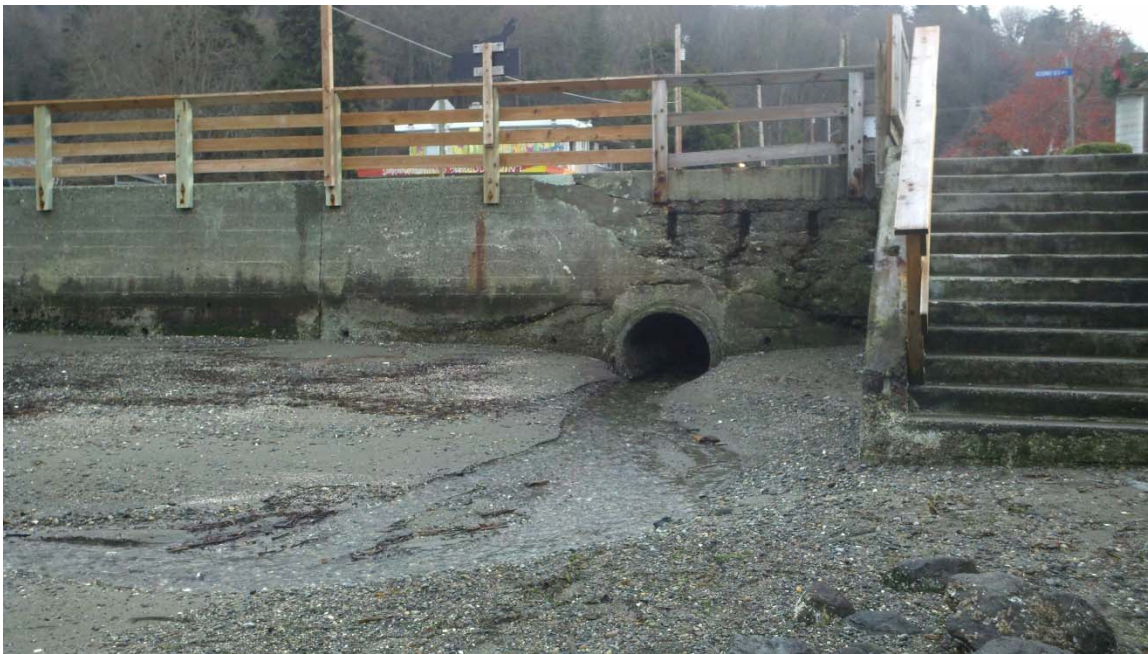
Redondo Creek exit at seawall on Puget Sound shoreline.

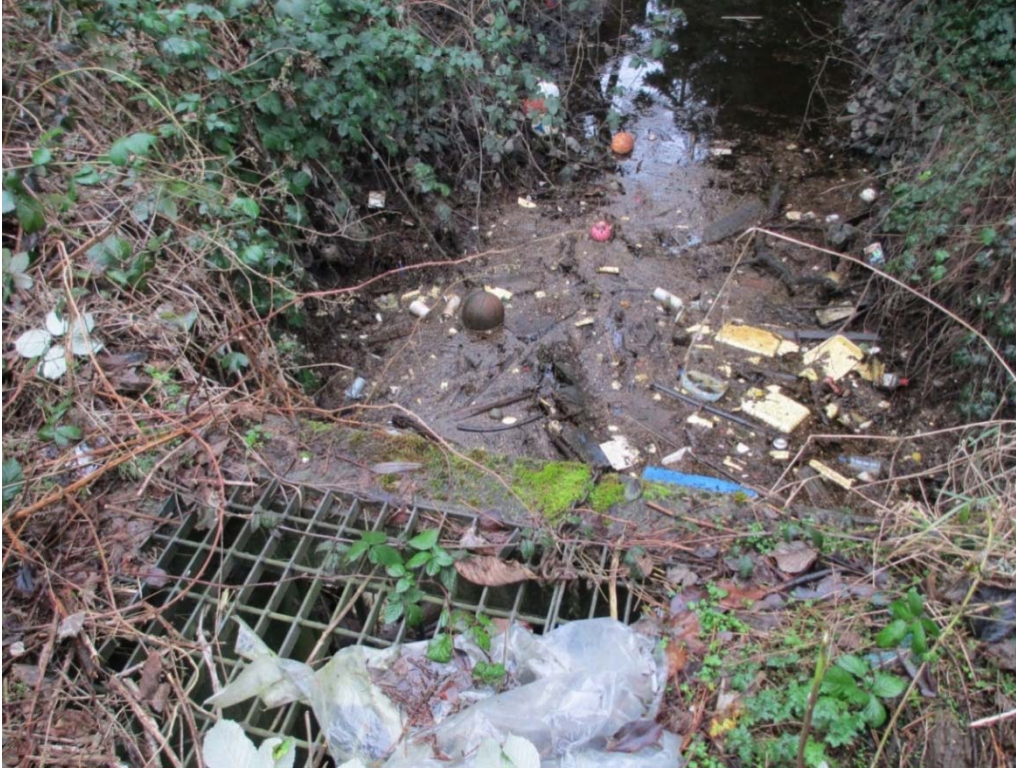
Bingaman Creek trash rack at culvert entrance on south side of S 288th Street.

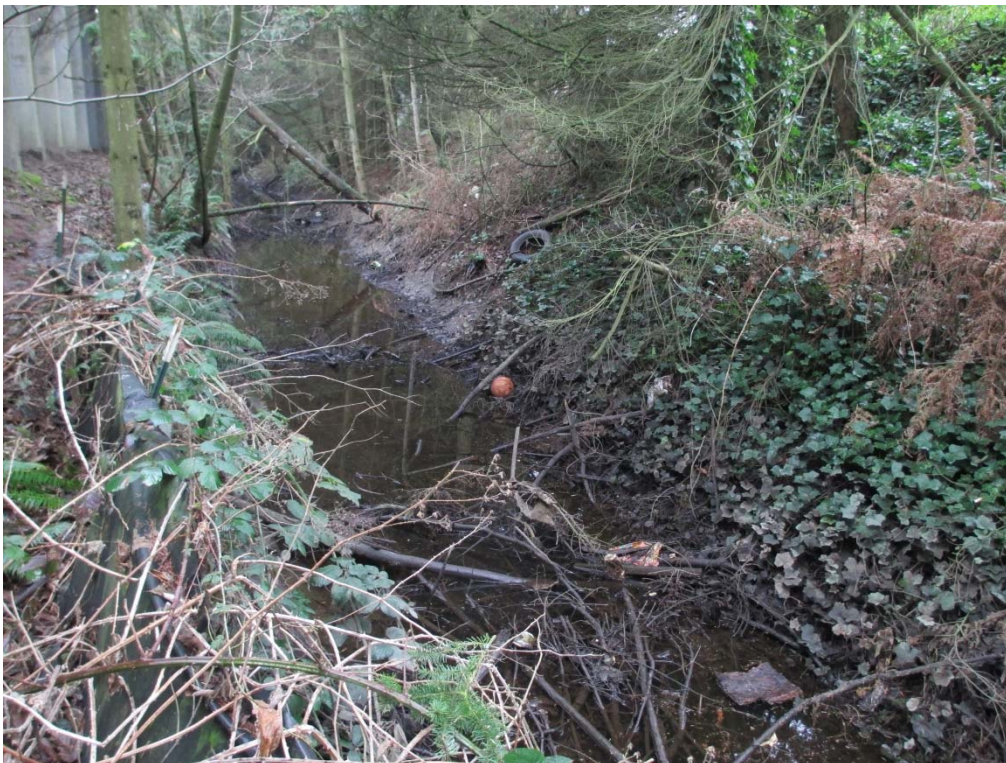
Bingaman Creek reach south of S 288th Street looking upstream. I-5 sound wall is in the left edge of the picture.

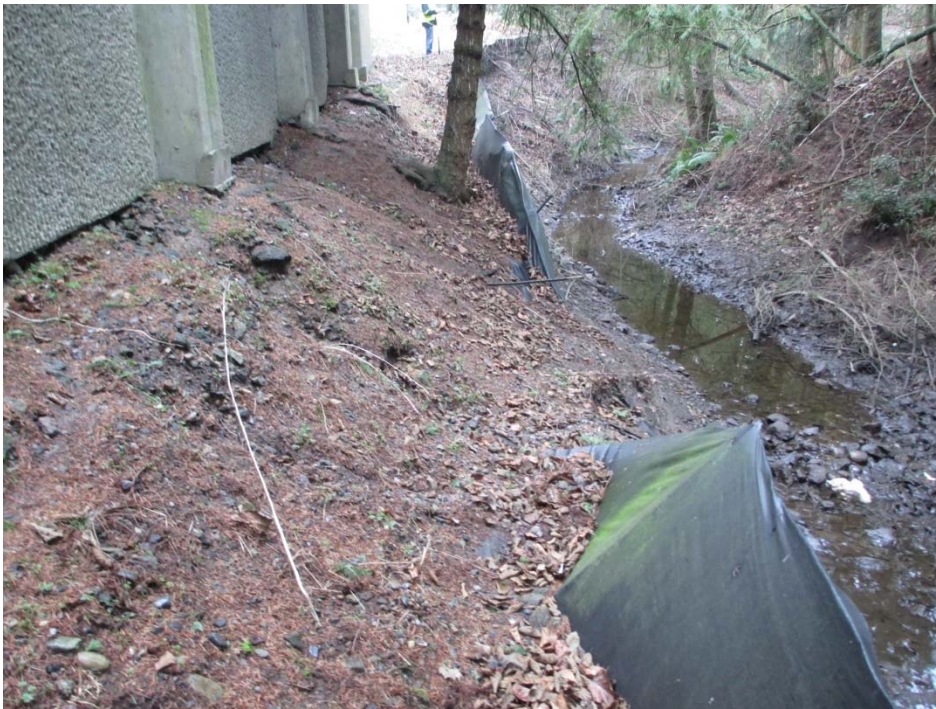
Bingaman Creek right bank eroding next to sound wall along Bingaman Creek reach south of S 288th Street.

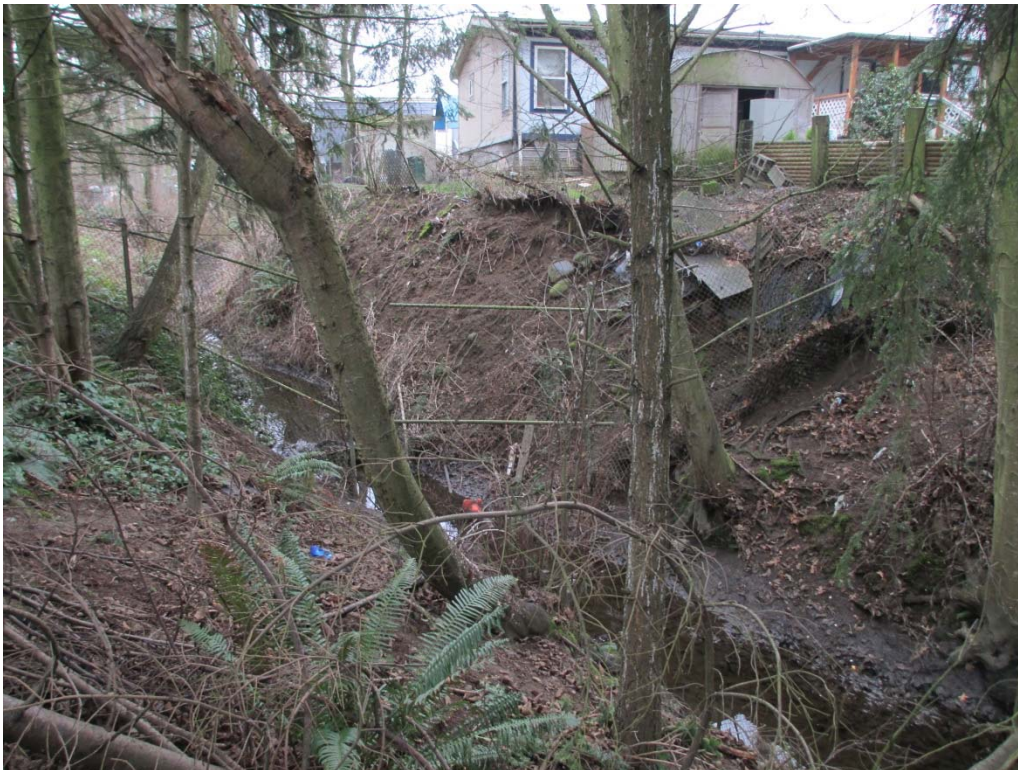
Bingaman Creek bank erosion next to mobile home park along Bingaman Creek reach south of S 288th Street.

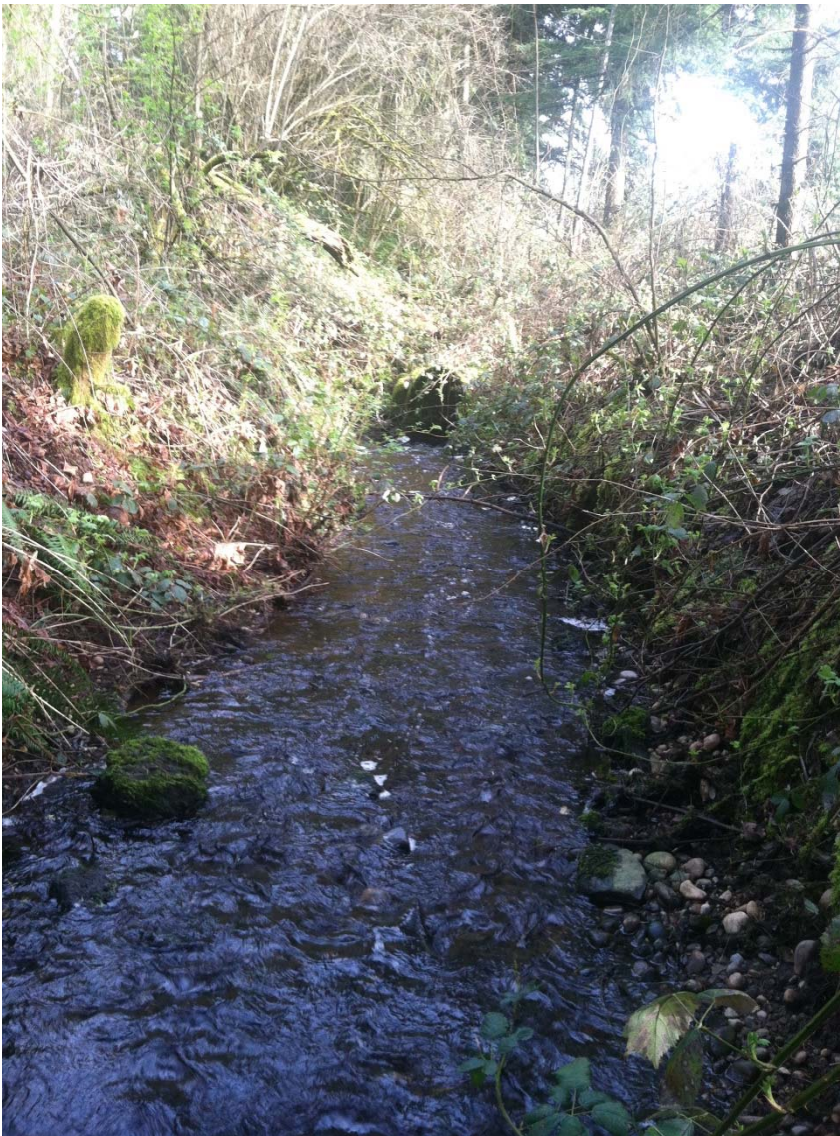
Bingaman Creek reach north of S 288th Street looking downstream to culvert under I-5.
