Federal Way Link Extension

ECOSYSTEMS TECHNICAL REPORT

Appendix G2

Wetland and Stream Photographs

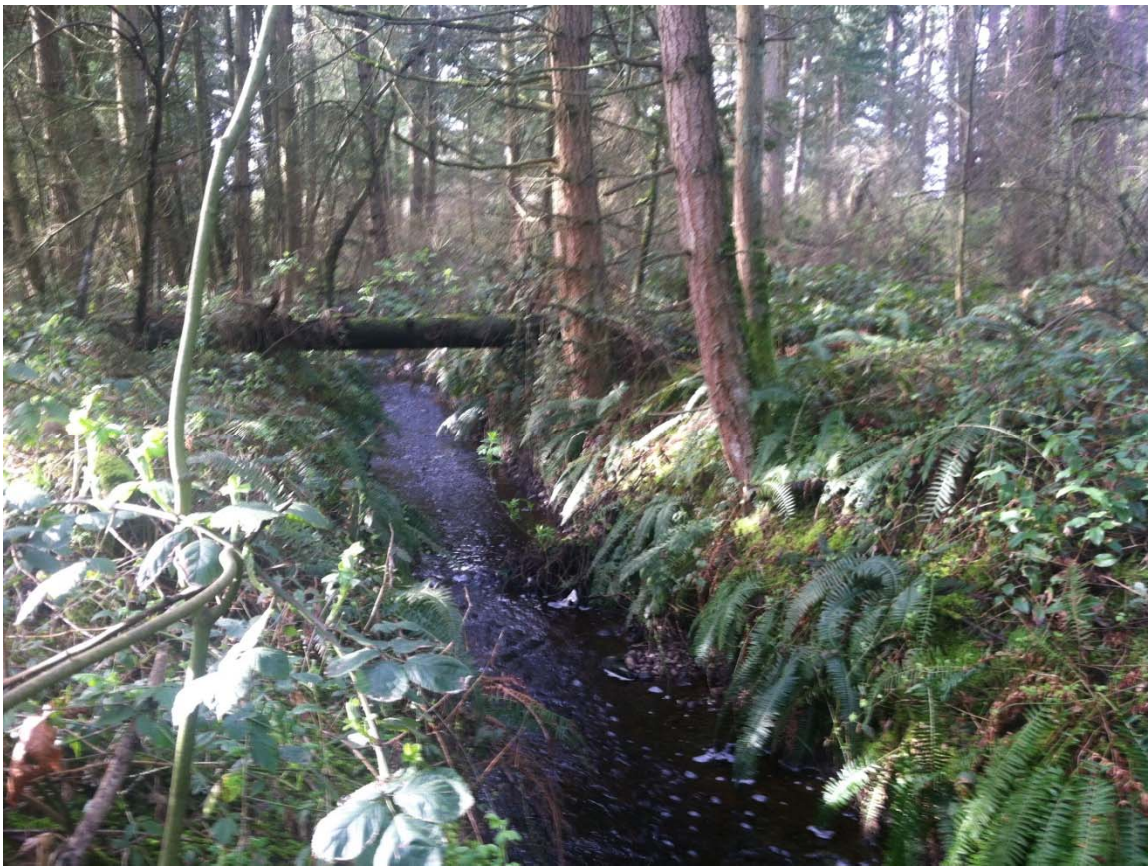
Bingaman Creek reach north of S 288th Street through forested area alongside I-5.

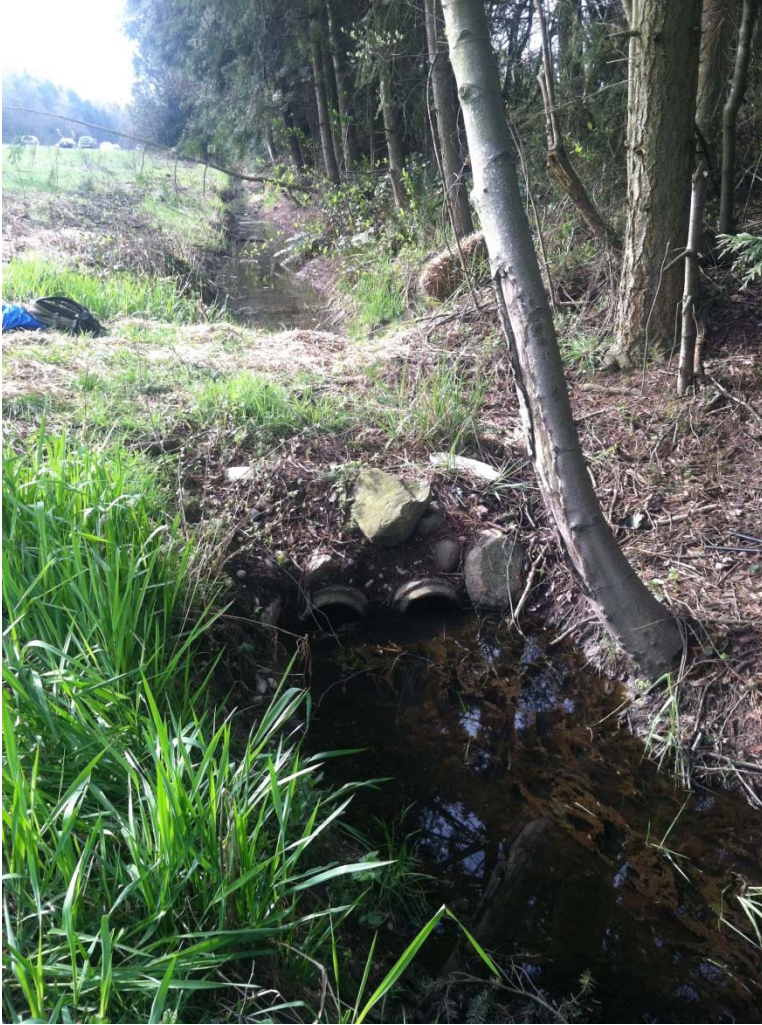
Small unnamed stream in I-5 ROW south of Kent-Des Moines Road. A narrow riparian corridor of conifers is on the left bank, but vegetation has been removed on the right bank along the I-5 road prism.

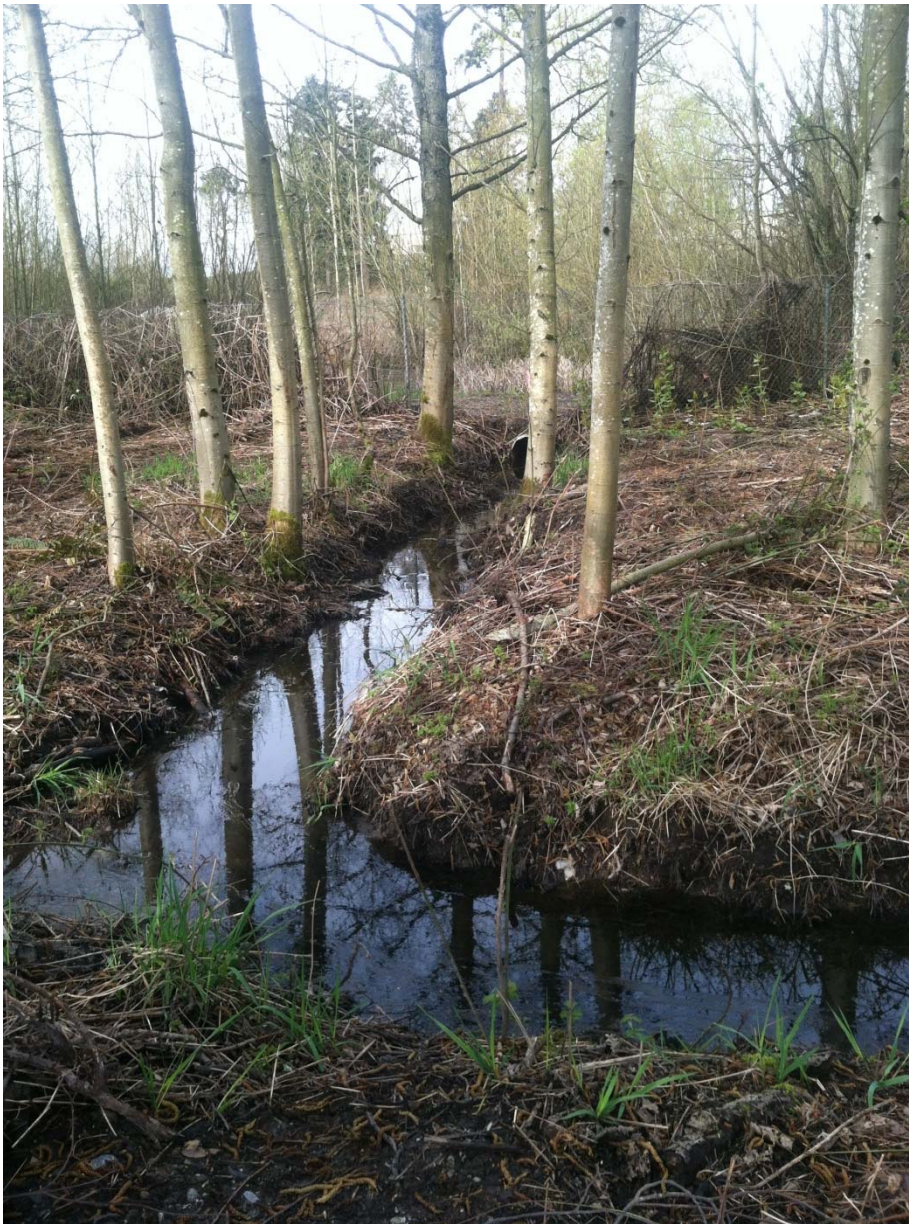
Small unnamed stream in I-5 ROW south of Kent-Des Moines Road. An artificially channelized segment flows east from Wetland 20-2 next to I-5.
